# Collision between passenger train 8070 and truck

Goornong, Victoria on 13 July 2022

**ATSB Transport Safety Report**

RO-2022-007

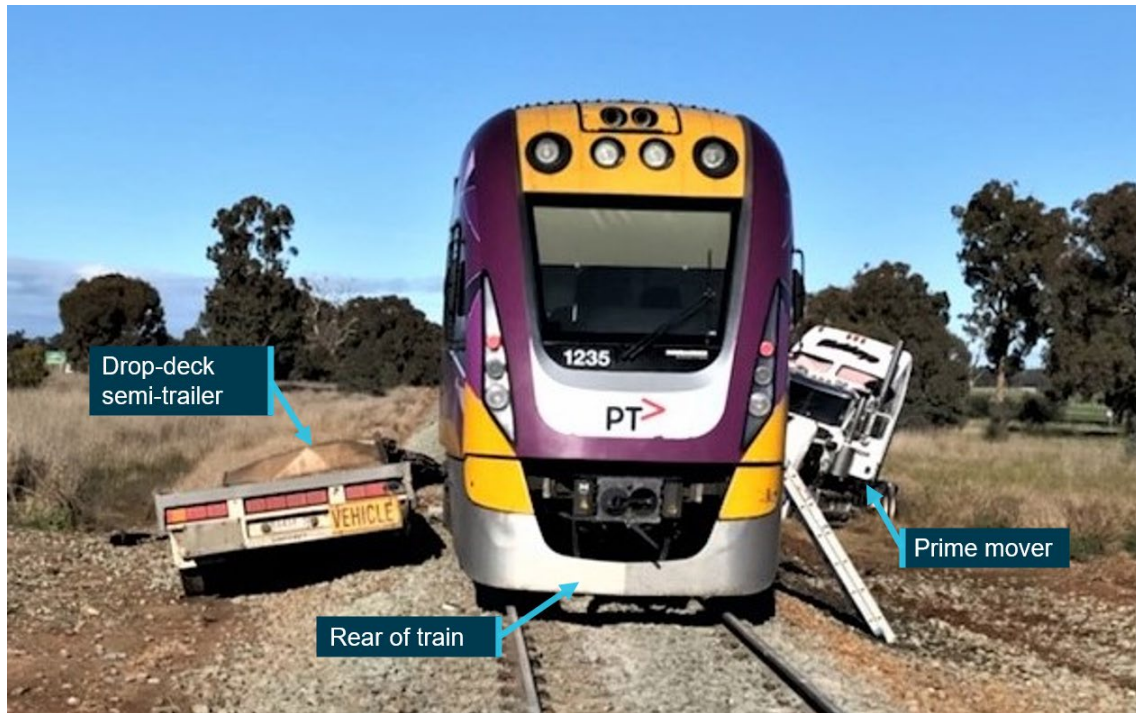
**Figure 2: Rear of train, prime mover and semi-trailer of truck after collision**

The impact resulted in the derailment of both bogies on the leading car of the train. The lead rail car and the track infrastructure were extensively damaged. The train driver sustained minor injuries. There were no injuries to the passengers on the train.

The truck driver was seriously injured in the collision. The truck was severely damaged, with the semi-trailer separating from the prime mover (Figure 2).

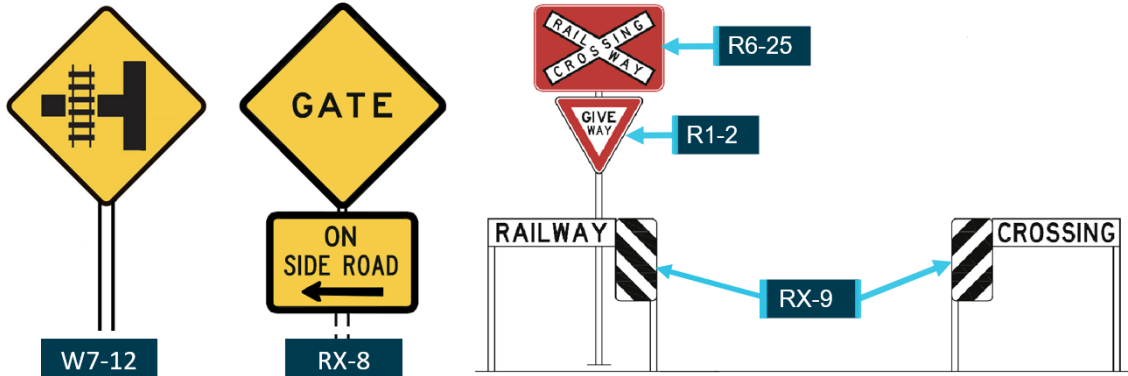
**Figure 4: Signage on approach to and at the level crossing**

The level crossing was also fitted with signage typical of a passive (give way) level crossing. The Australian Standard 1742.7<sup>1</sup> specified the signage requirements. W7-12<sup>2</sup> and RX-8<sup>3</sup> signs were located on the Midland Highway before the turn-off to the level crossing (Figure 4).

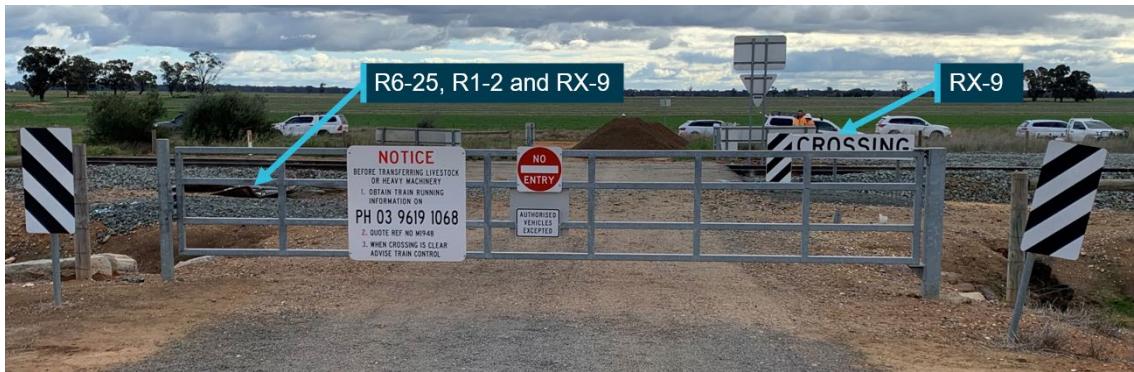
**Figure 5: Holmes Road level crossing access from east of the rail track**

On either side of the crossing, R6-25,<sup>4</sup> R1-2<sup>5</sup> and RX-9<sup>6</sup> signs were installed (Figures 5 and 6).

Holmes Road level crossing shown from the east side, the approach side of the truck. At the time of incident, the gate was open. R6-25, R1-2 and RX-9 assemblies to the left of the road were knocked to the ground during the collision.  
Source: Chief Investigator, Transport Safety (Victoria)

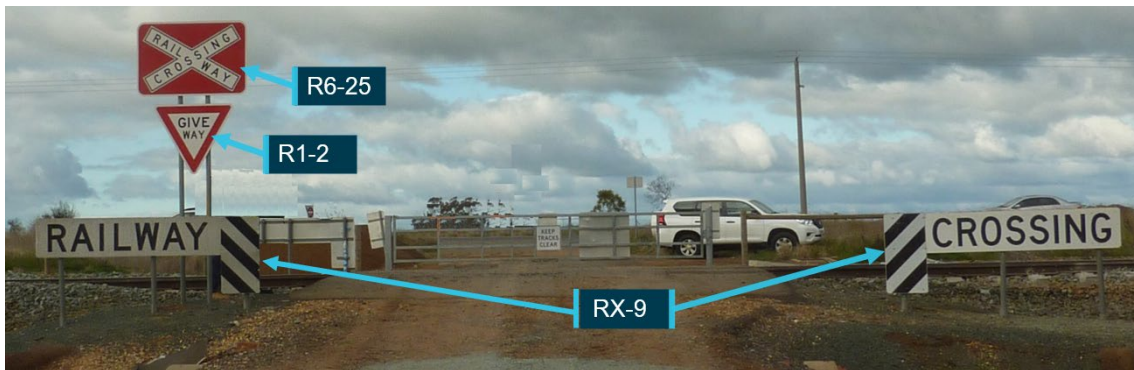
**Figure 6: Holmes Road level crossing access from west of the rail track**

Holmes Road level crossing shown from the west side with all signage intact.  
Source: Chief Investigator, Transport Safety (Victoria)

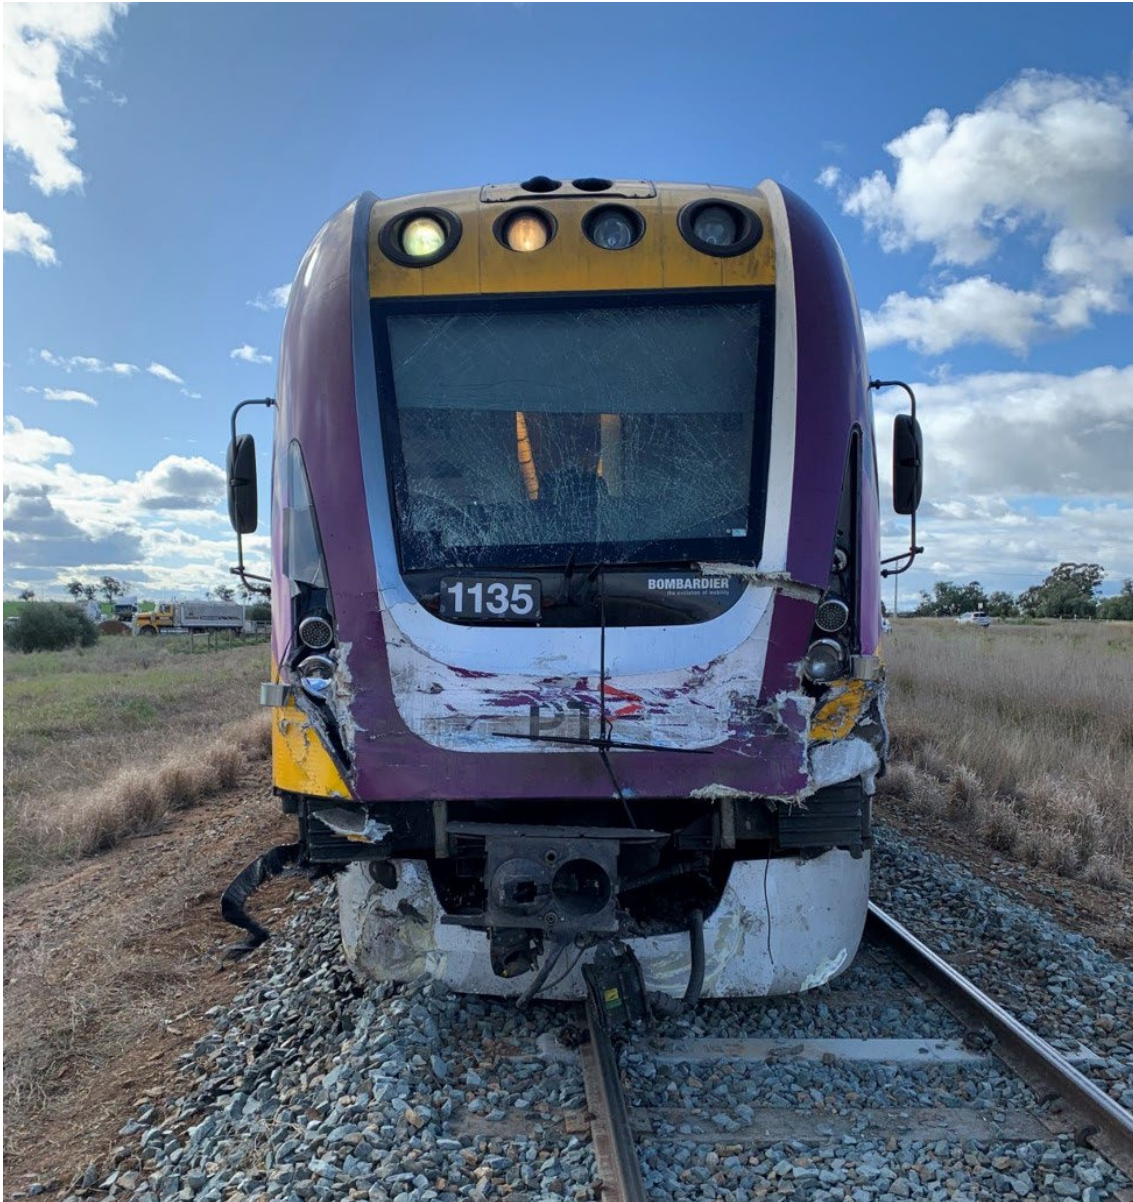
**Figure 7: Damage to the front of the train**

In addition to its derailment, the impact with the truck caused damage to the front of the leading car. The laminated safety glass of the windscreen and side windows were shattered, but all windows remained within their frames (Figure 7). The driver’s cab floor was pushed up and the underside of the control desk was deformed.

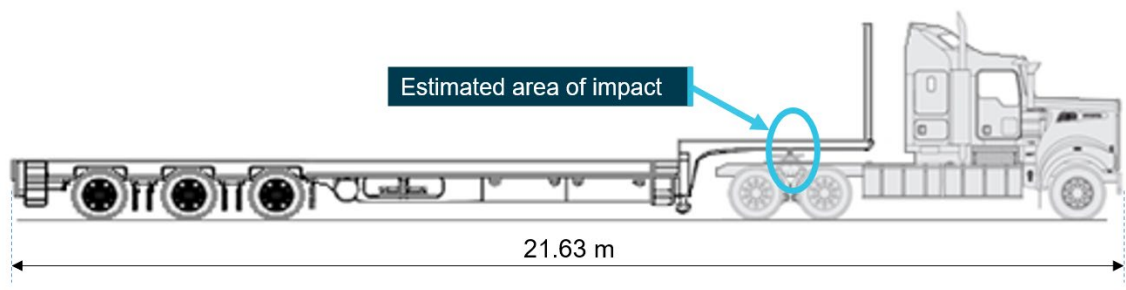
**Figure 8: Drop-deck semi-trailer**

The truck consisted of a 2013 Kenworth T909 prime mover, coupled to a 45-ft drop-deck semi-trailer (Figure 8).
