Reaction to fire test report

Test standard: Ad-hoc test based off ISO 13785-1:2002

System: Aluminium composite panel wall system representative of the in-situ wall located at [REDACTED]
[REDACTED] – Scenario 2 - Test 1

Job number: RTF220104

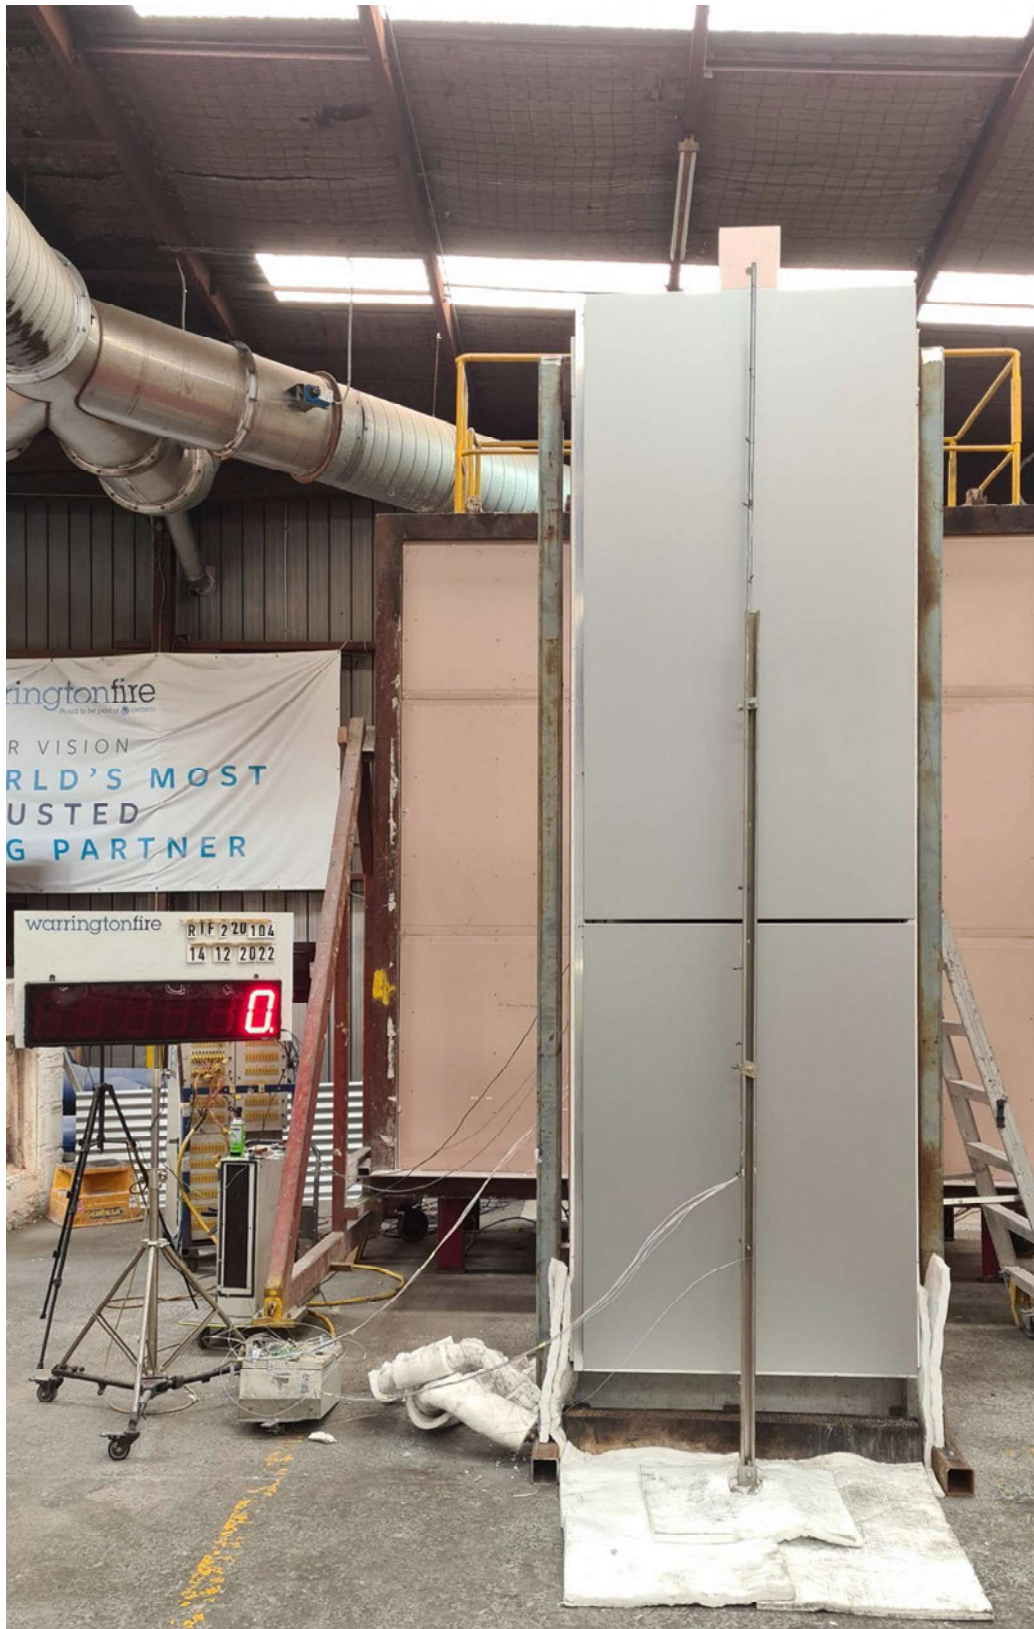
Figure 9 The specimen before the reaction to fire test

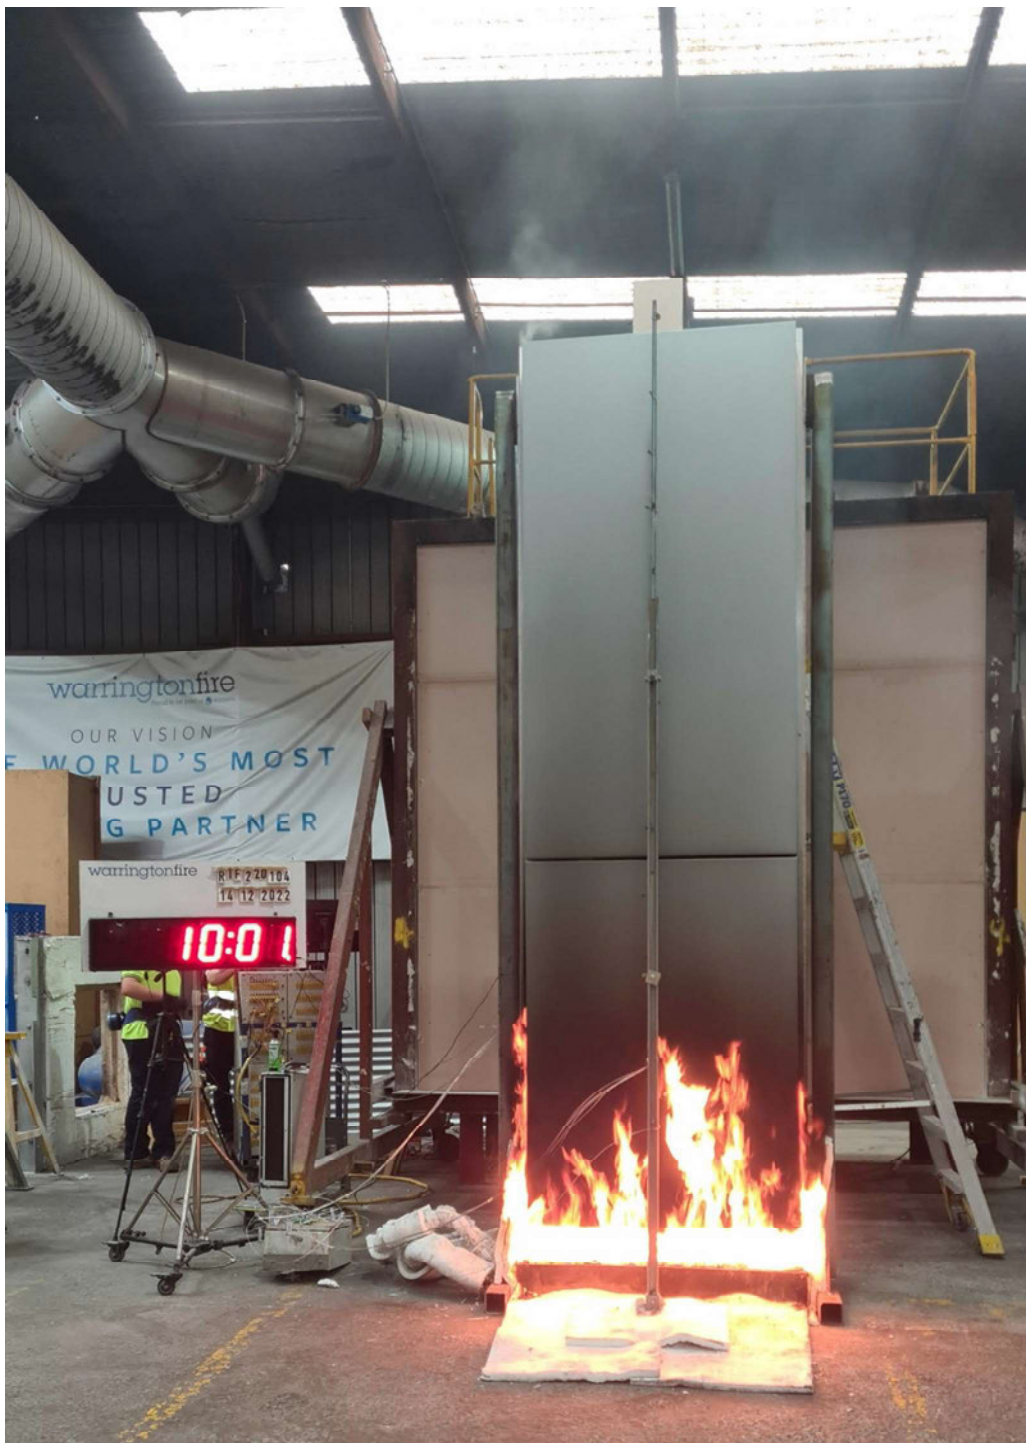
Figure 11 The specimen 10 minutes 1 second into the test (burner output at 100 kW)

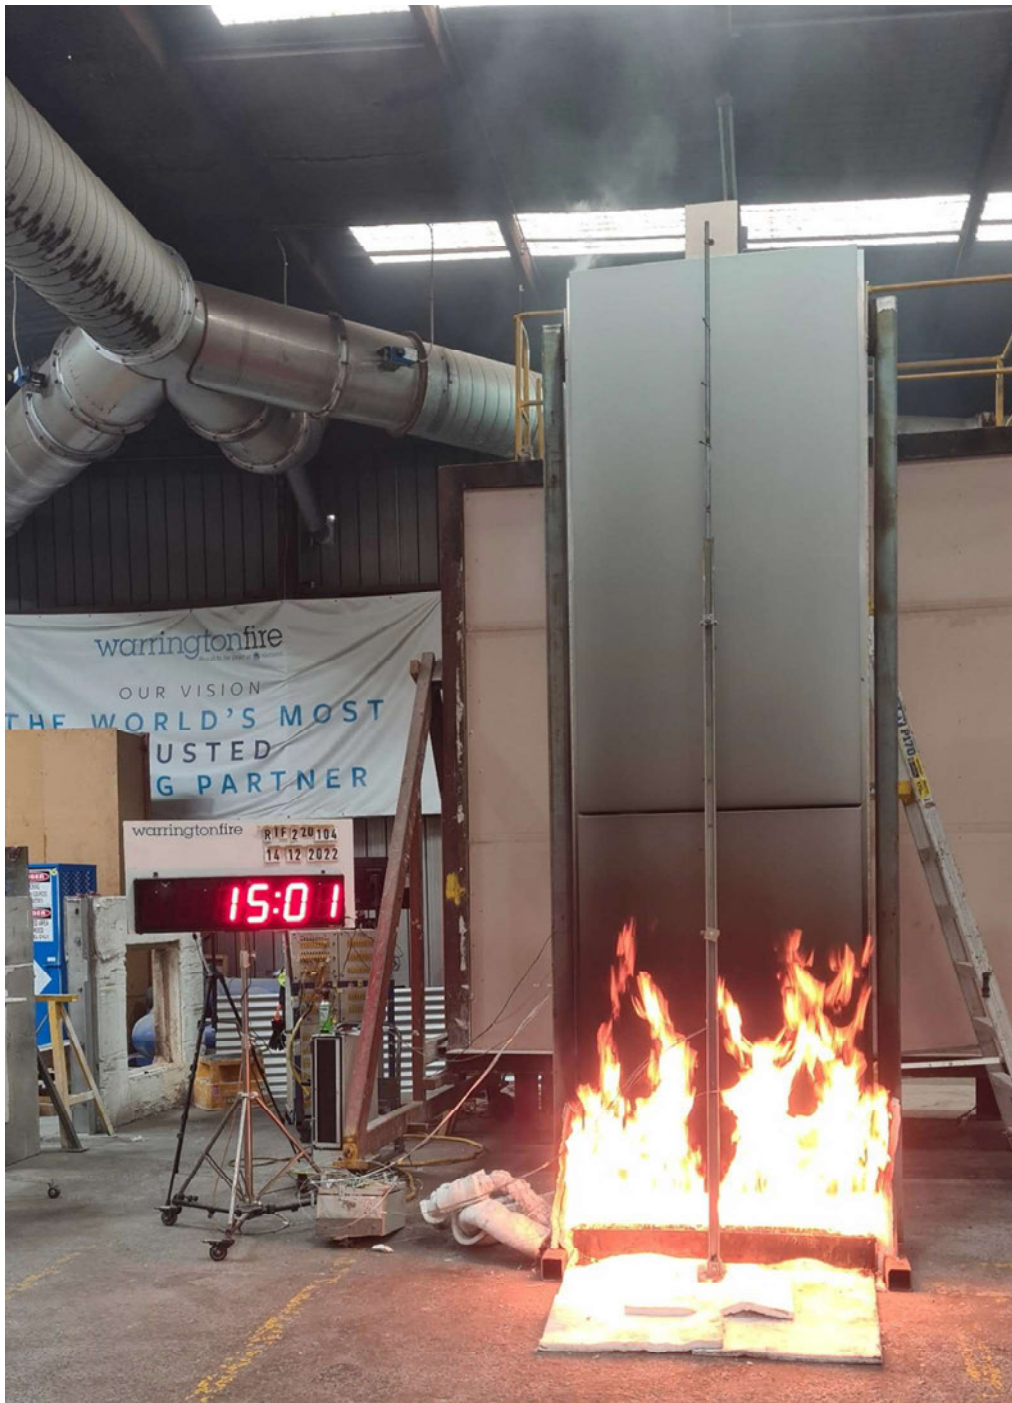
Figure 12 The specimen 15 minutes 1 second into the test (burner output at 100 kW changed to 300 kW)

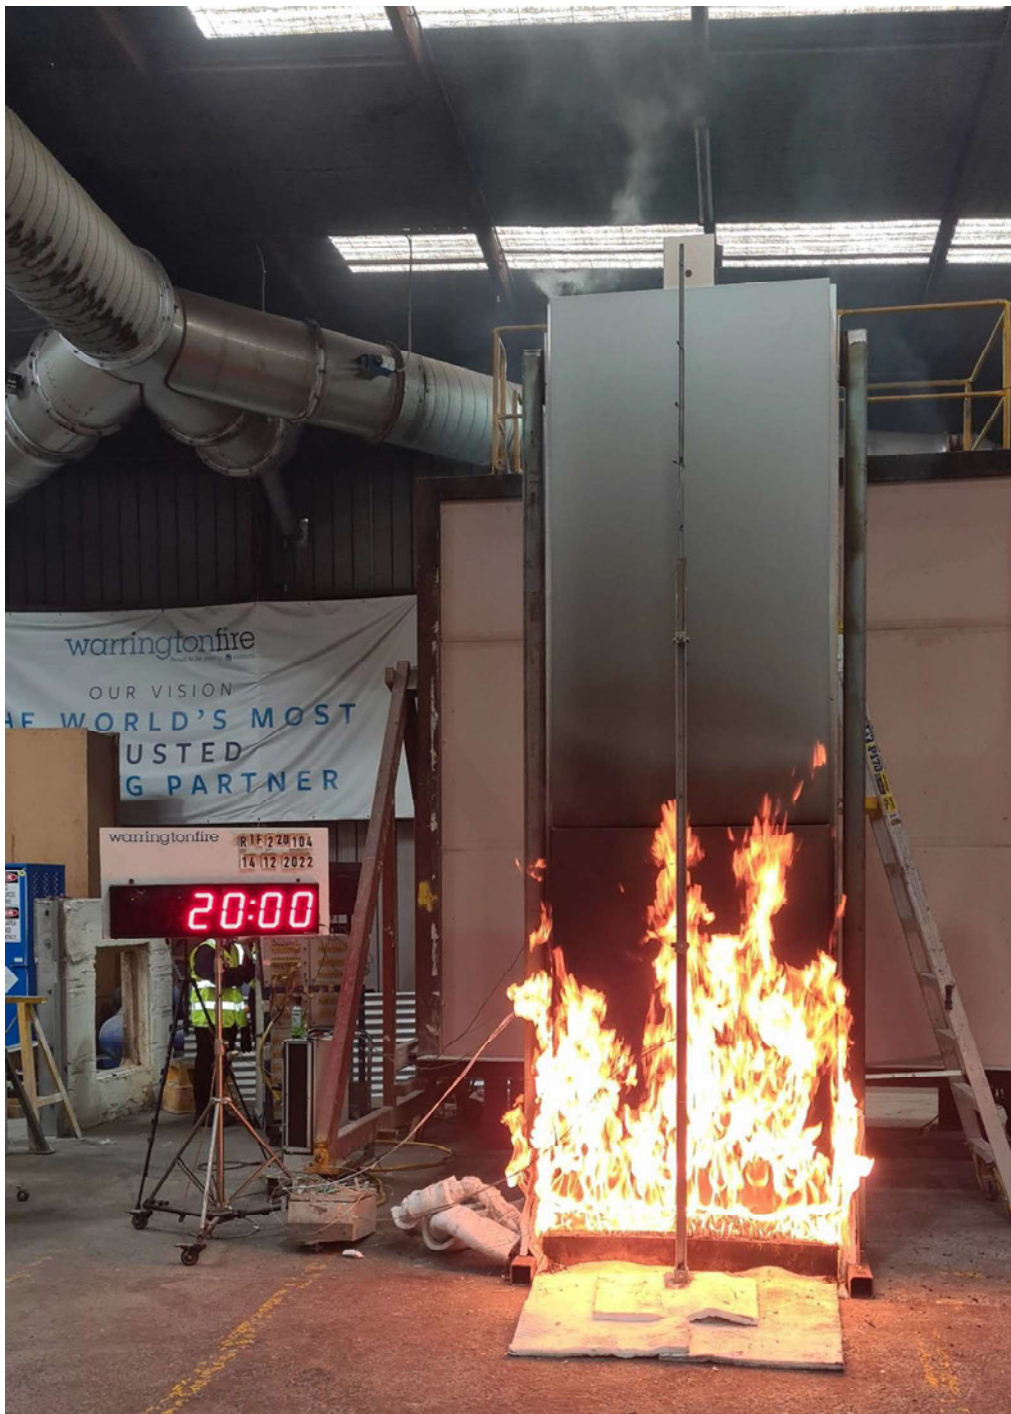
Figure 13 The specimen 20 minutes into the test (5 minutes after burner output was increased to 300 kW)

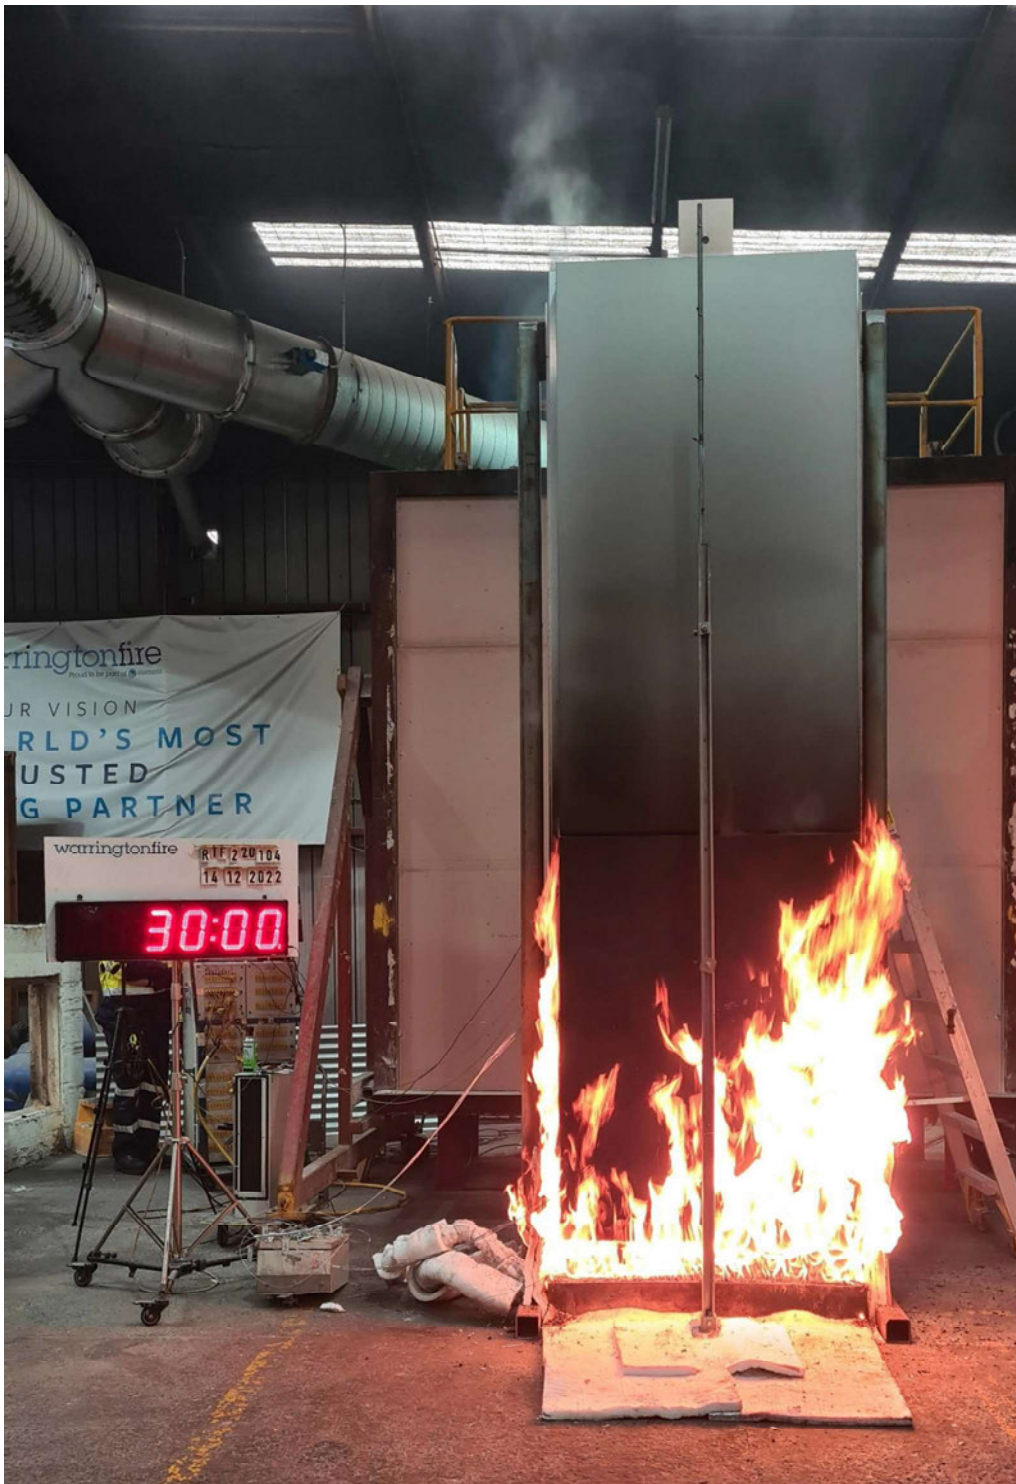
Figure 14 The specimen 30 minutes into the test (15 minutes after burner output was increased to 300 kW)

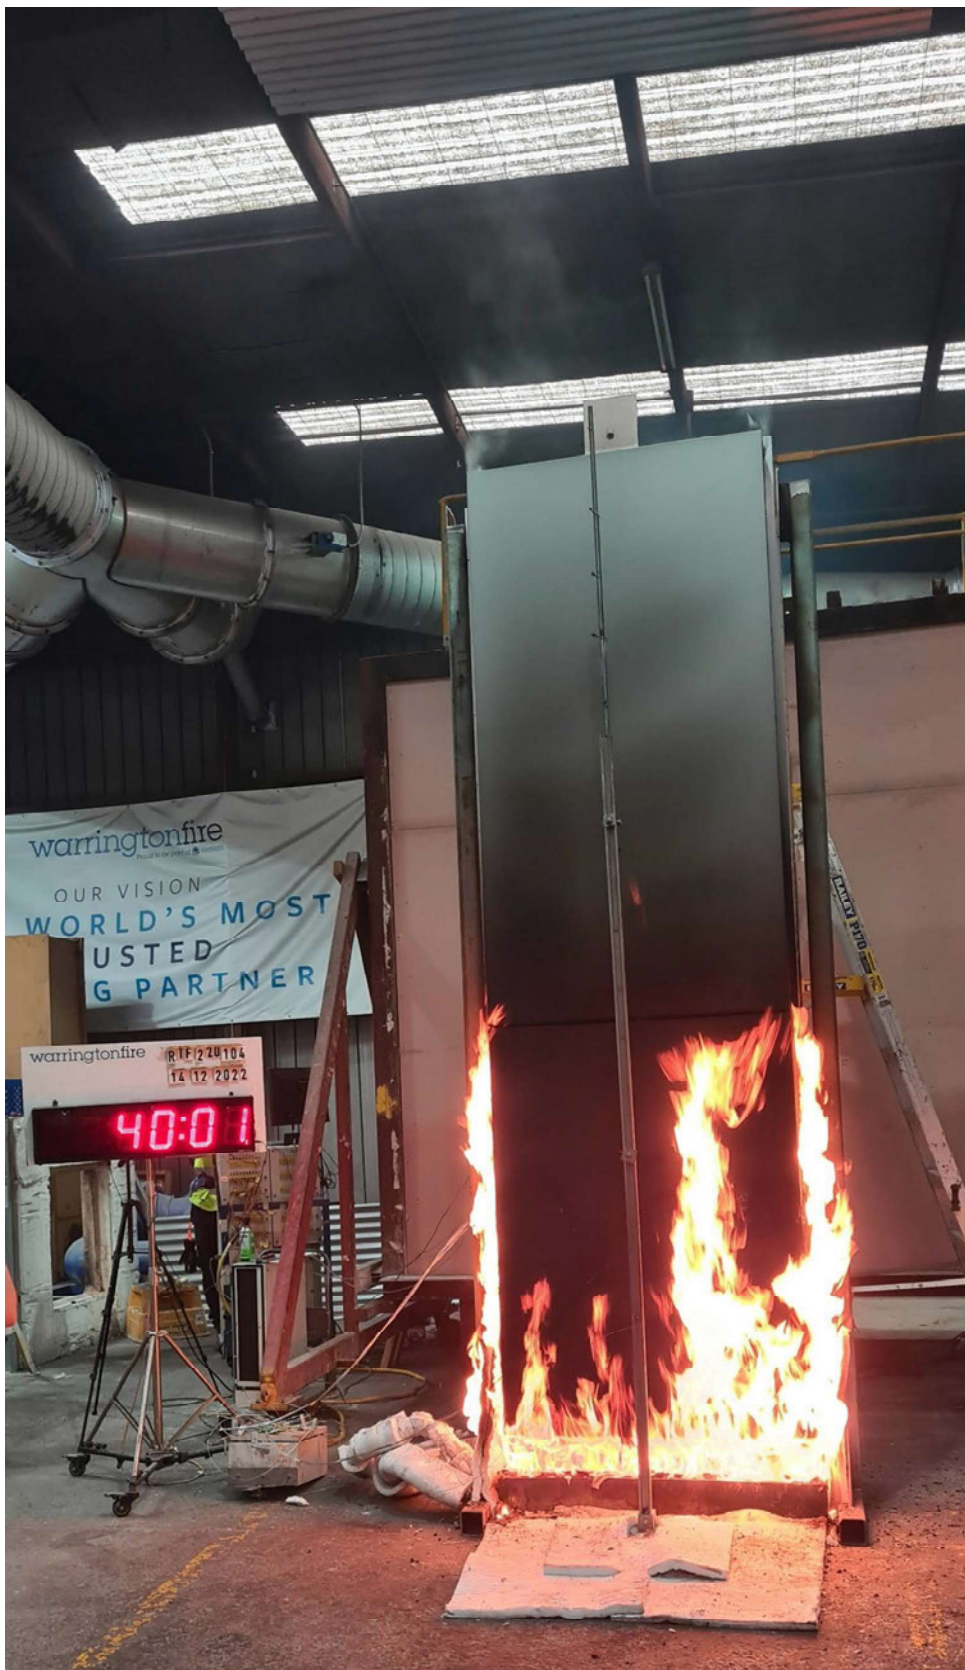
Figure 15 The specimen 40 minutes 1 second into the test (25 minutes 1 second after burner output was increased to 300 kW) – burner turned off.

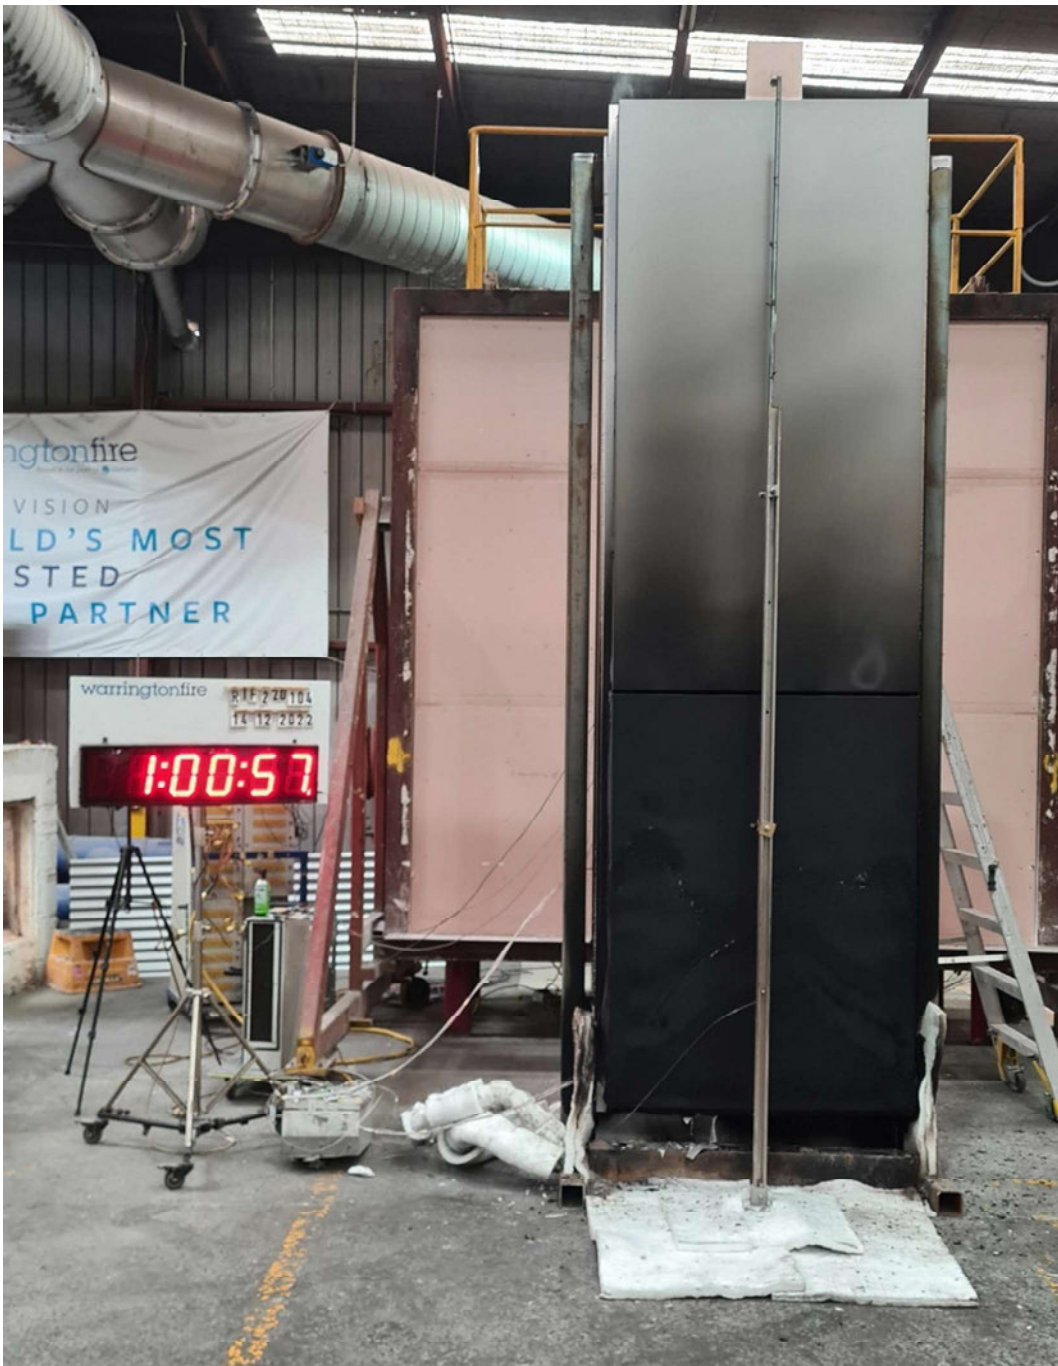
Figure 16 The specimen at the end of test.
