# Reaction to fire test report

Test standard: Ad-hoc test based off ISO 13785-1:2002 with an additional wind component.

System: Aluminium composite panel wall system representative of the in-situ wall located at [REDACTED]  
[REDACTED] – Scenario 1

Job number: RTF230002

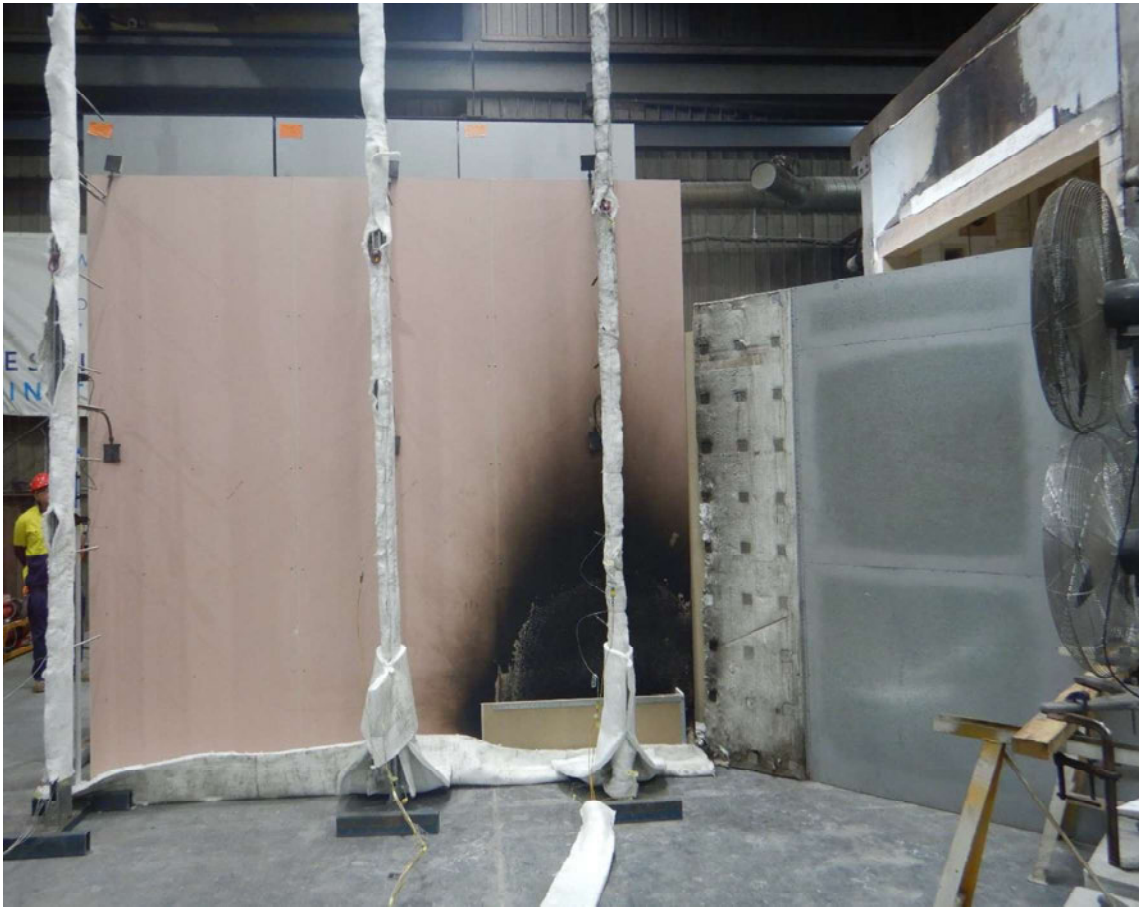
**Figure 5** Photograph of baseline setup – 1.5 mm MIMS thermocouples were measuring 60 mm from the plasterboard.

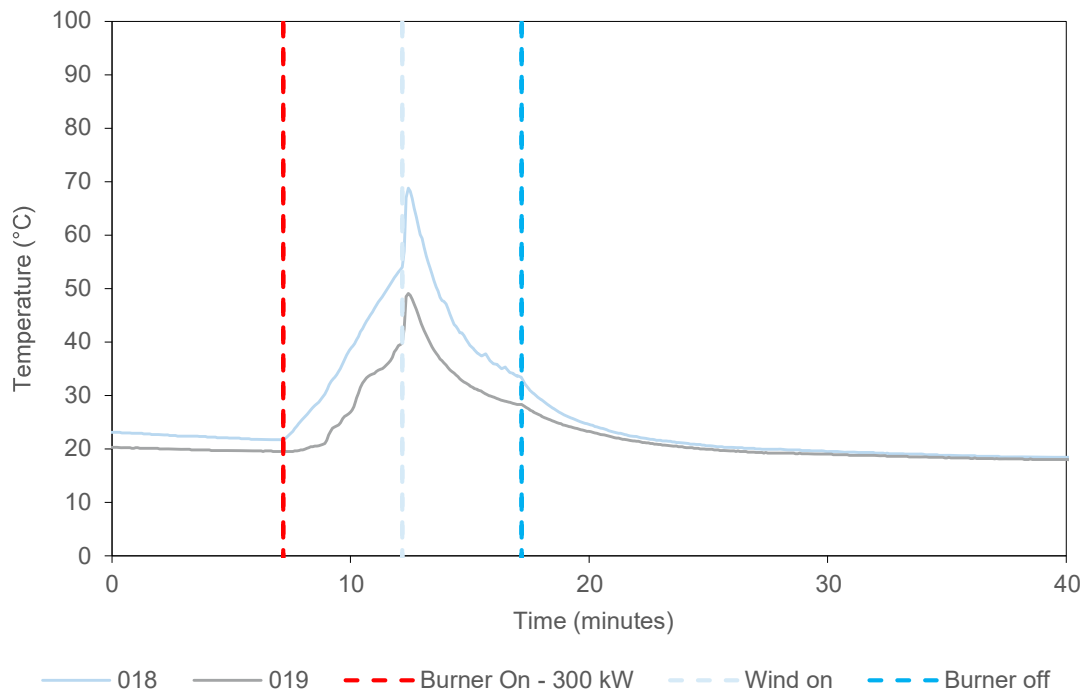
**Figure 9** Baseline data collection - Plate thermocouples placed 60 mm from the front face of the blanking wall - centre.

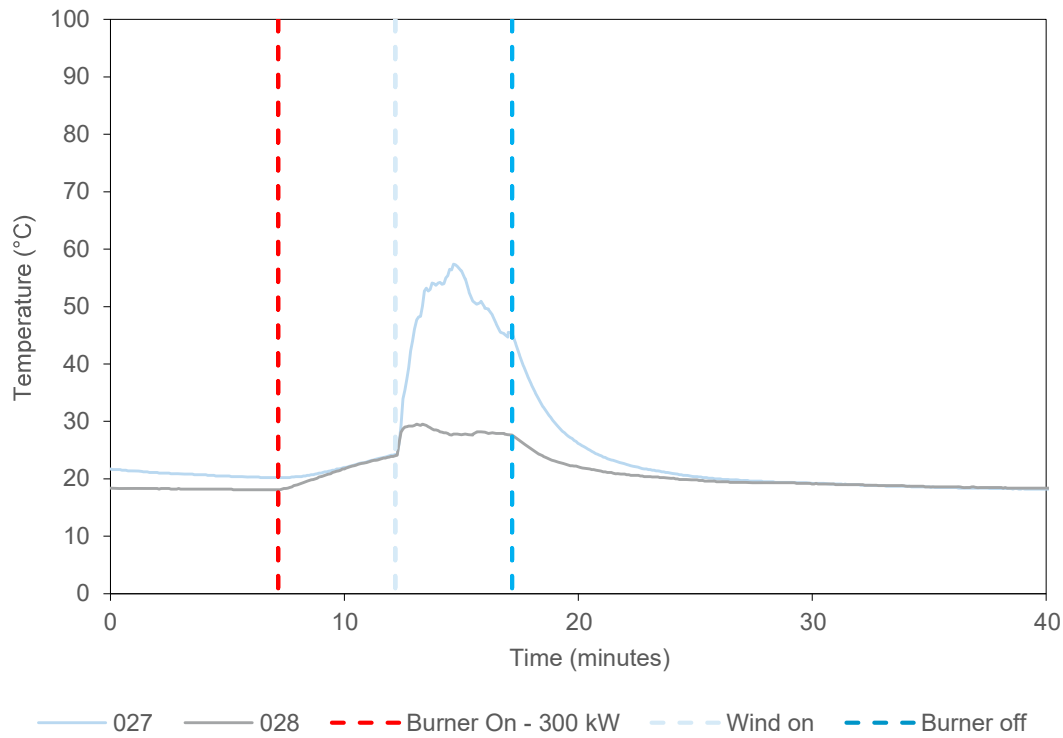
**Figure 11** Baseline data collection - Plate thermocouples placed 60 mm from the front face of the blanking wall - away from burner.

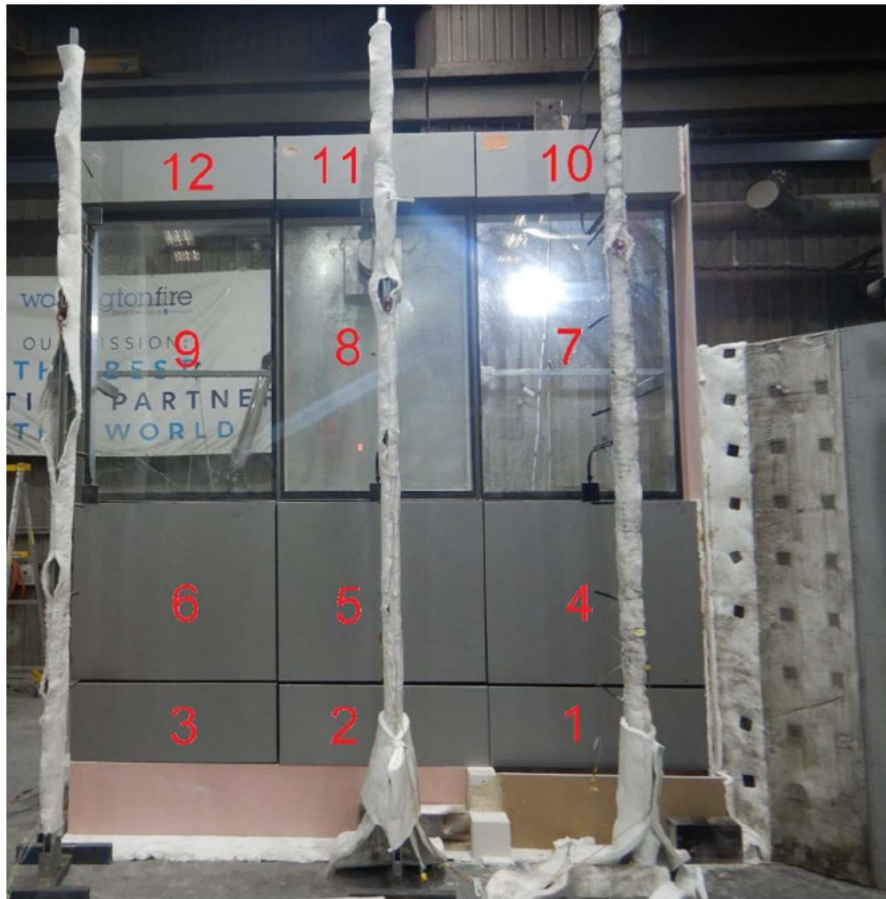
Figure 20 Designation of section for the test observations.

Table 4 shows the observations of any significant behaviour of the specimen during the test. Figure 19 shows the panel and glazing designations sighted in the observations.

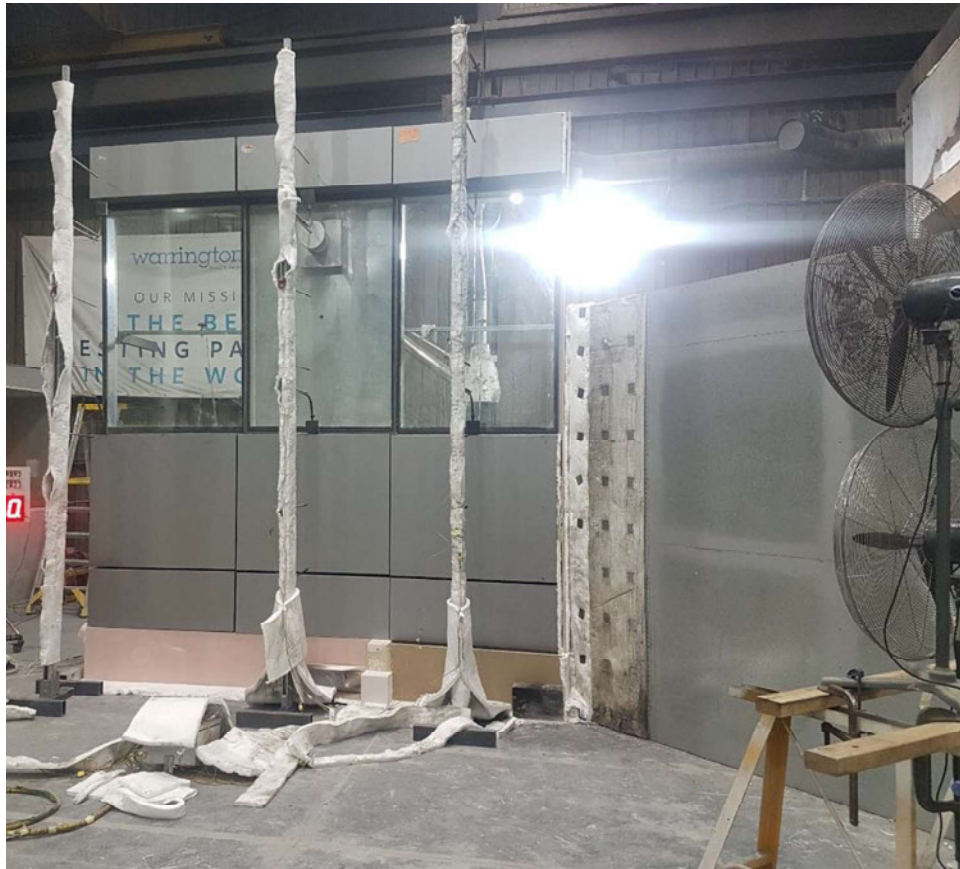
Figure 29 The specimen and test setup (angled - exposed side) before the reaction to fire test

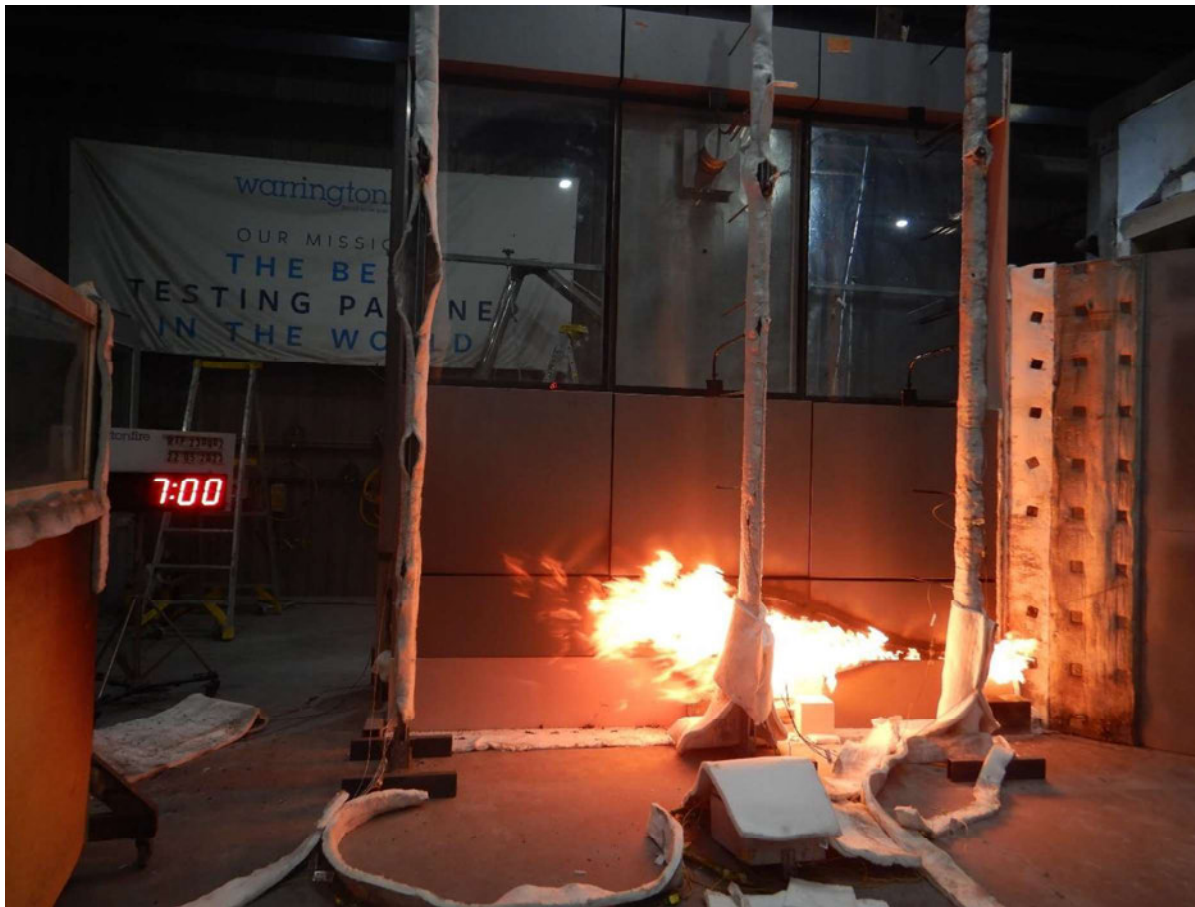
Figure 34 The specimen 7 minutes into the test (burner output at 300 kW and wind on)

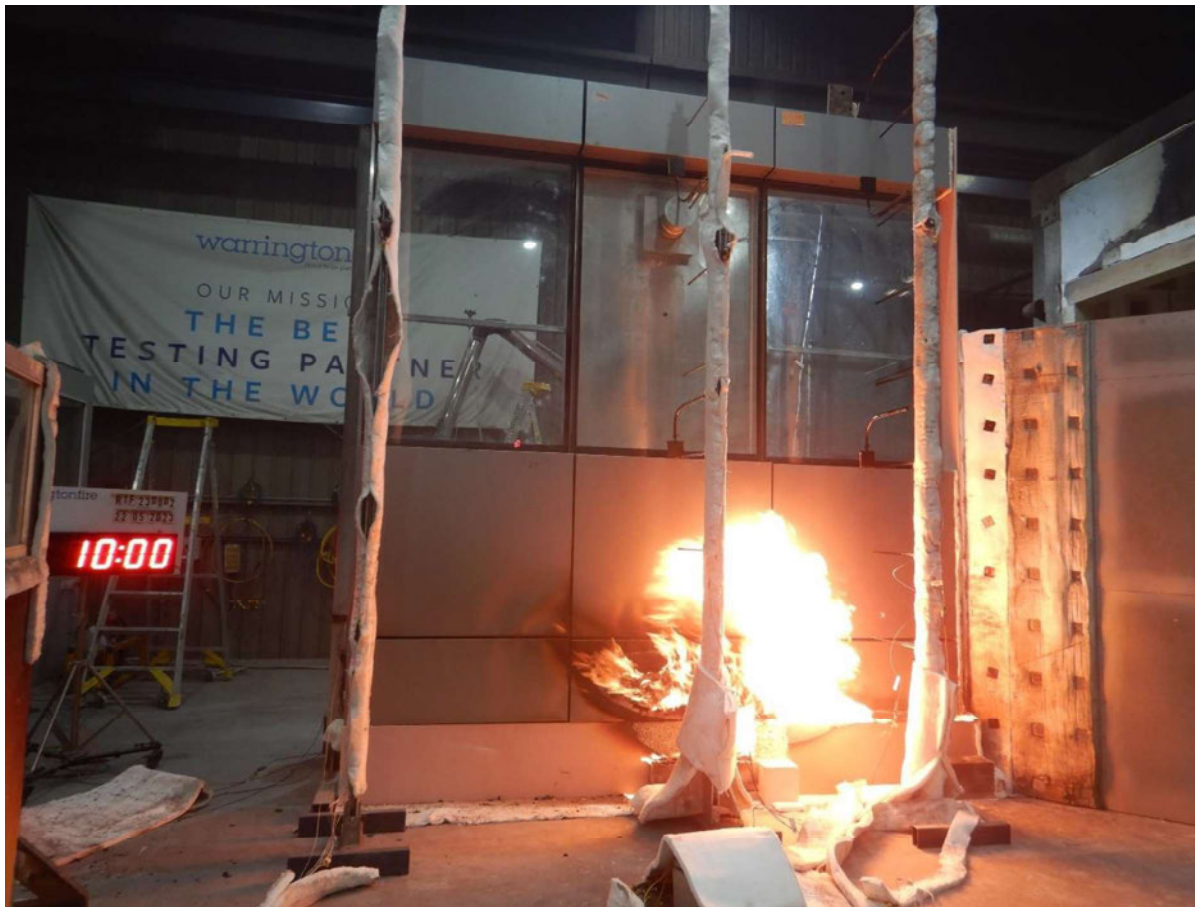
Figure 35 The specimen 10 minutes into the test (burner output at 300 kW and wind on)

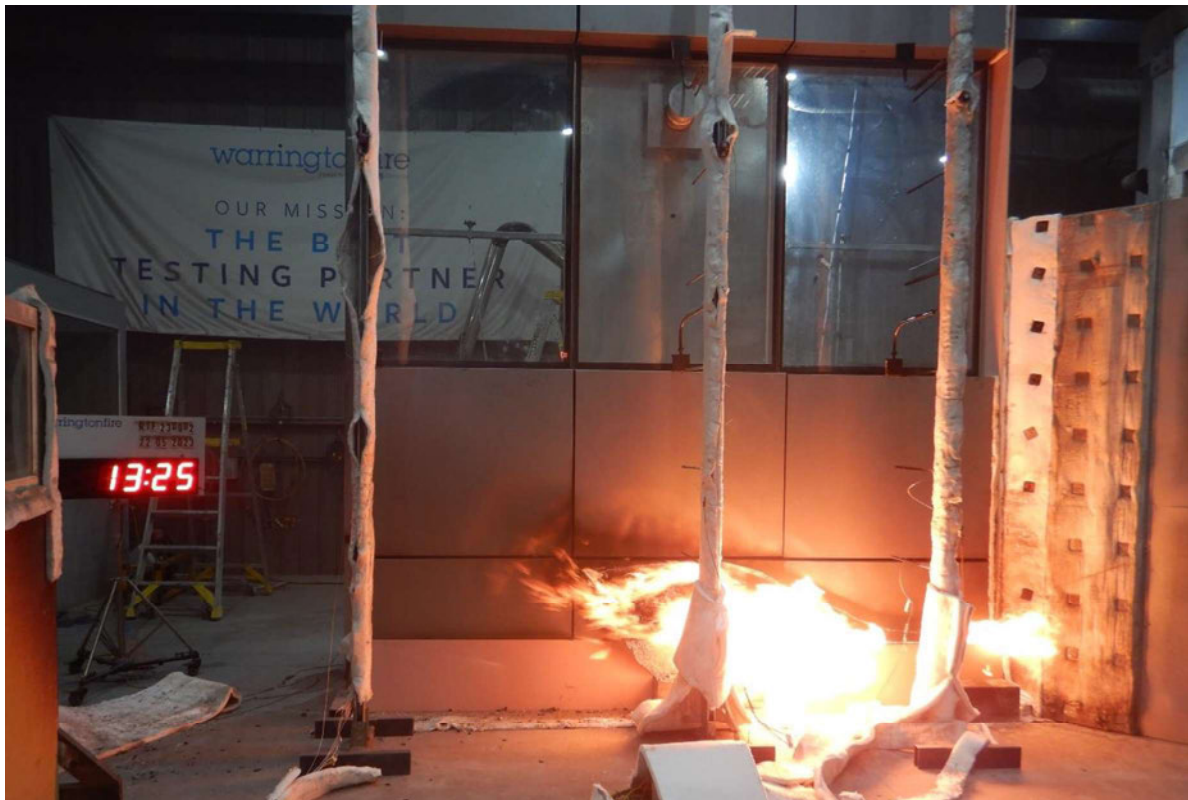
**Figure 36** The specimen 13 minutes 25 seconds into the test (burner output at 300 kW and wind on).

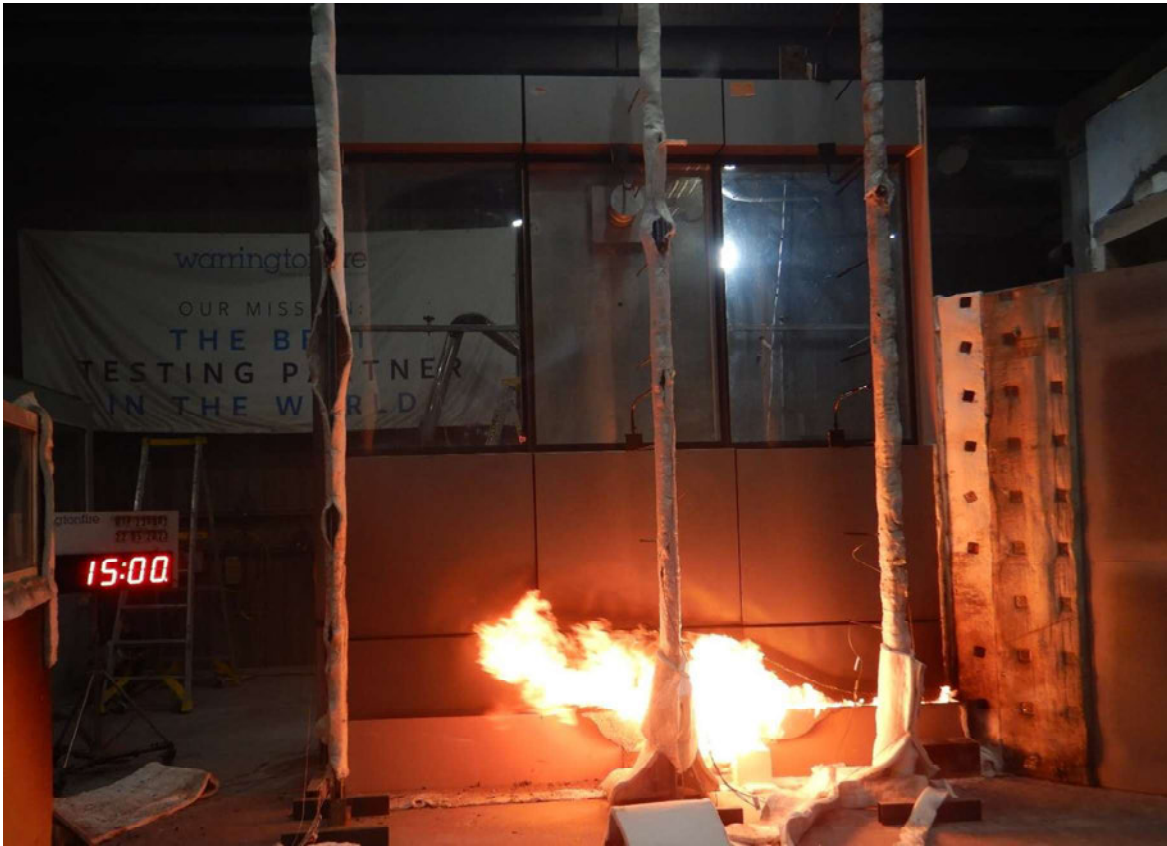
Figure 37 The specimen 15 minutes into the test (burner output at 300 kW and wind on).

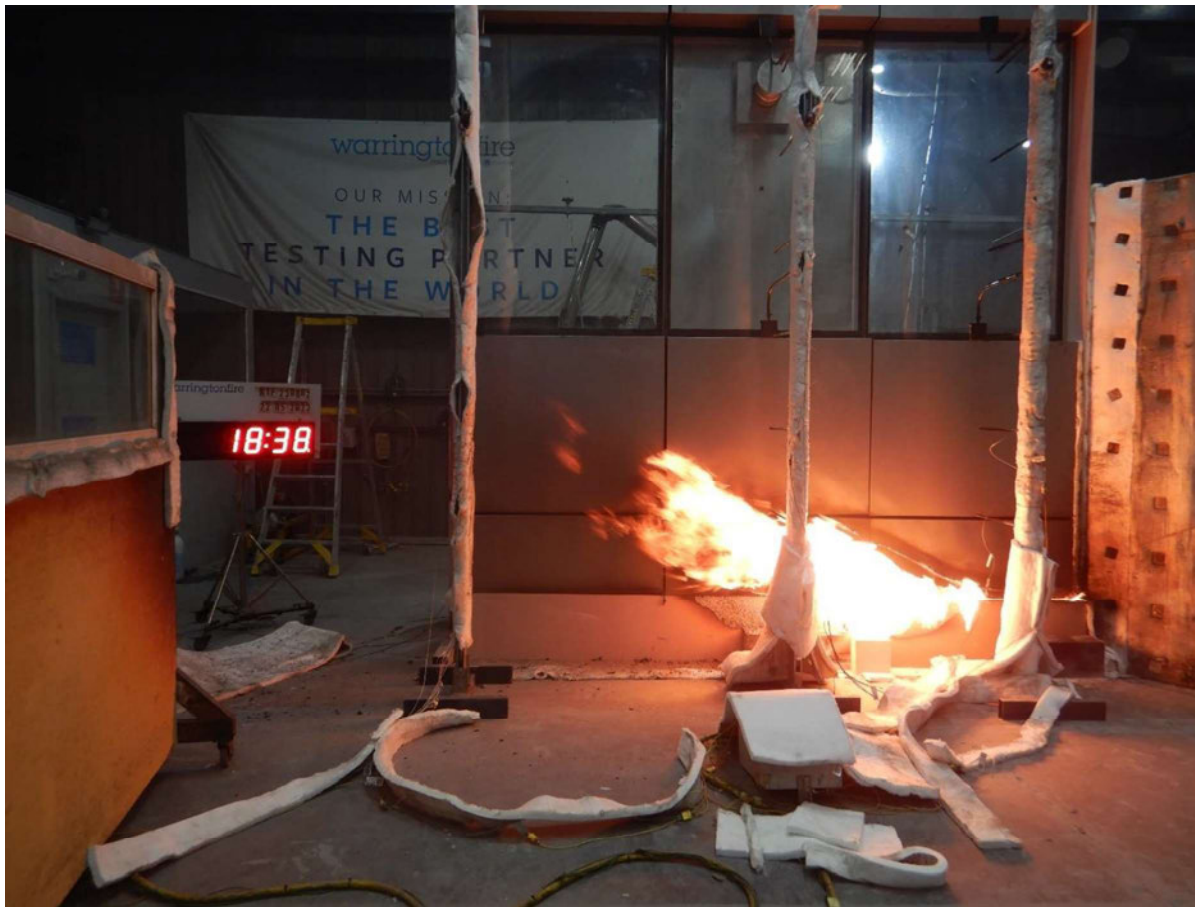
Figure 38 The specimen 18 minutes 38 seconds into the test (burner output at 300 kW and wind on).

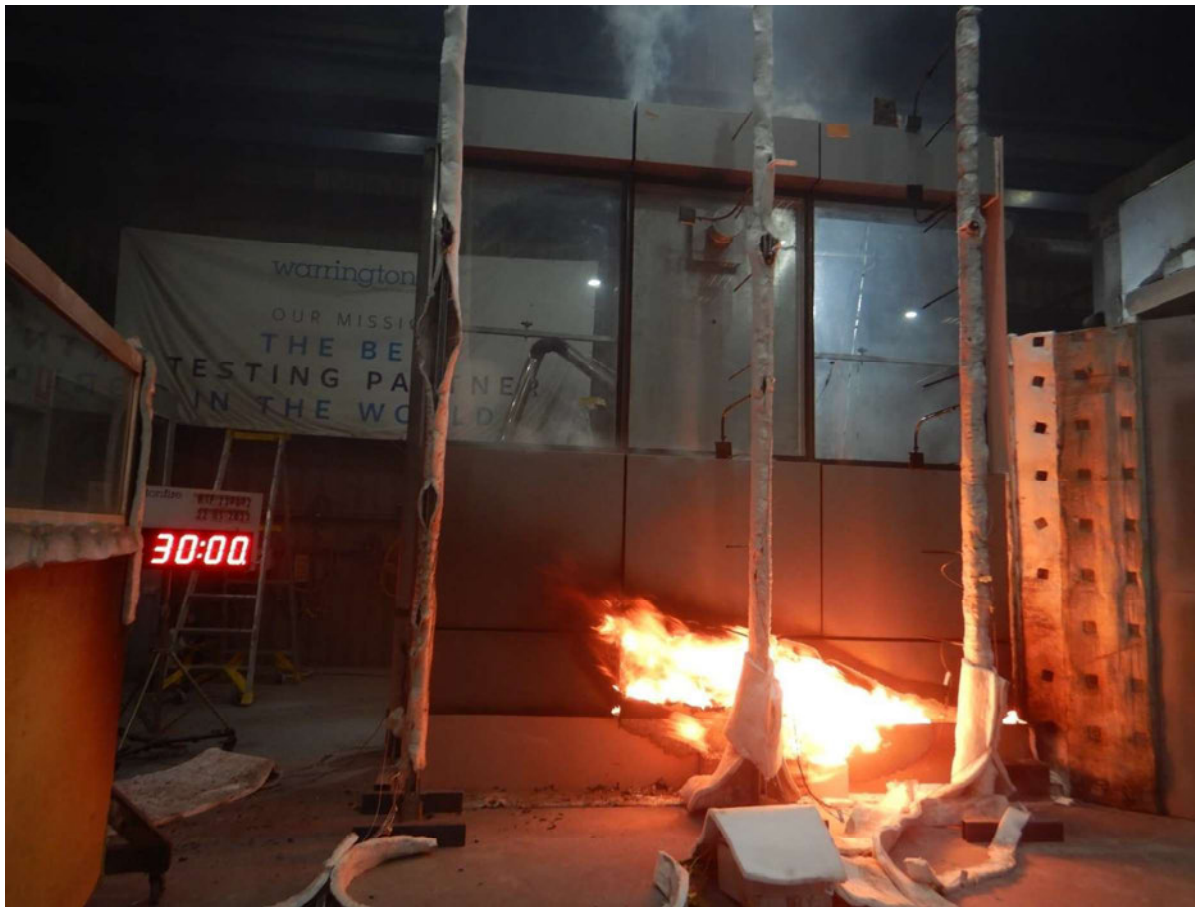
Figure 49 The specimen 30 minutes into the test (burner output at 300 kW and wind on).

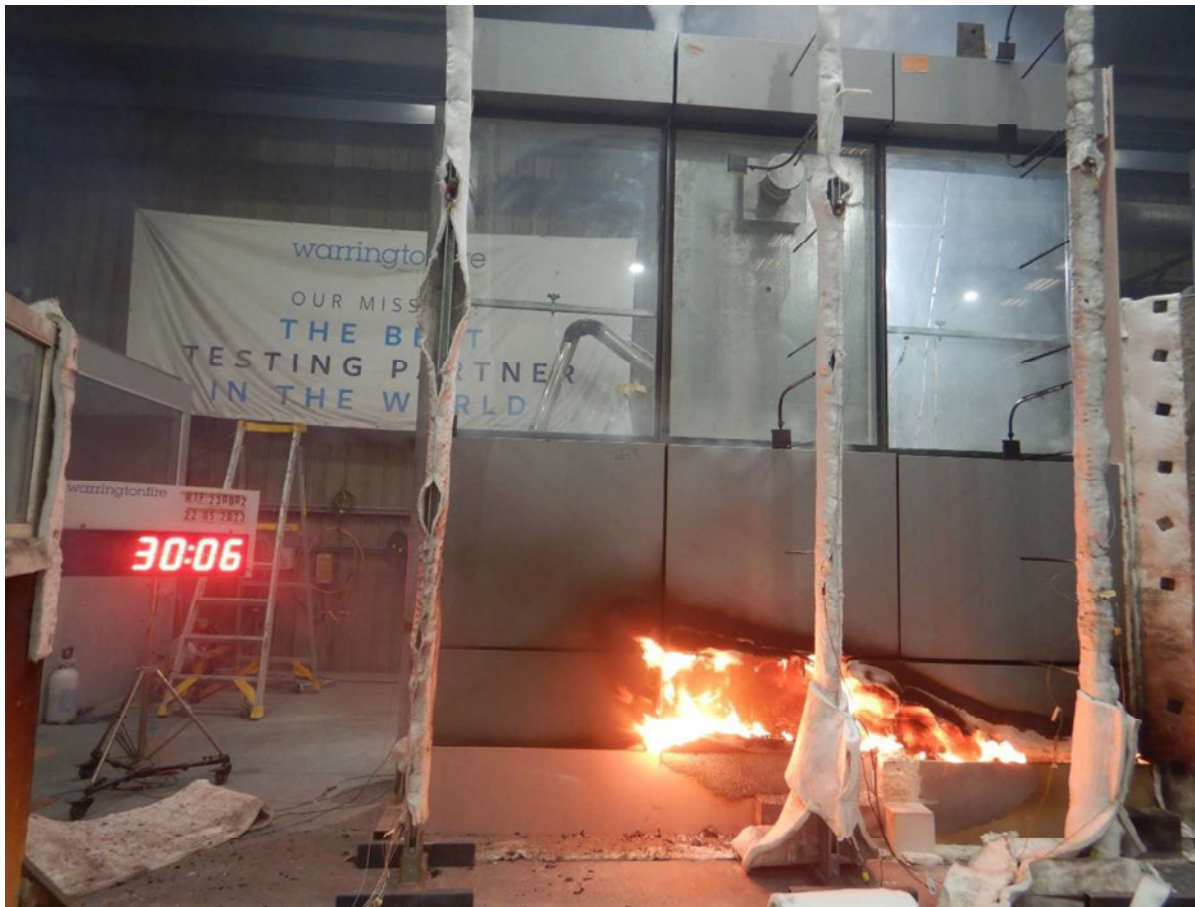
Figure 50 The specimen 30 minutes 6 seconds into the test – just after burner is turned off.

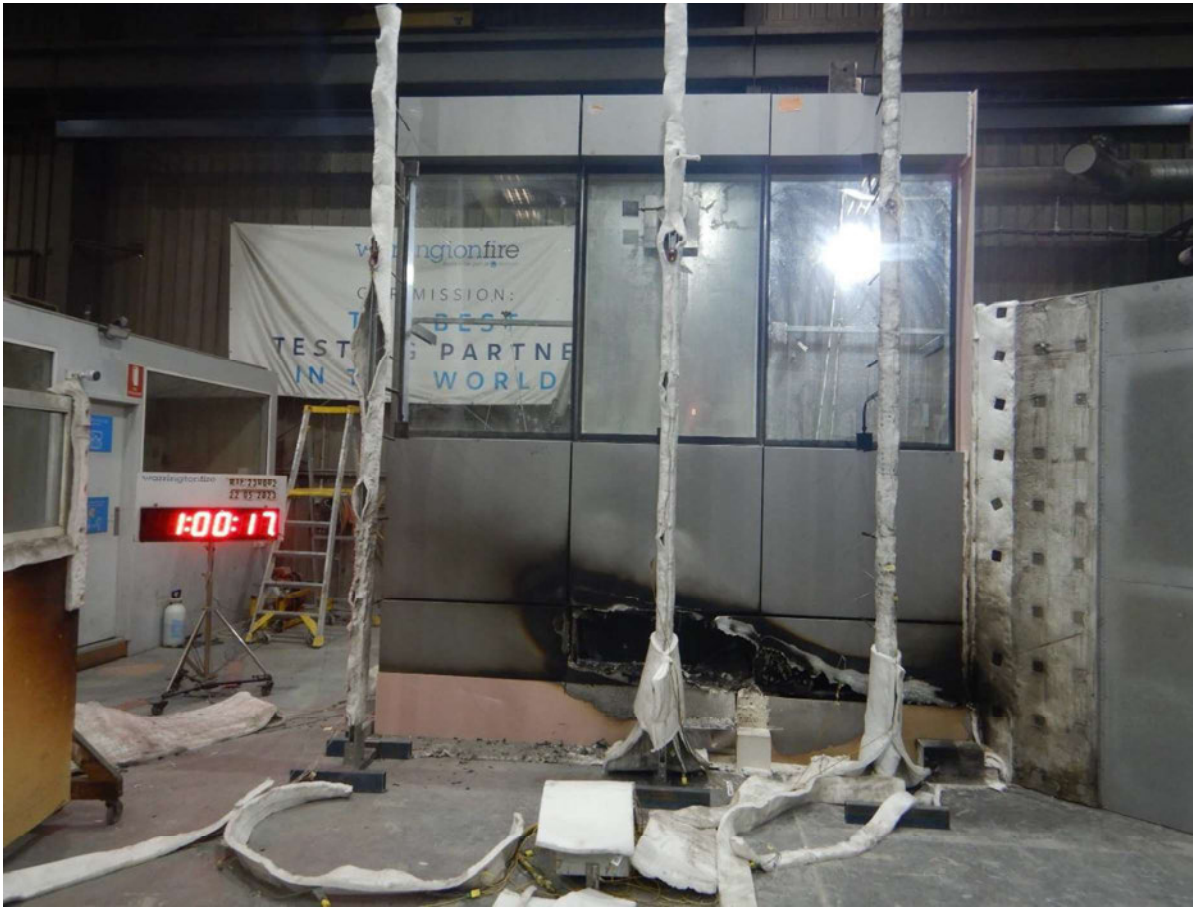
Figure 56 The specimen at the end of test.

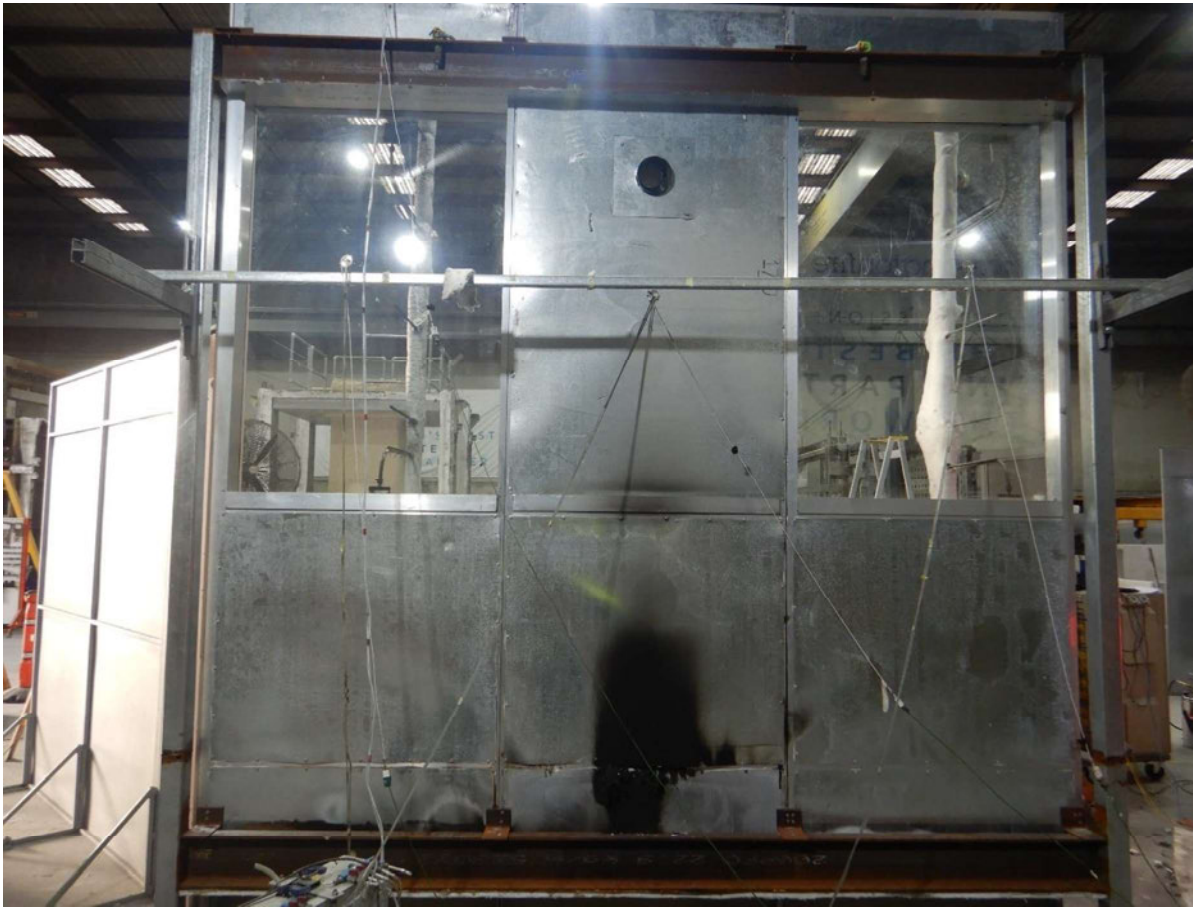
Figure 57 The specimen at the end of test – unexposed side.
