Reaction to fire test report

Test standard: Ad-hoc test based off ISO 13785-1:2002

System: Aluminium composite panel (ACP) blanking wall system

Job number: RTF230142

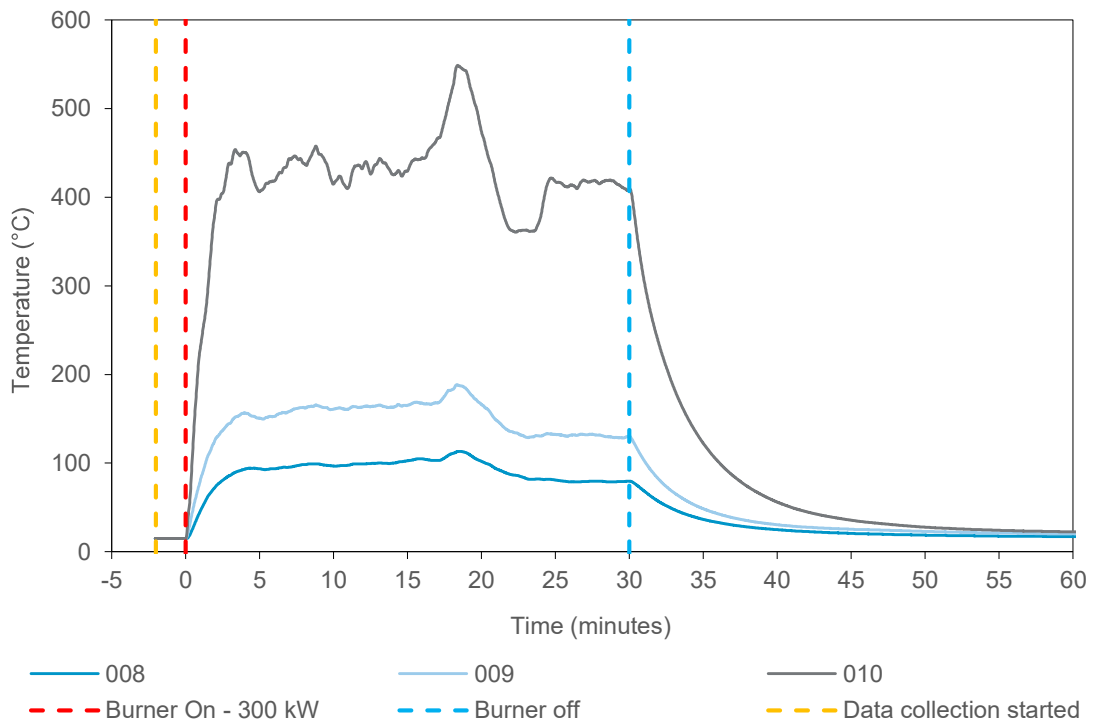
Figure 4 External temperature data collected by plate thermocouples in-line with ACP - in-line with the burner.

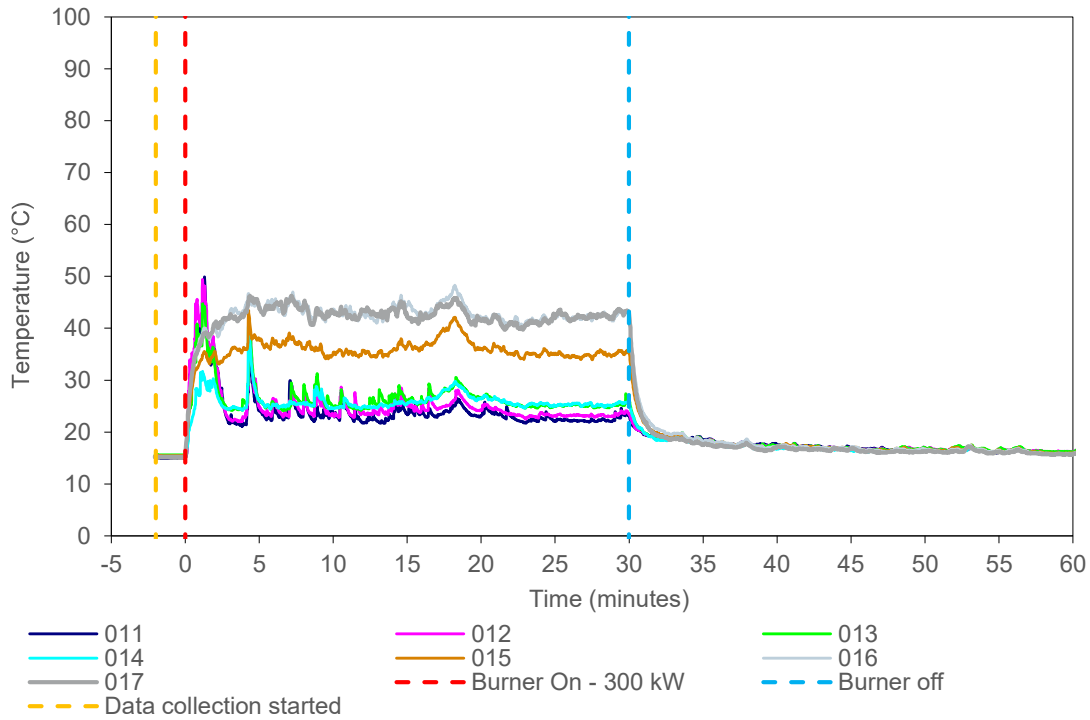
Figure 5 External temperature data collected by thermocouples placed 60 mm from the front face of the specimen – central module.

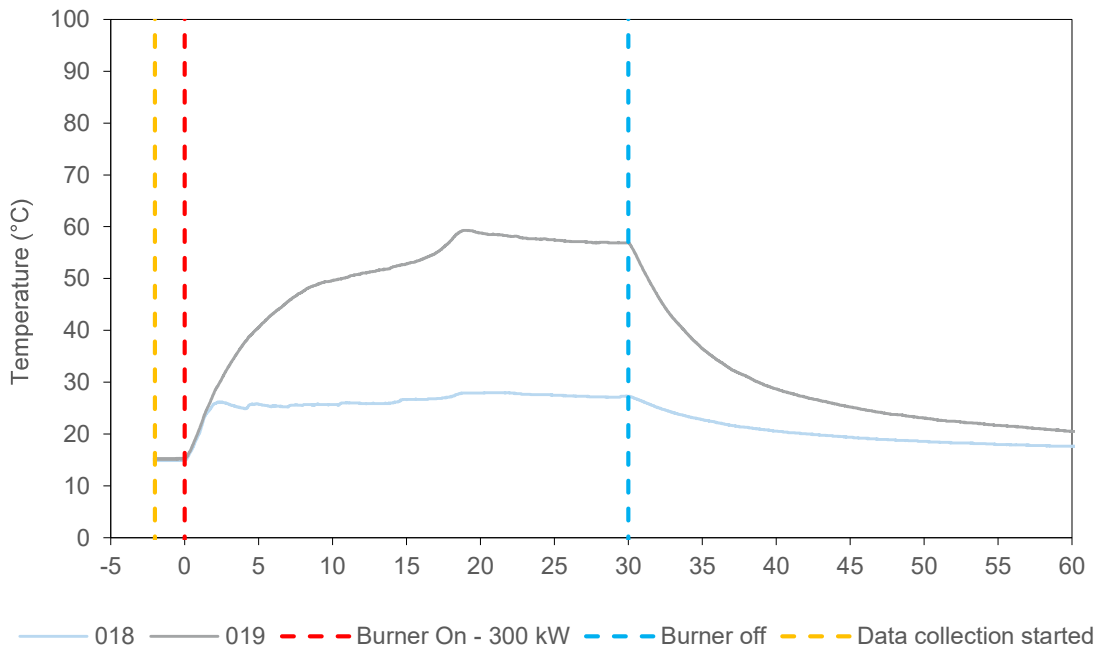
Figure 6 External temperature data collected by plate thermocouples in-line with ACP – central module.

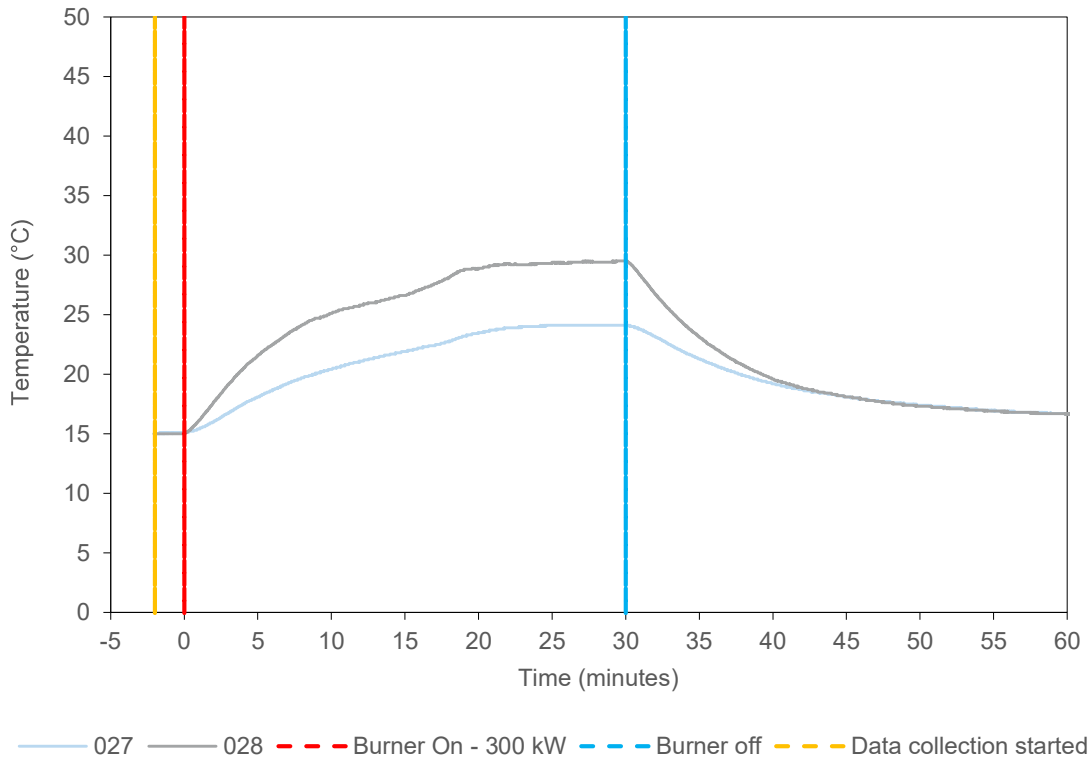
Figure 8 External temperature data collected by plate thermocouples in-line with ACP – away from burner.

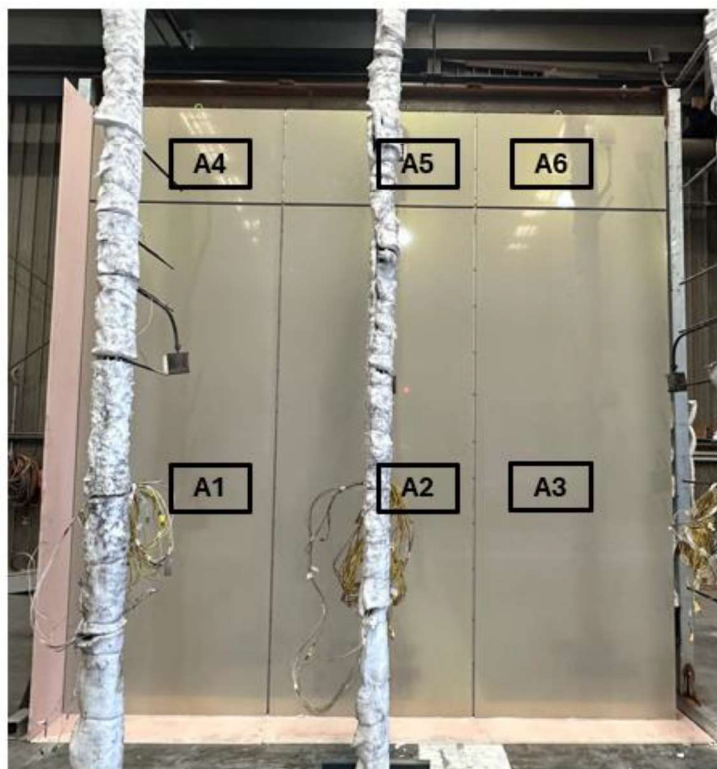
Figure 9 Designation of section for the test observations.

Table 4 shows the observations of any significant behaviour of the specimen during the test. Figure 9 shows the panel designation sighted in the observations.

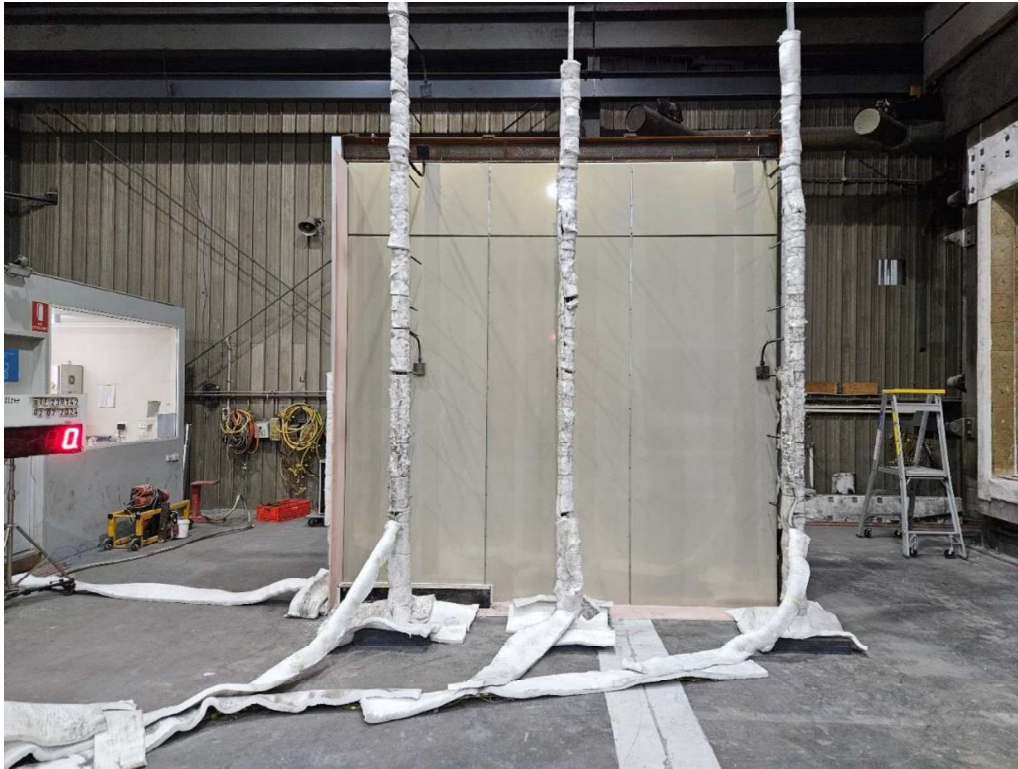
Figure 14 The specimen before the reaction to fire test - exposed side

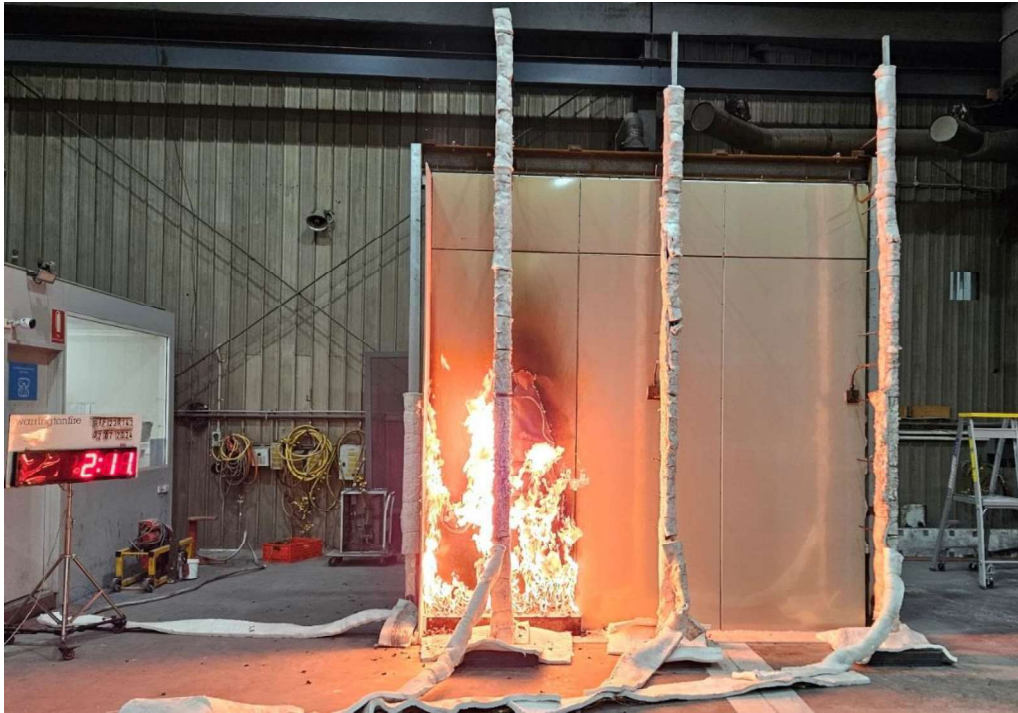
Figure 16 The specimen 2 minutes 11 seconds into the test (burner output at 300 kW)

Time		Des.	Observation
Min	Sec		
-2	00	All	Data collection started.
0	00	All	The reaction to fire test was started with the burner ignited with a heat output set at 300 kW.
1	06	A1	The paint in the lower area started to burn away, and the panel face was discolouring.
2	09	A1	The lower face of the panel started to deform.
5	18	A2	The lower left edge was discolouring.
7	15	A1	3/4 area of paint was burned away.
8	50	A4	Smoke emitted from the top left corner.
12	56	A1/A2	The vertical joint was smoking.
17	00	A1	The lower part of the panel had opened up.

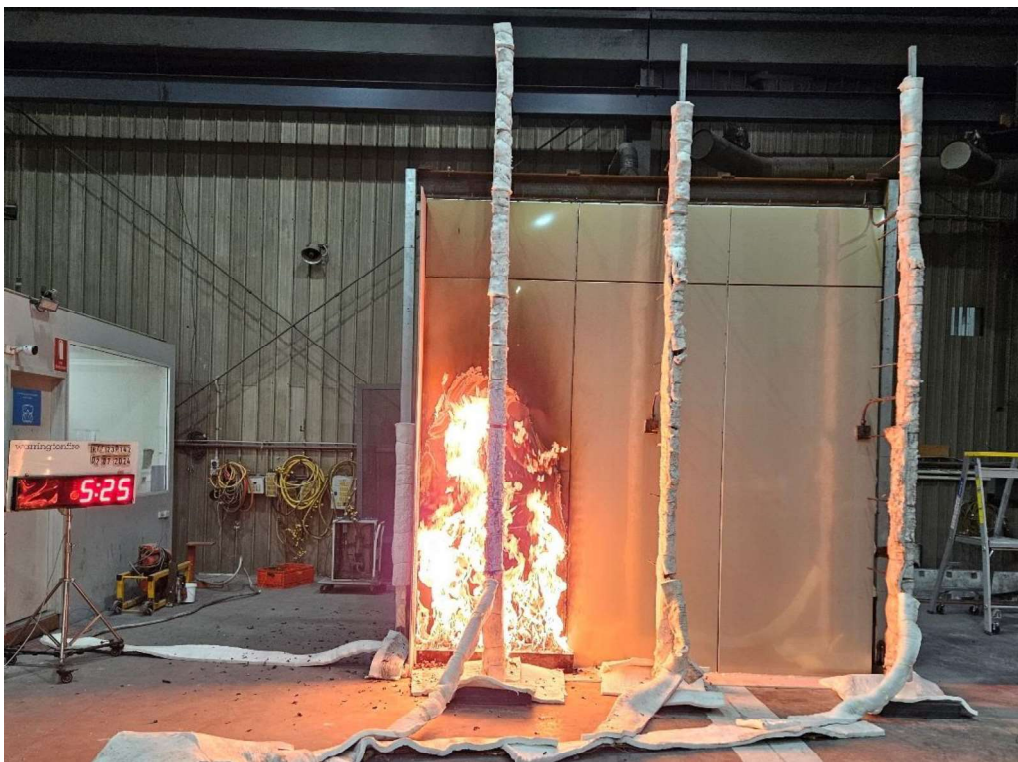
Figure 17 The specimen 5 minutes 25 seconds into the test (burner output at 300 kW)

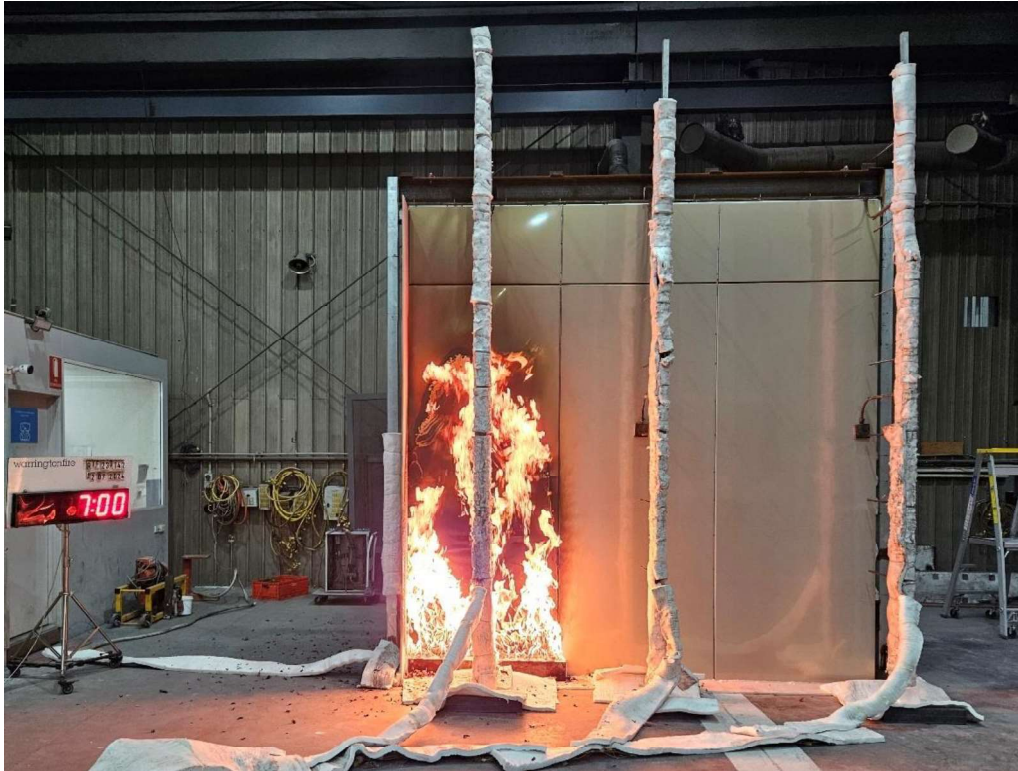
Figure 18 The specimen 7 minutes into the test (burner output at 300 kW)

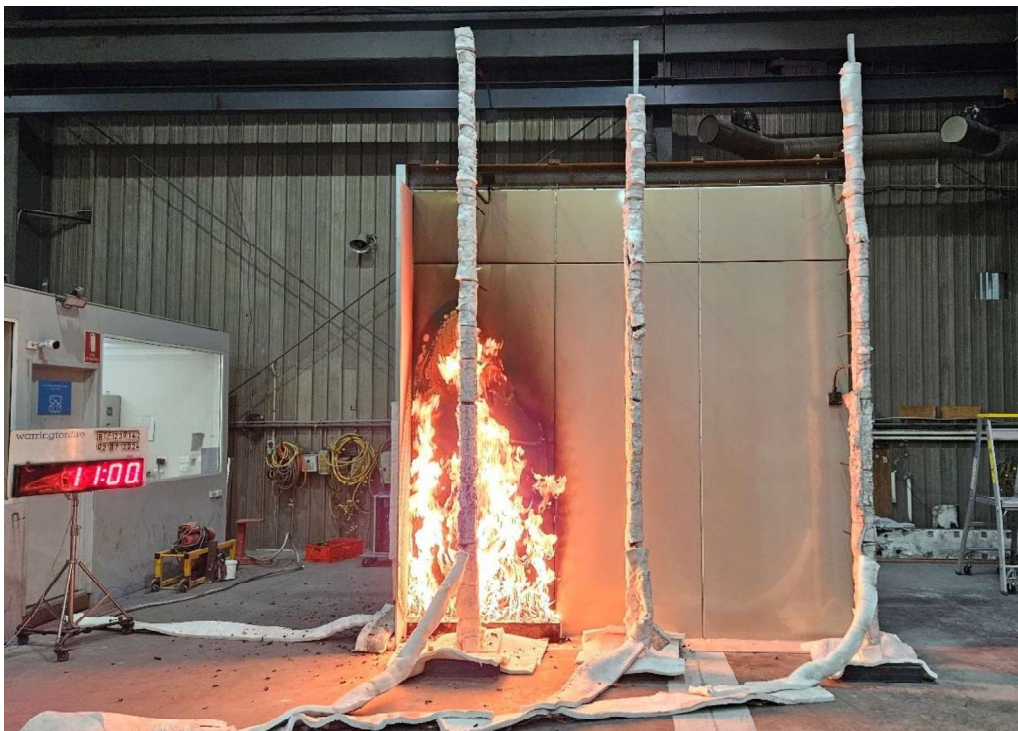
Figure 19 The specimen 11 minutes into the test (burner output at 300 kW)

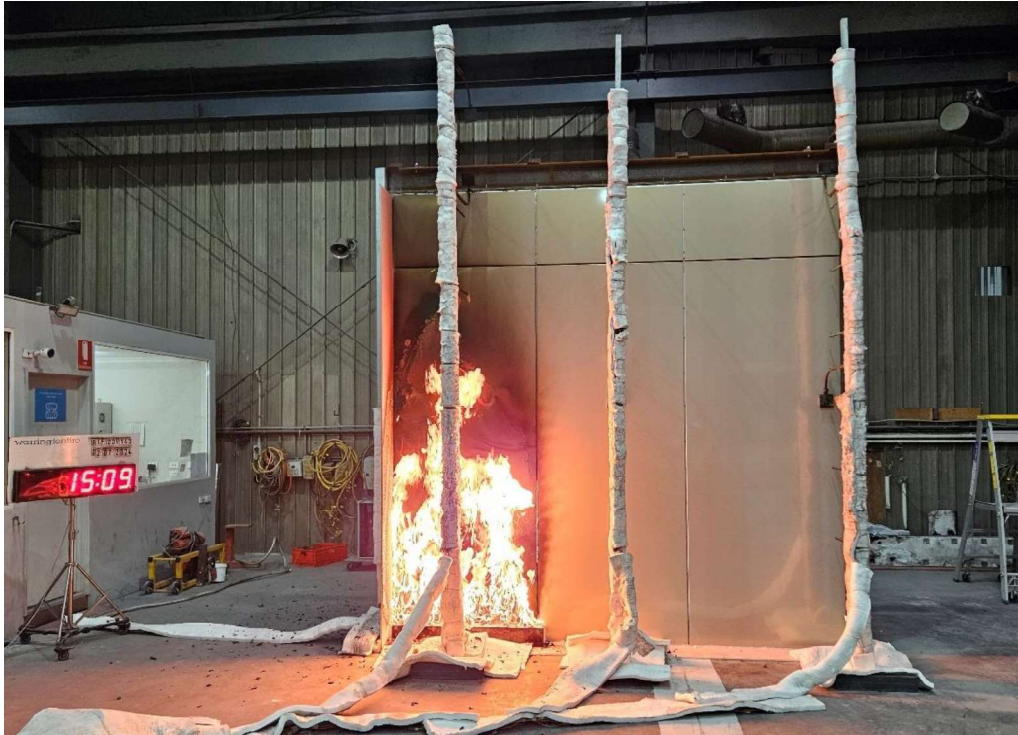
Figure 20 The specimen 15 minutes 9 seconds into the test (burner output at 300 kW)

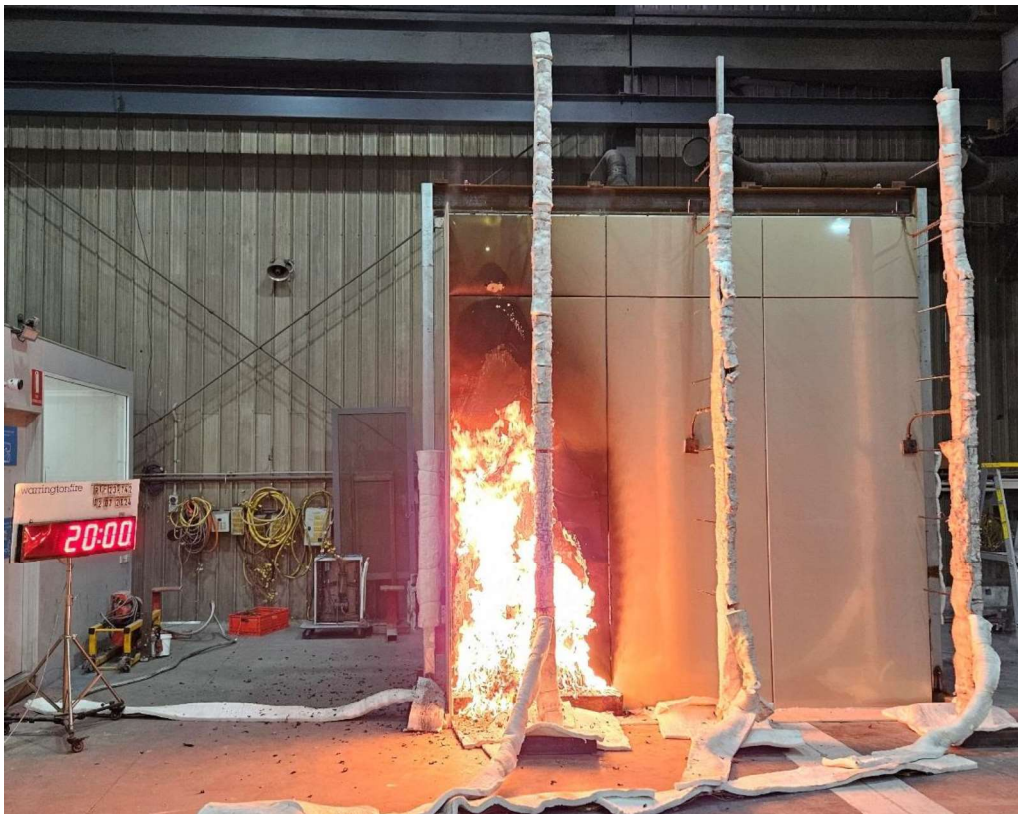
Figure 21 The specimen 20 minutes into the test (burner output at 300 kW)

Time		Des.	Observation
Min	Sec		
17	48	A1	Flaming debris fell to the ground.
18	18	A4	The paint in the lower area started to burn away, and the panel face was discolouring.
19	02	A4	The left side of the panel face started to deform.
21	44	A1	Opened area reached almost 1/2 up panel.
30	00	All	The burner was turned off.
30	24	A1	The bottom part of the panel was still burning.
39	20	A1	Flaming had self-extinguished.
60	00	All	The reaction to fire test was ended

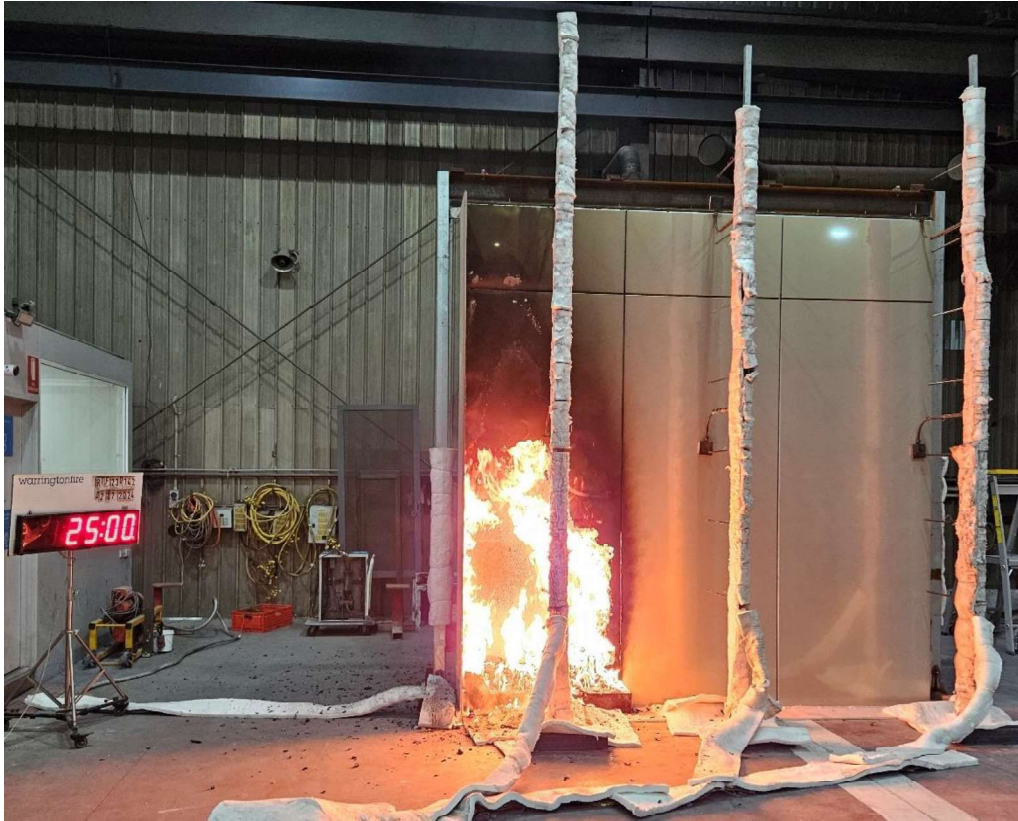
Figure 22 The specimen 25 minutes into the test (burner output at 300 kW)

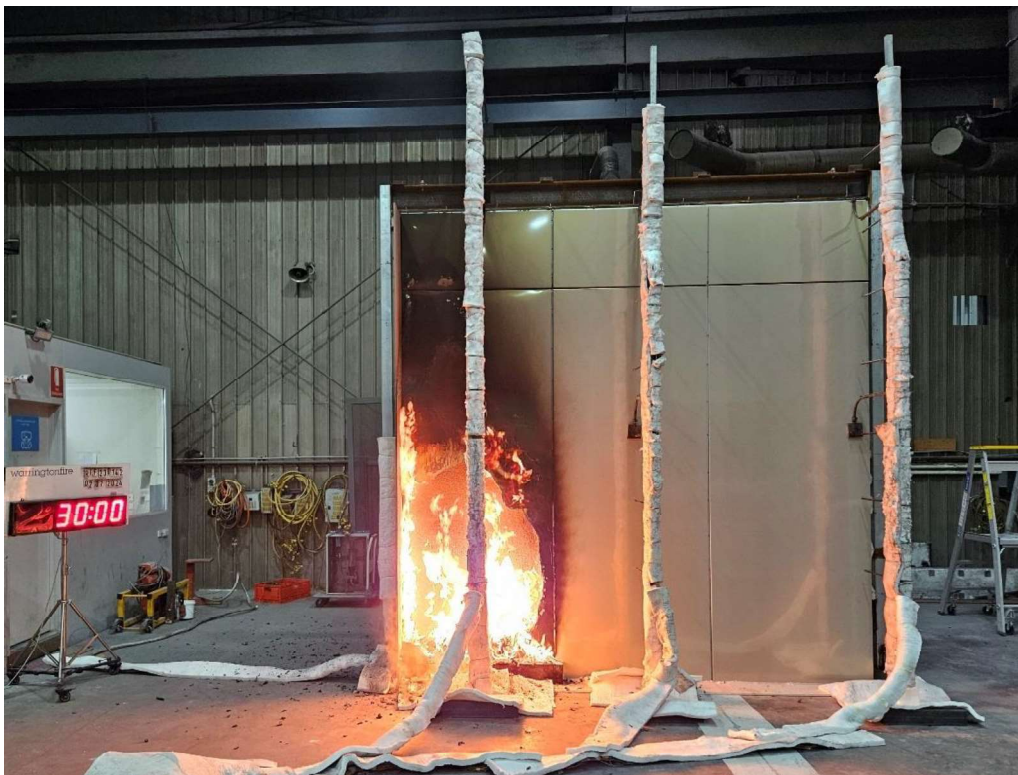
Figure 23 The specimen 30 minutes into the test (burner output at 300 kw)

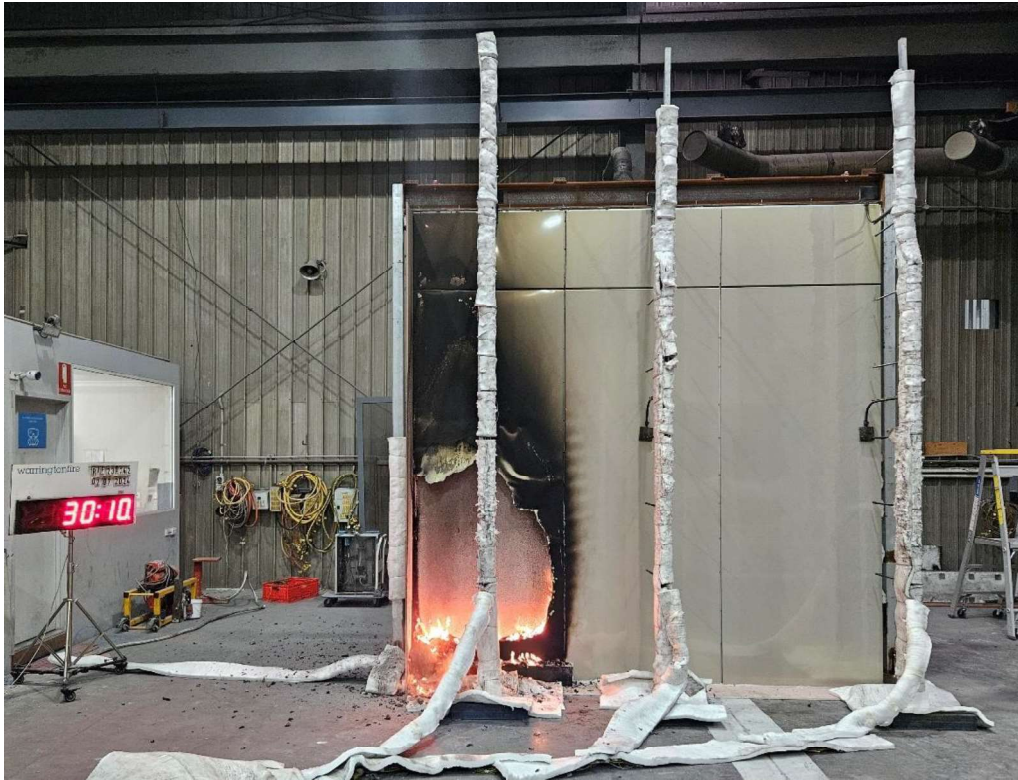
Figure 24 The specimen 30 minutes 10 seconds into the test (10 seconds after burner off)

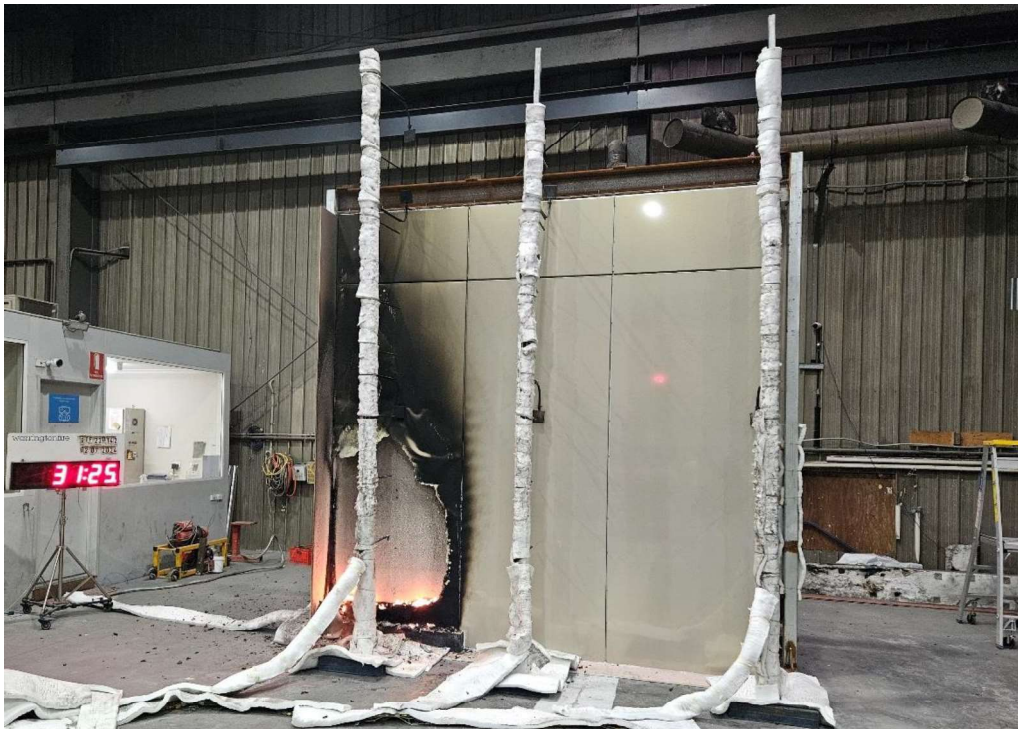
Figure 25 The specimen 31 minutes 25 seconds into the test (1 minute and 25 seconds after burner off)

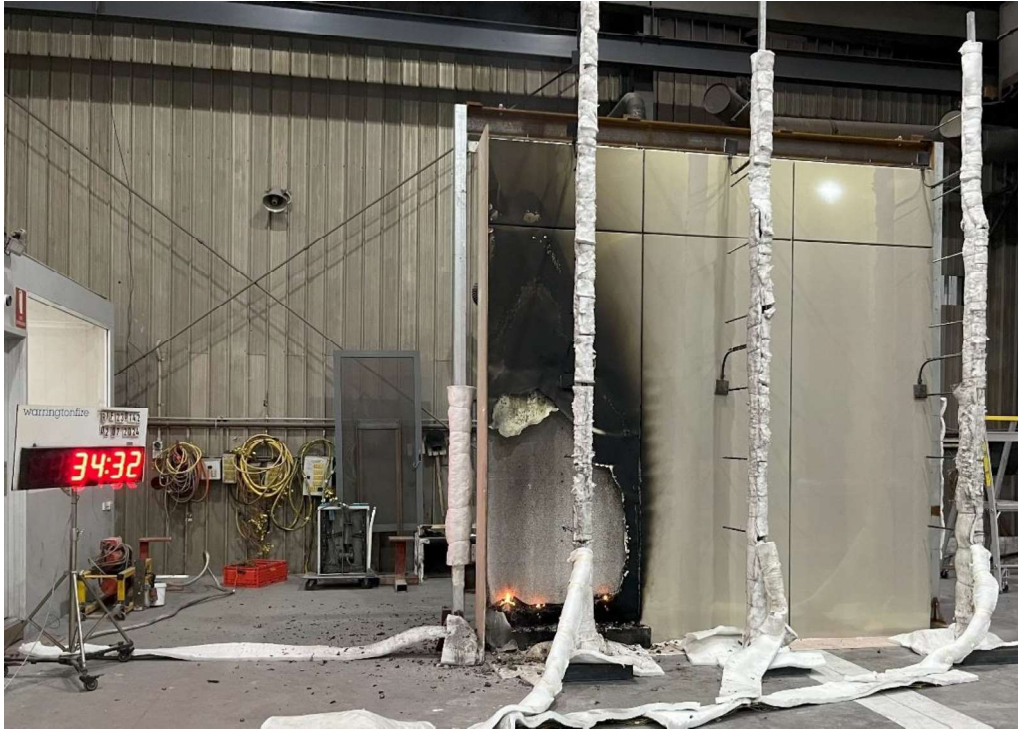
Figure 26 The specimen 34 minutes 32 seconds into the test (4 minutes 32 seconds after burner off)

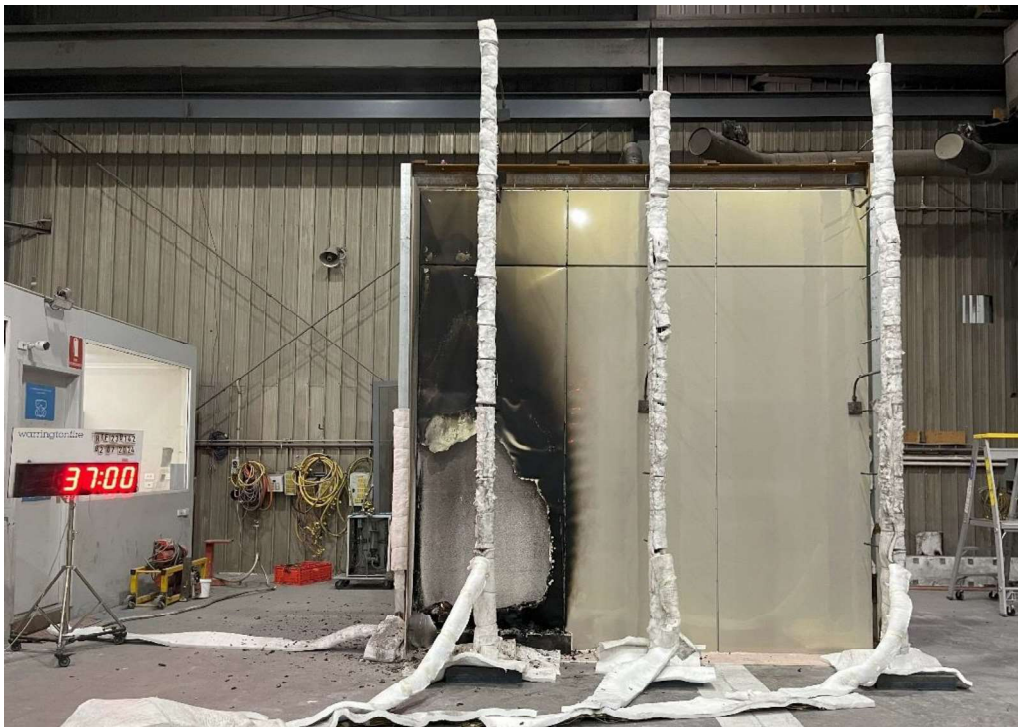
Figure 27 The specimen 37 minutes into the test (7 minutes after burner off)

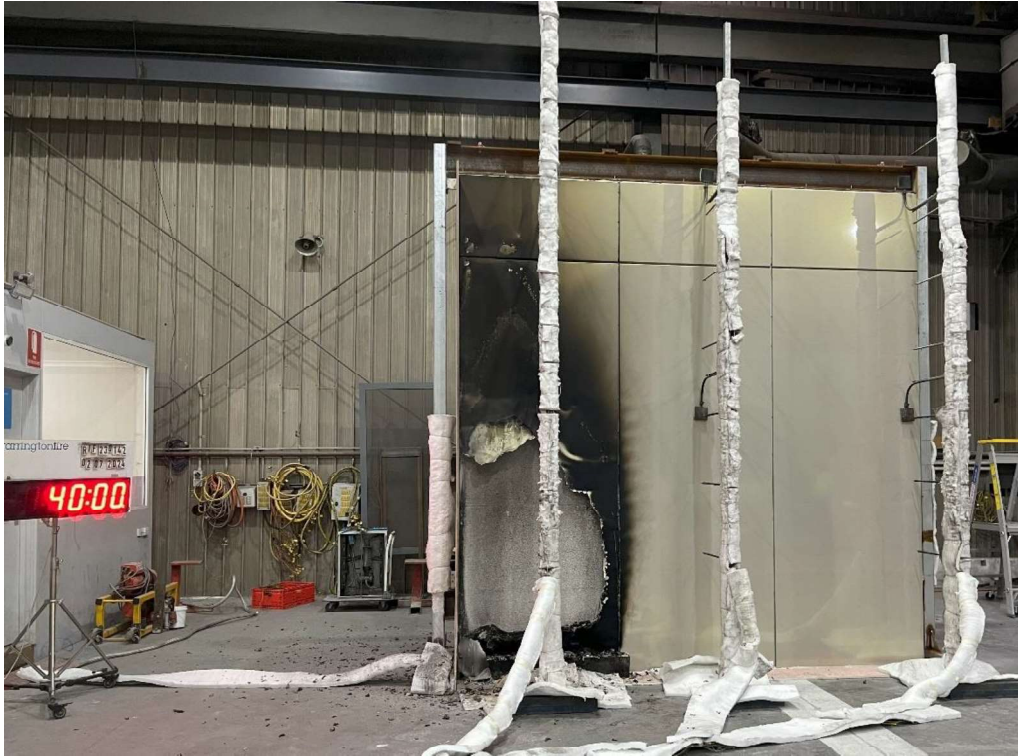
Figure 28 The specimen 40 minutes into the test (10 minutes after burner off)

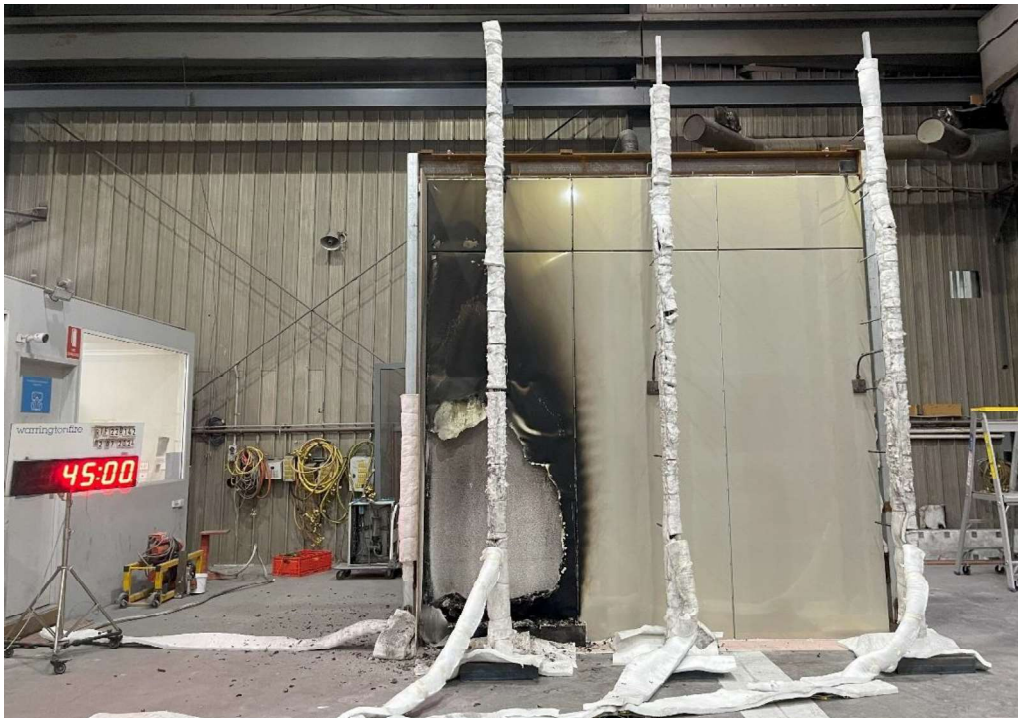
Figure 29 The specimen 45 minutes into the test (15 minutes after burner off)

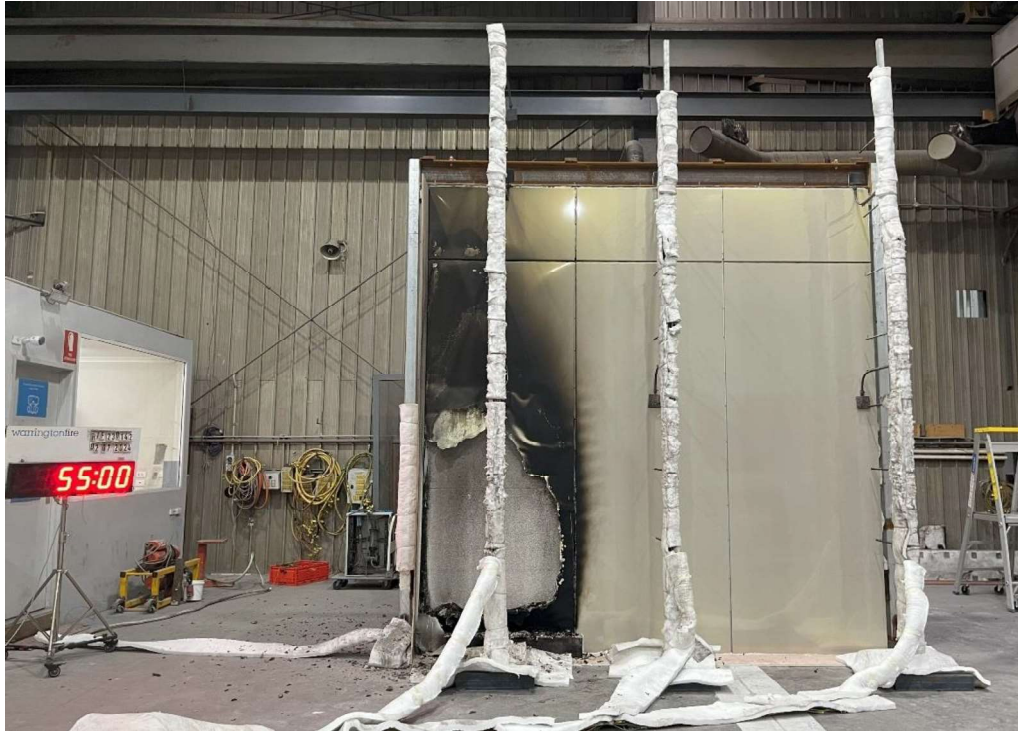
Figure 30 The specimen 55 minutes into the test (25 minutes after burner off)

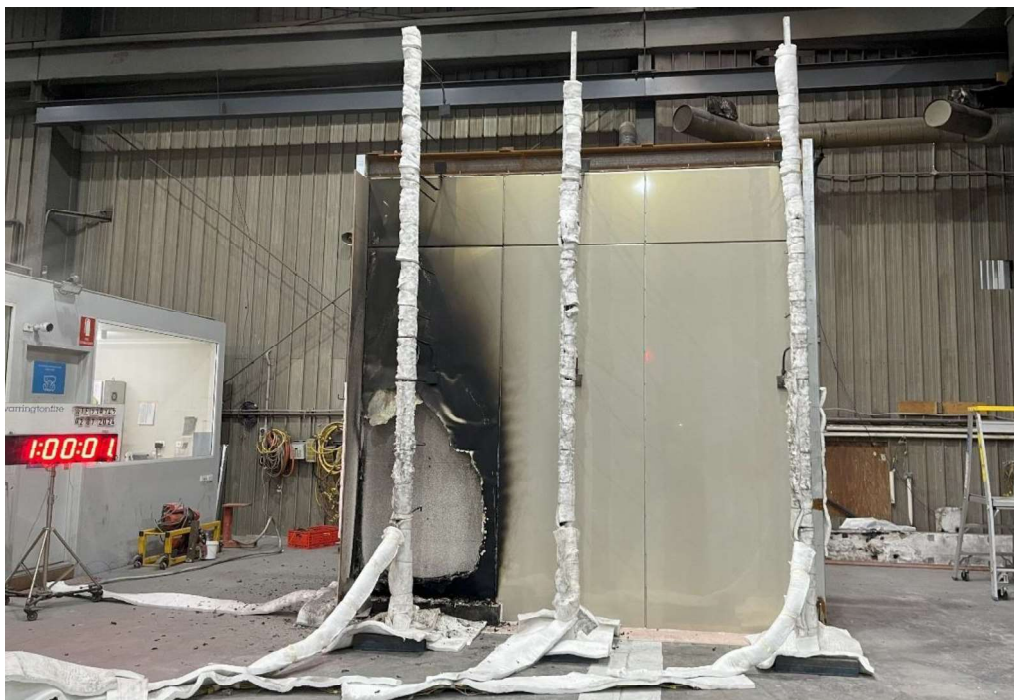
Figure 31 The specimen at the end of test

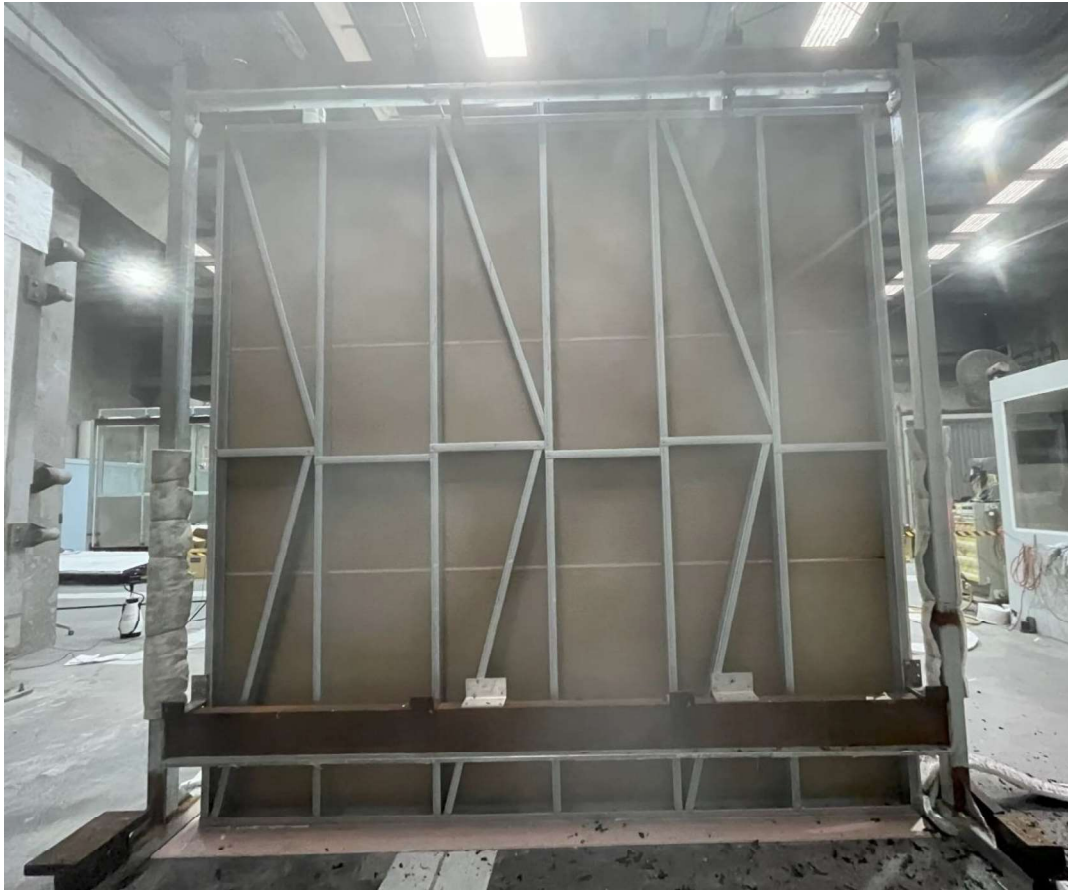
Figure 32 The unexposed side of the specimen at the end of test
