Reaction to fire test report

Test standard: Ad-hoc test based off ISO 13785-1:2002

System: A cassetted aluminium composite panel wall system

Job number: RTF230139

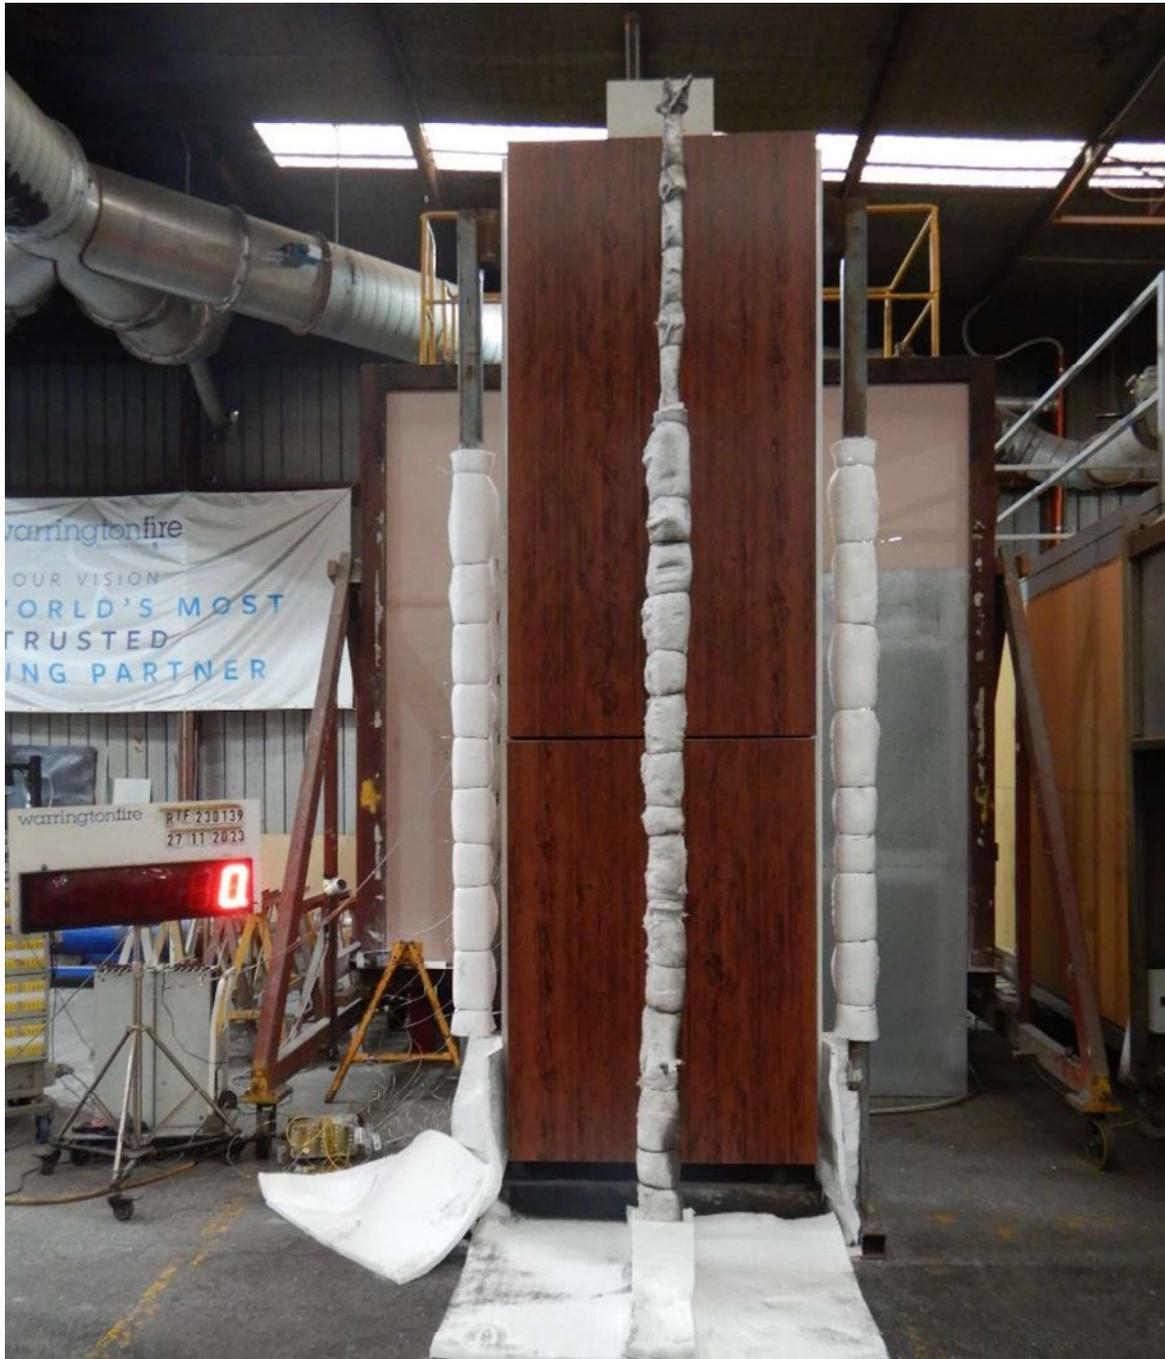
Figure 11 The specimen before the reaction to fire test

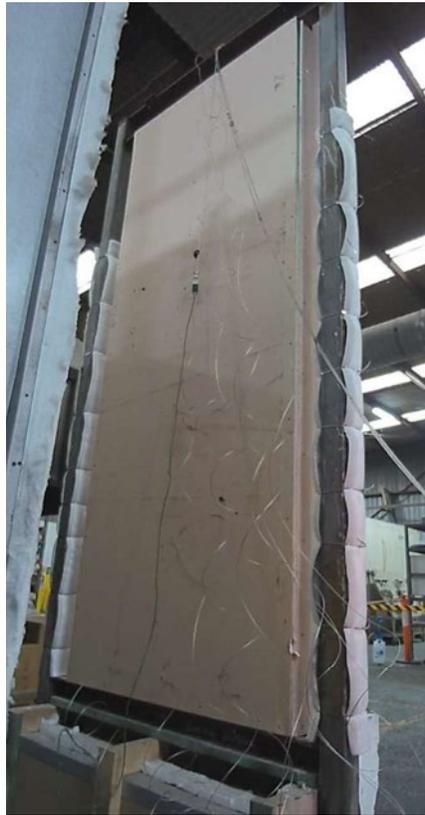
Figure 12 The specimen before the reaction to fire test – unexposed side

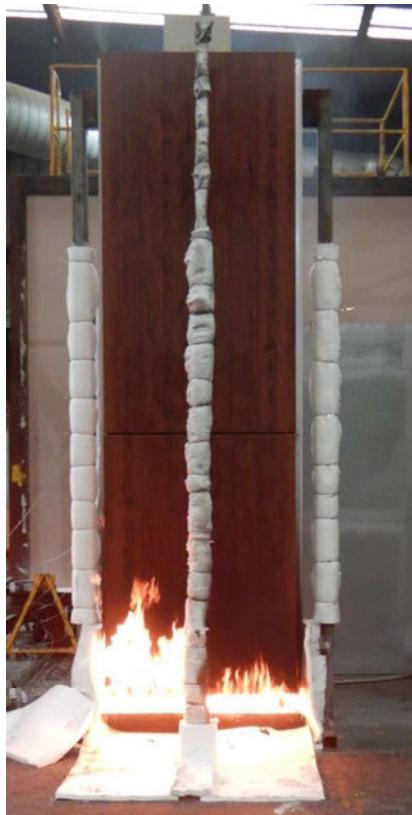
Figure 13 The specimen 3 minutes 58 seconds into the test (burner output at 100 kW)

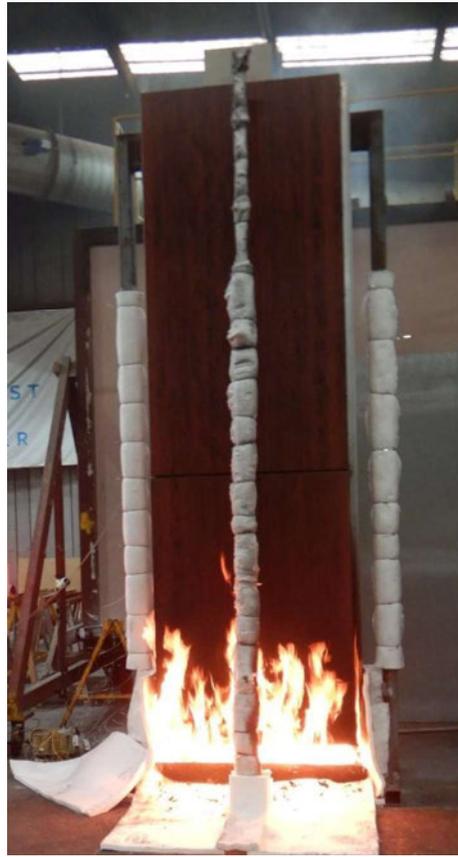
Figure 14 The specimen 8 minutes 49 seconds into the test (burner output at 100 kW)

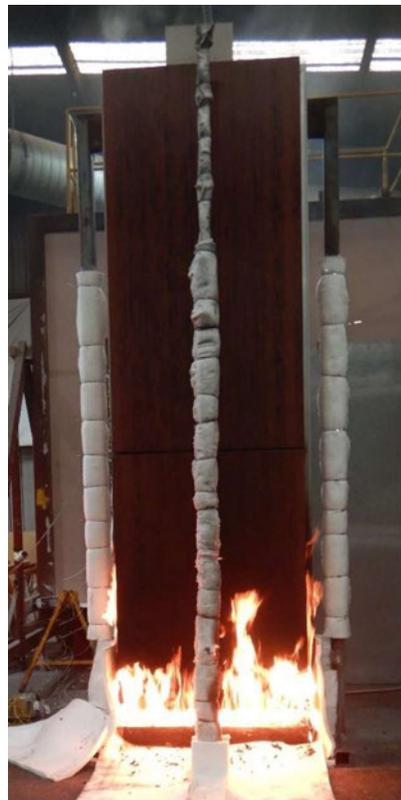
Figure 15 The specimen 12 minutes into the test (burner output at 100 kW)

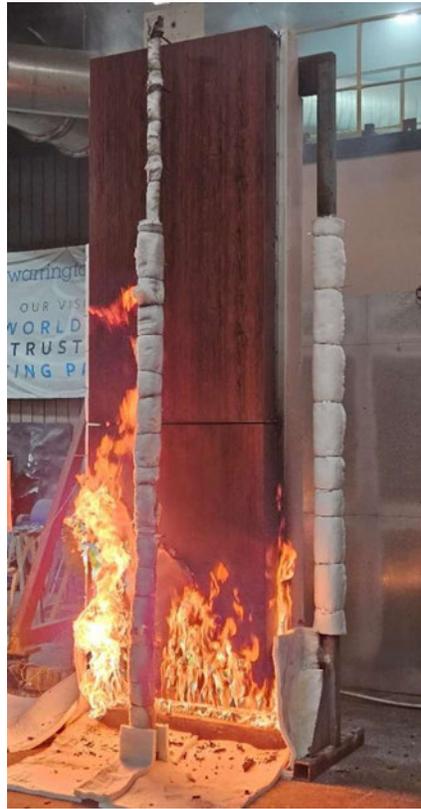
Figure 16 The specimen 16 minutes 12 seconds into the test (1 minute 12 seconds after burner output was changed to 300 kW)

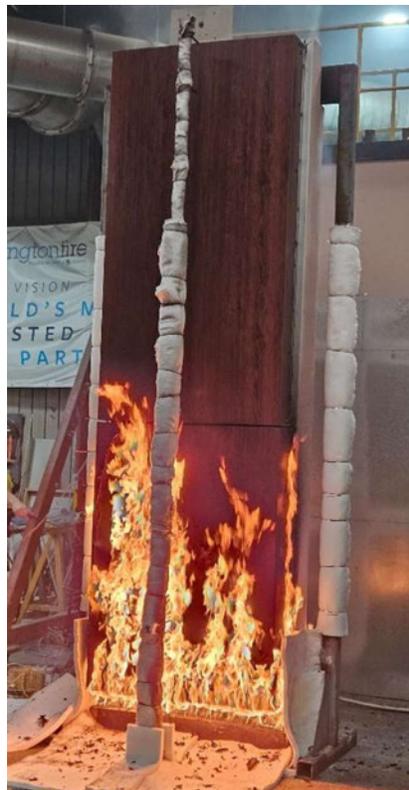
Figure 17 The specimen 18 minutes 44 seconds into the test (3 minutes 44 seconds after burner output was changed to 300 kW)

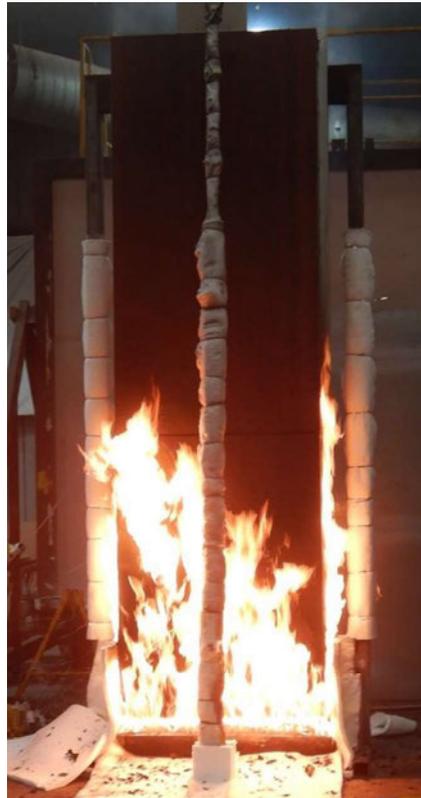
Figure 18 The specimen 21 minutes 40 seconds into the test (6 minutes 40 seconds after burner output was changed to 300 kW)

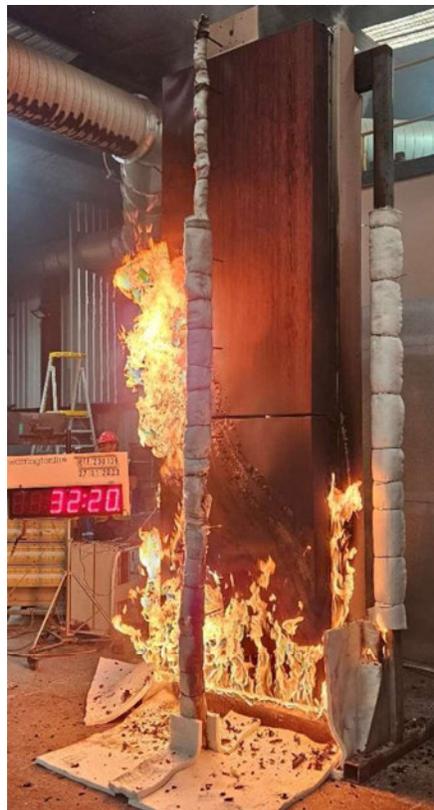
Figure 19 The specimen 32 minutes 20 seconds into the test (17 minutes 20 seconds after burner output was changed to 300 kW)

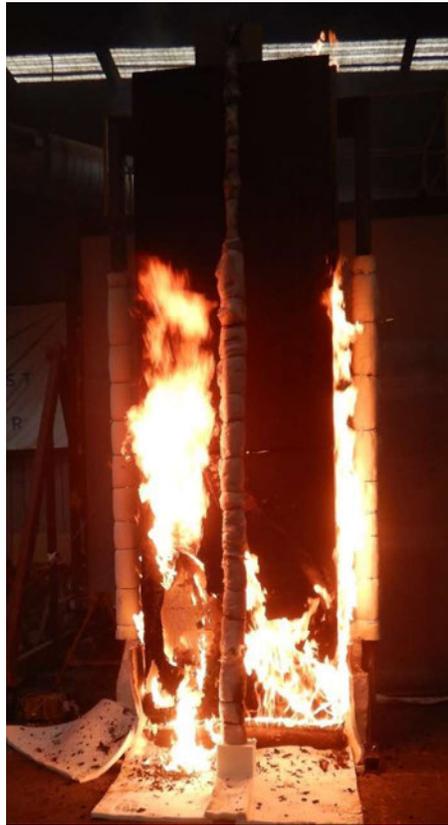
Figure 20 The specimen 36 minutes 37 seconds into the test (21 minutes 37 seconds after burner output was changed to 300 kW)

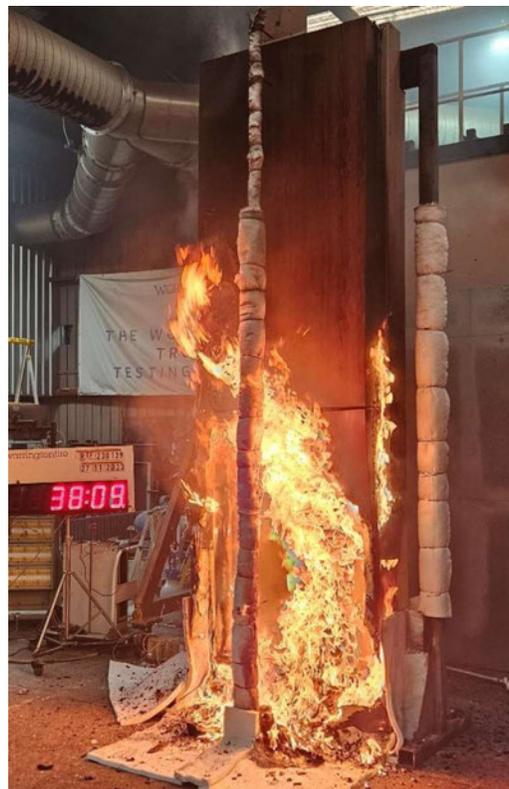
Figure 21 The specimen 38 minutes 9 seconds into the test (23 minutes 9 seconds after burner output was changed to 300 kW)

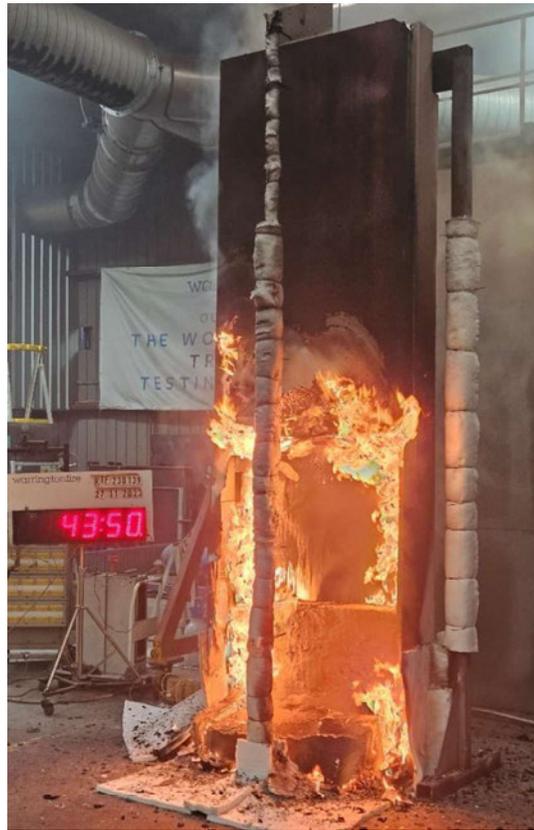
Figure 22 The specimen 43 minutes 50 seconds into the test (28 minutes 50 seconds after burner output was changed to 300 kW)

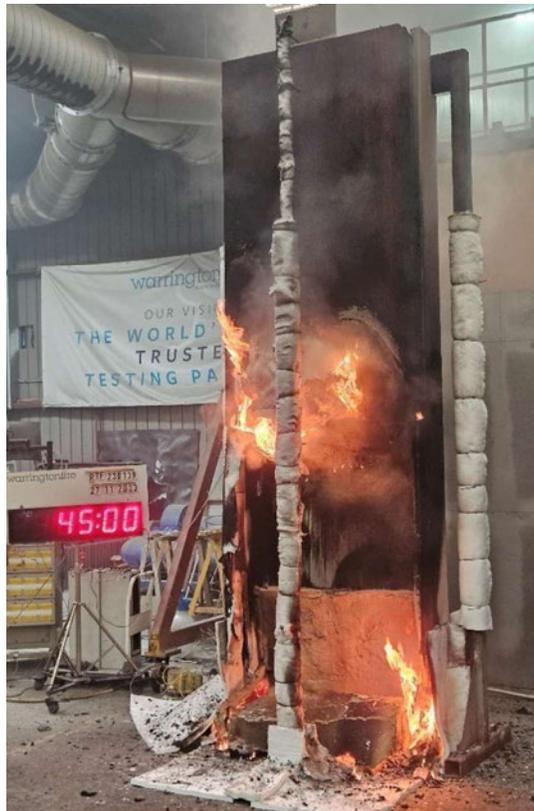
Figure 23 The specimen 45 minutes into the test (1 minute after burner was switched off)

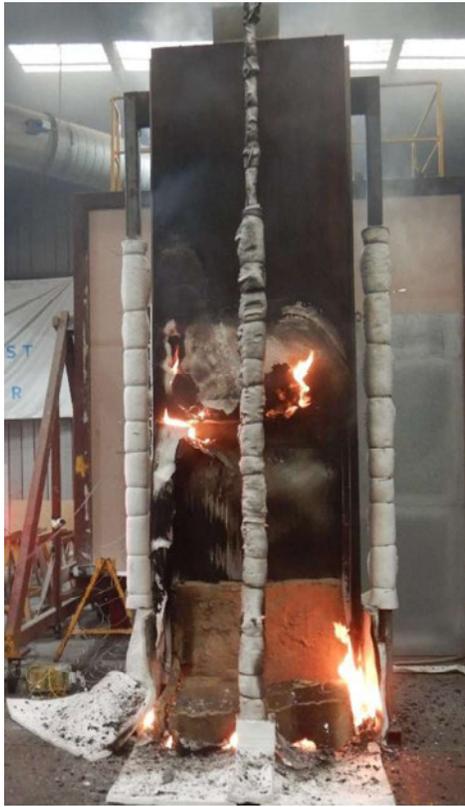
Figure 24 The specimen 47 minutes 58 seconds into the test (3 minutes 58 seconds after burner was switched off)

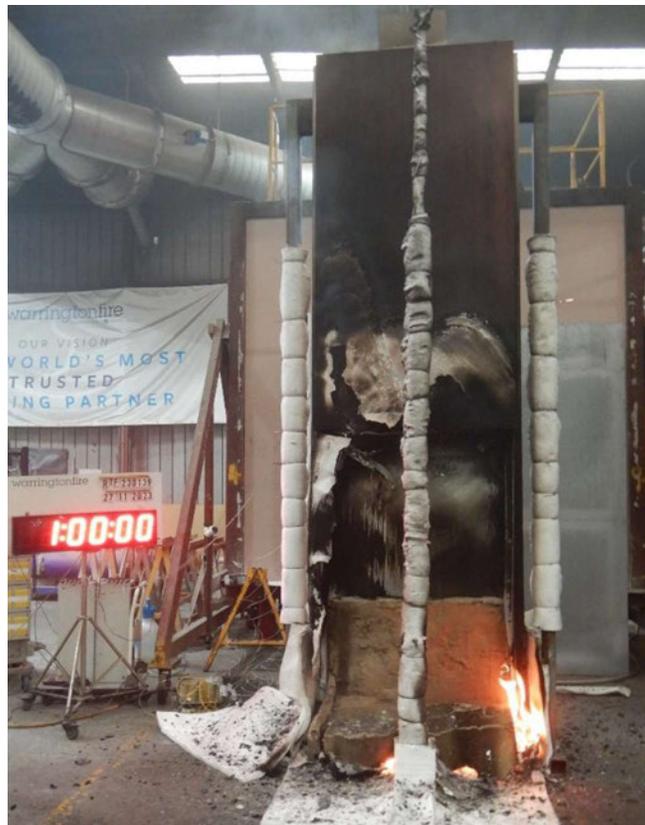
Figure 25 The specimen at the end of the test

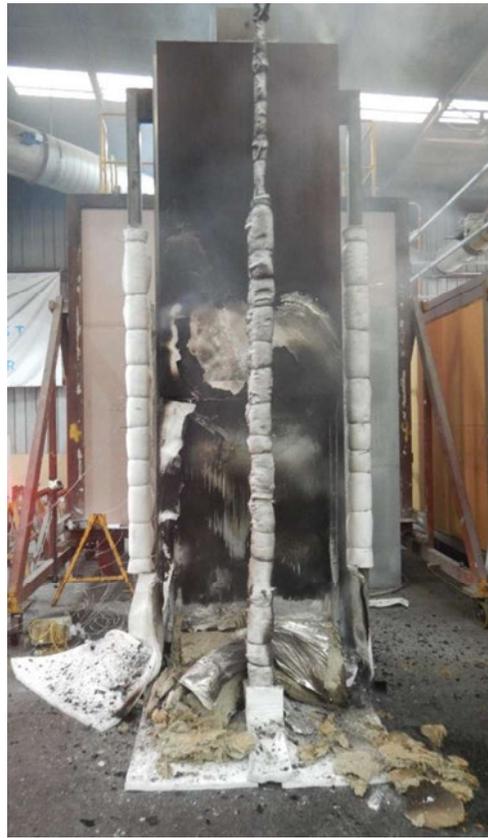
Figure 26 The specimen after the test, after being sprayed with water.

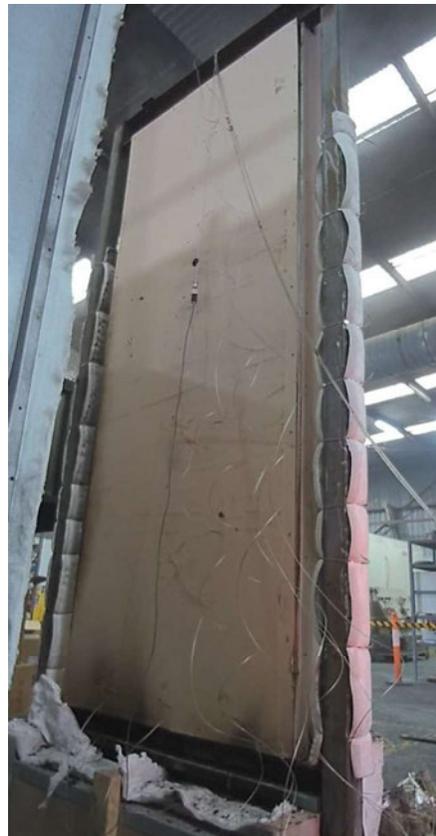
Figure 27 The specimen after the test – unexposed side.
