Reaction to fire test report

Test standard: Ad-hoc test based off ISO 13785-1:2002

System: Aluminium composite panel wall system representative of the in-situ wall located at [redacted] – Scenario 1 - Test 3

Job number: RTF220102

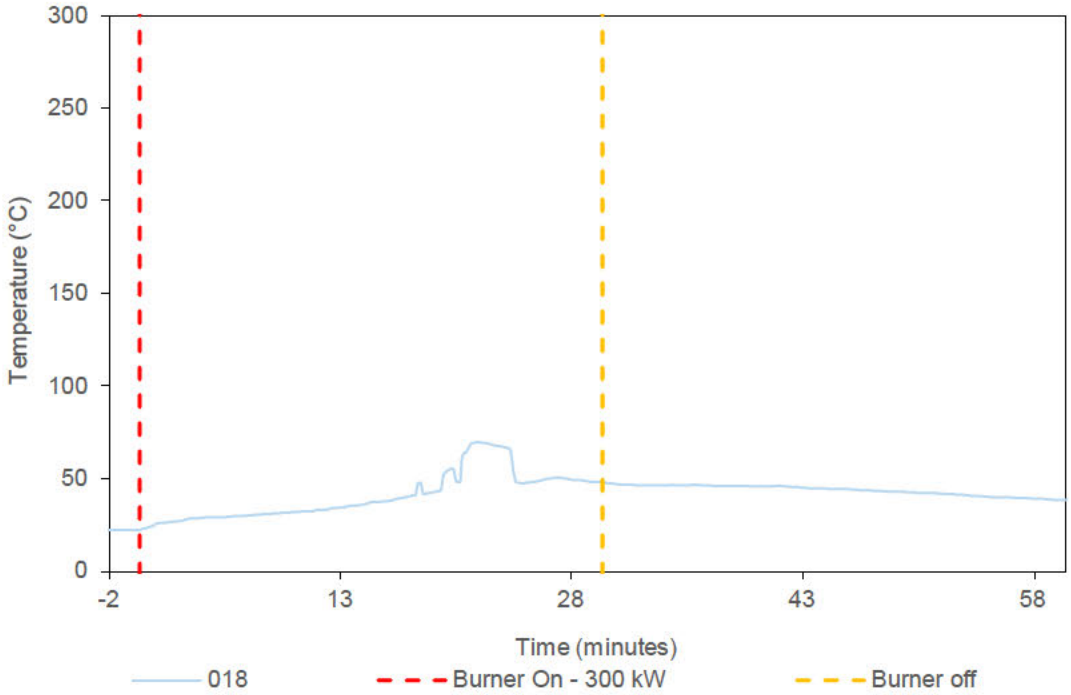
Figure 6 **External temperature data collected by thermocouples in-line with ACP, above and below, respectively – central module. N.B. That data from TC019 was removed as data appeared erroneous.**

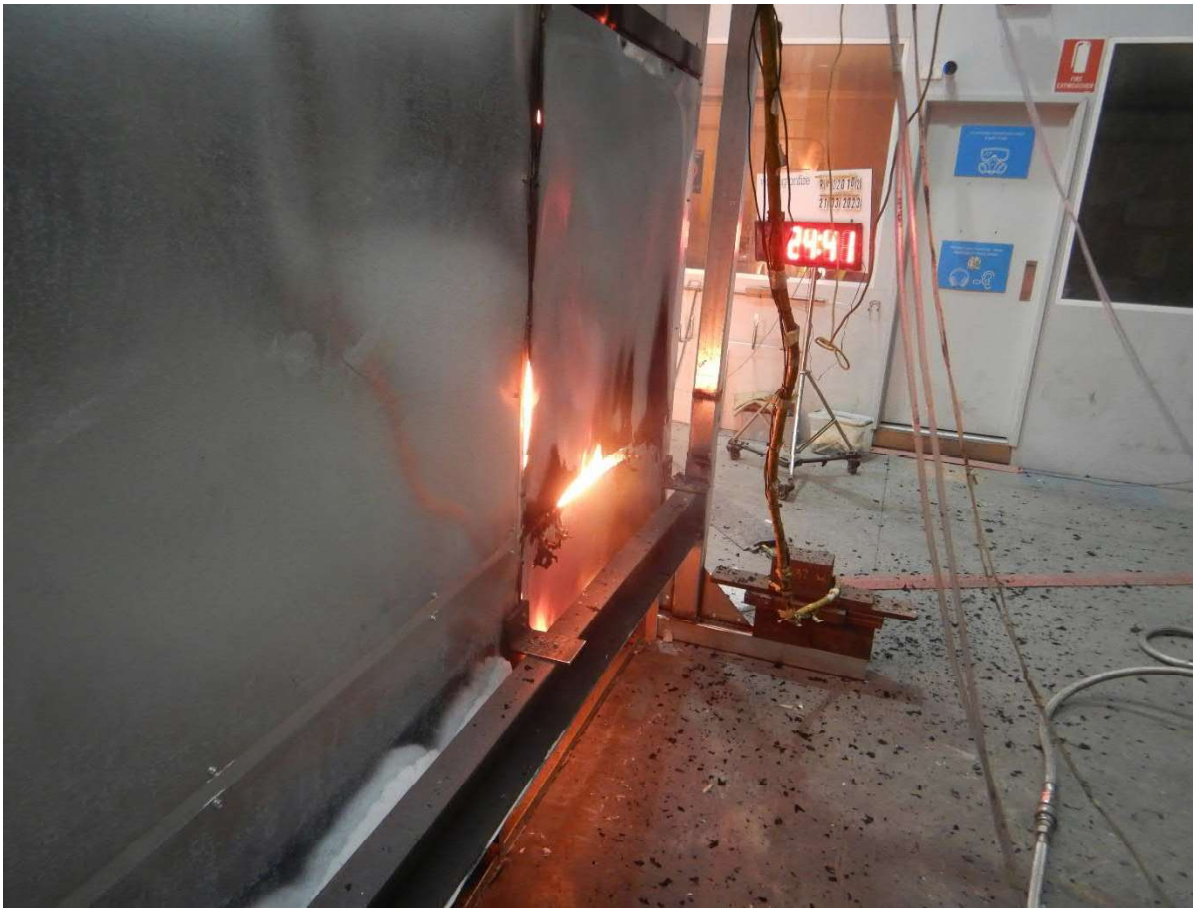
Figure 33 The specimen 24 minutes 41 seconds into the test (burner output at 300 kW) – unexposed side.

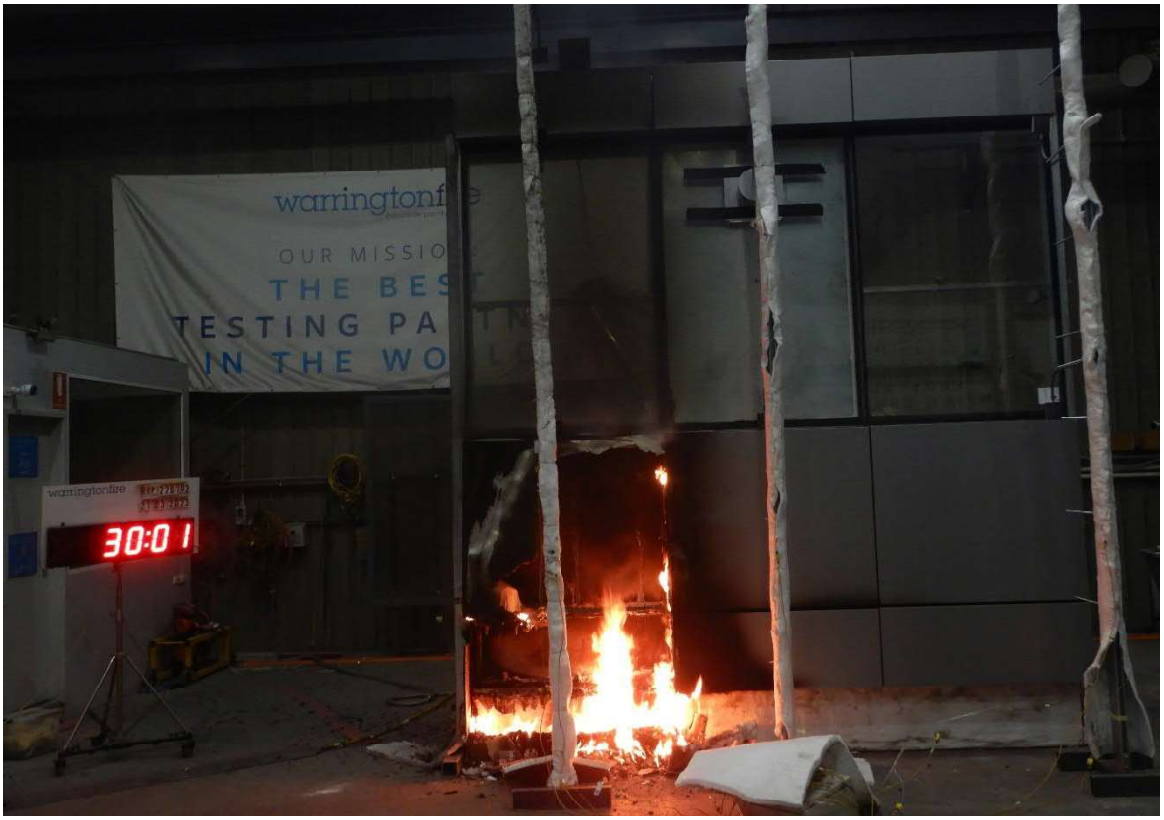
Figure 36 The specimen 30 minutes (1 second) into the test - burner turned off.
