Research Paper

Research analysis on issues and risks associated with balcony defects

Date: 6 January 2023

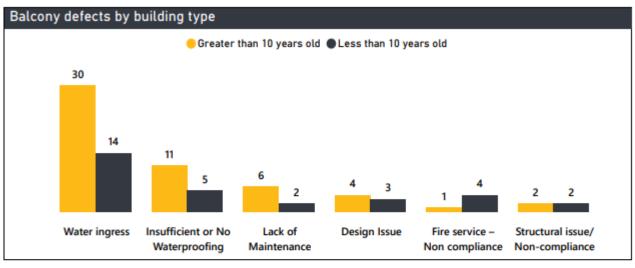
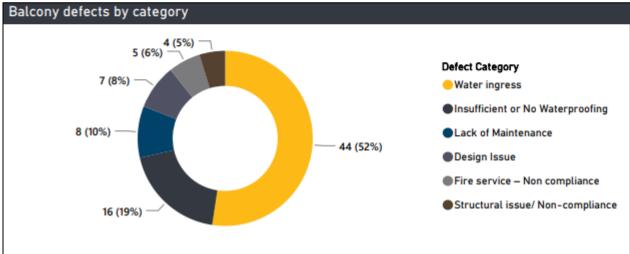
Figure 1 Balcony defects.

Figure 1 reveals that of the 84 buildings where CSV has been able to assess the cause of the defects (60 in total) a significant number of buildings have balcony defects related to insufficient water proofing and improper drainage systems leading to water ingress issues.

A total of 44 buildings (52 per cent) have defective balconies caused by water ingress issues and a further 16 buildings (19 per cent) have waterproofing issues due to lack or insufficient waterproofing as the chief cause of the defects. In addition, seven buildings appear to have balcony defects relating to poor design.

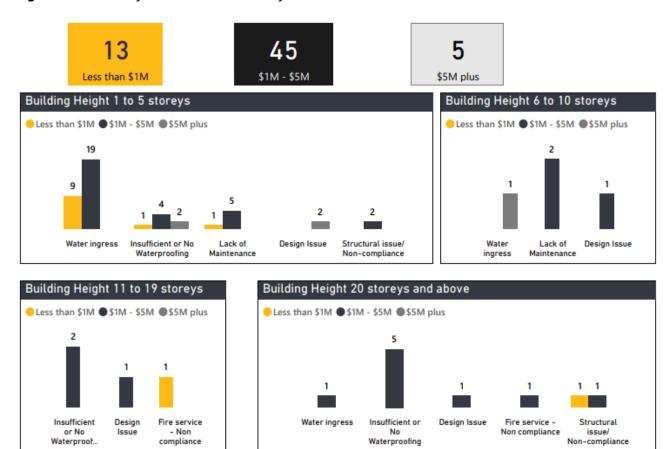
Figure 4 Number of levels and related defects.

In terms of building size, the data indicates that most low-rise buildings have water ingress issues of which the majority require funding of between \$1 million and \$5 million to rectify – see *Figure 4*.

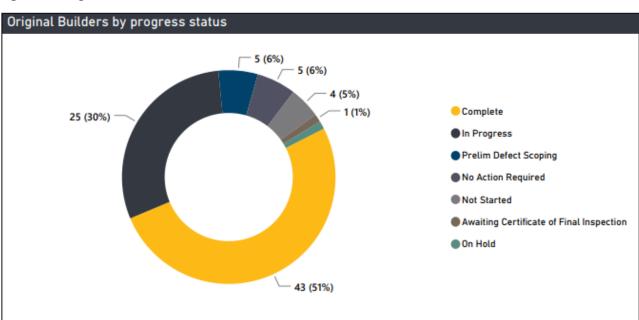
Figure 6 Progress status.

Given the limited nature of CSV's program, it is critical that the cladding and defects rectification of buildings is completed within the agreed timeframes. *Figure 6* indicates that defective balconies on over 80 per cent of buildings have already been addressed or are in progress.
