Office of the Chief Investigator
Transport Safety

**Rail Investigation
Report No 2009/13**

**Derailment
Passenger Train 8235
Footscray
15 October 2009**

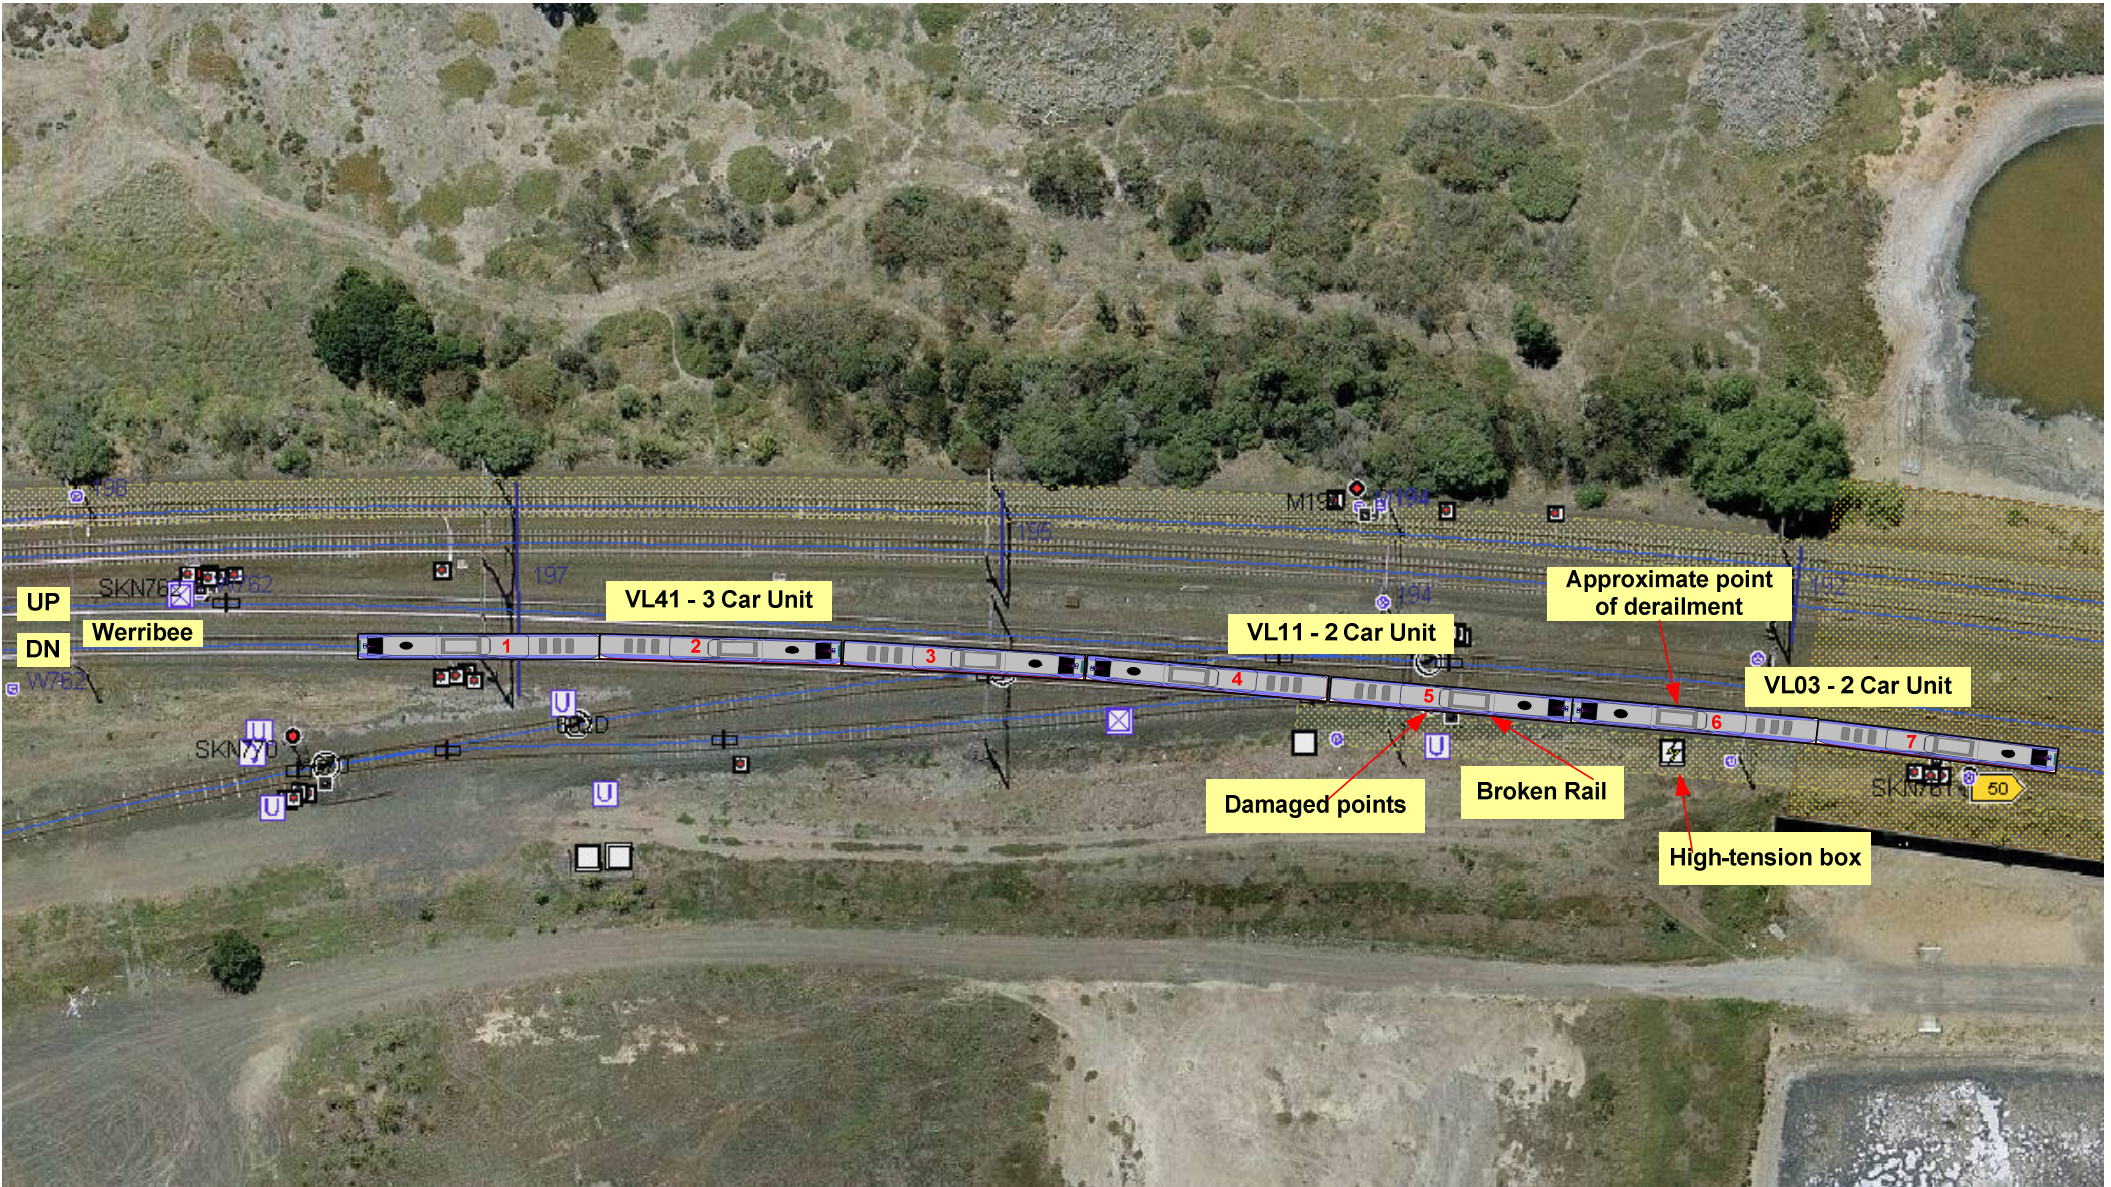
Figure 2 - Location of 7 Car VLocity stopped after emergency braking

On Thursday 15 October 2009, V/Line train 8235 was operating the 1729 service from Southern Cross Station to Marshall Station. The service was on schedule and at about 1738 the driver reported that the train had travelled over a broken rail between South Kensington Station and Footscray Station. The driver applied the emergency brakes and after travelling about 113 metres, the seven-car train came to a halt with the fifth carriage across 661 points.

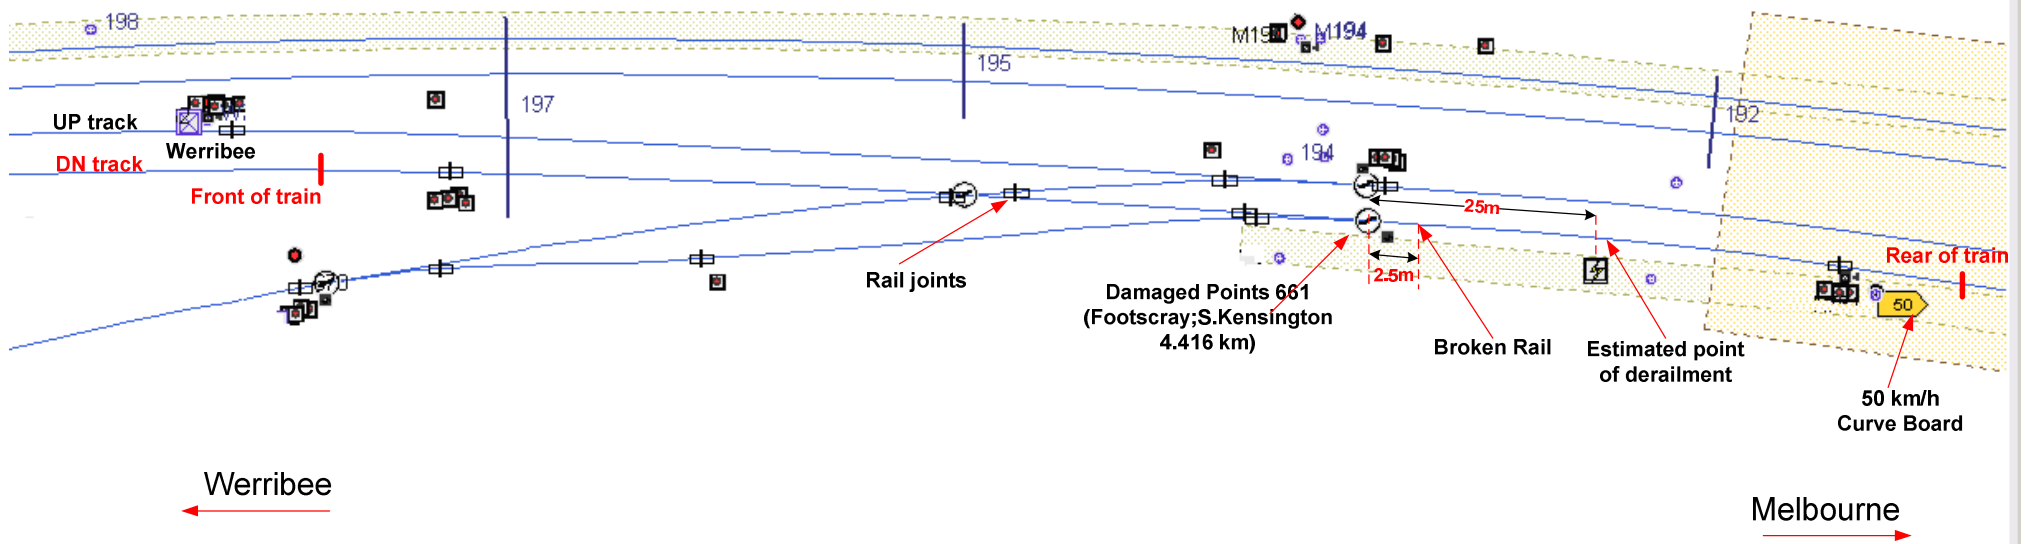
Figure 5 - Track layout, damage and final position of train

A broken rail was observed on the down leg⁵ of the track approximately 2.5 metres from points 661. The break was observed to be at a welded rail joint. The rail head was split and the crack extended for about 20 millimetres vertically into the web before tapering off at an angle to the foot of the rail. A triangular section of metal had fractured off the foot of the rail.

The track repair was completed and included the replacement of approximately 40 metres of rail, the installation of a new set of points, and the reinstatement of the fastenings. Rail services were resumed the following morning.

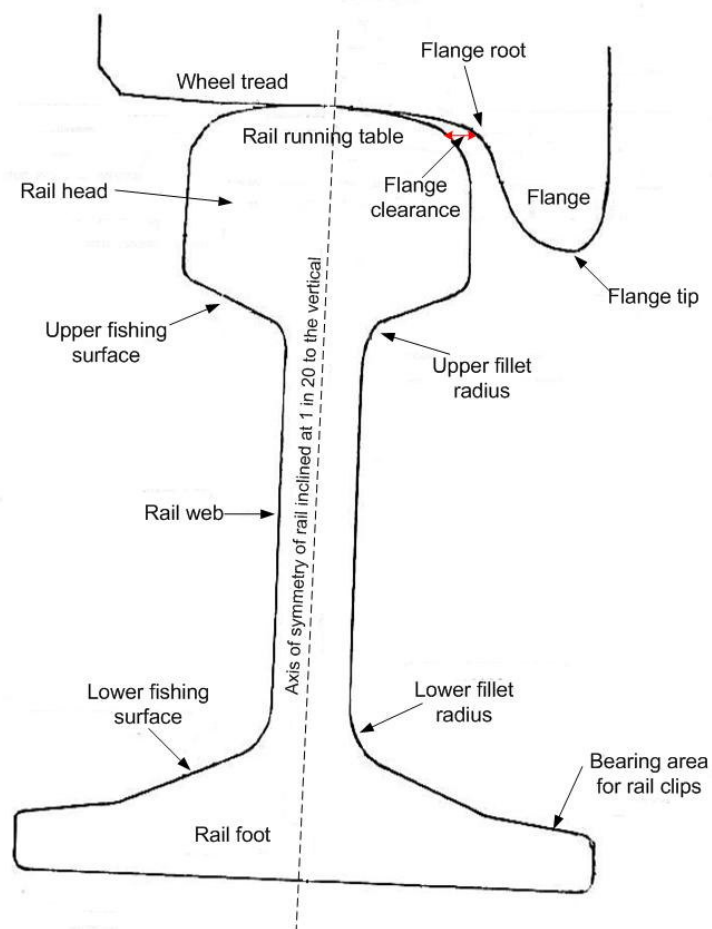
Figure 6 - Wheel profile running in central position on rail

When a train is in motion varying forces are applied to the track. As the outer wheel traverses a curved rail, it is displaced and the flange clearance (Figure 6) is taken up. This results in a lateral force being imparted on the rail head that can result in 'gauge spreading' if the track is not firmly secured. The magnitude of the lateral force is a function of the speed of the vehicle, the curve radius and track cant. Higher speeds and tighter radii generate higher lateral forces. The degree of track cant modifies the curving behavior of a vehicle and alters the magnitude and balance of the lateral forces. The design cant specified in the curve register for this section of track is 30 millimetres. The measured track cant for the section was between 26 millimetres and 29 millimetres. Higher speeds and lower track cant could result in a cant deficiency that would result in a higher load on the high rail and a decreased load on the low rail contributing to track spread.
