Loss of propulsion on passenger cruise ship *Norwegian Star*

Bass Strait, 22 NM SW of Cape Liptrap, Victoria | 10 February 2017

ATSB Transport Safety Report
Marine Occurrence Investigation
MO-2017-003
Final – 24 May 2018

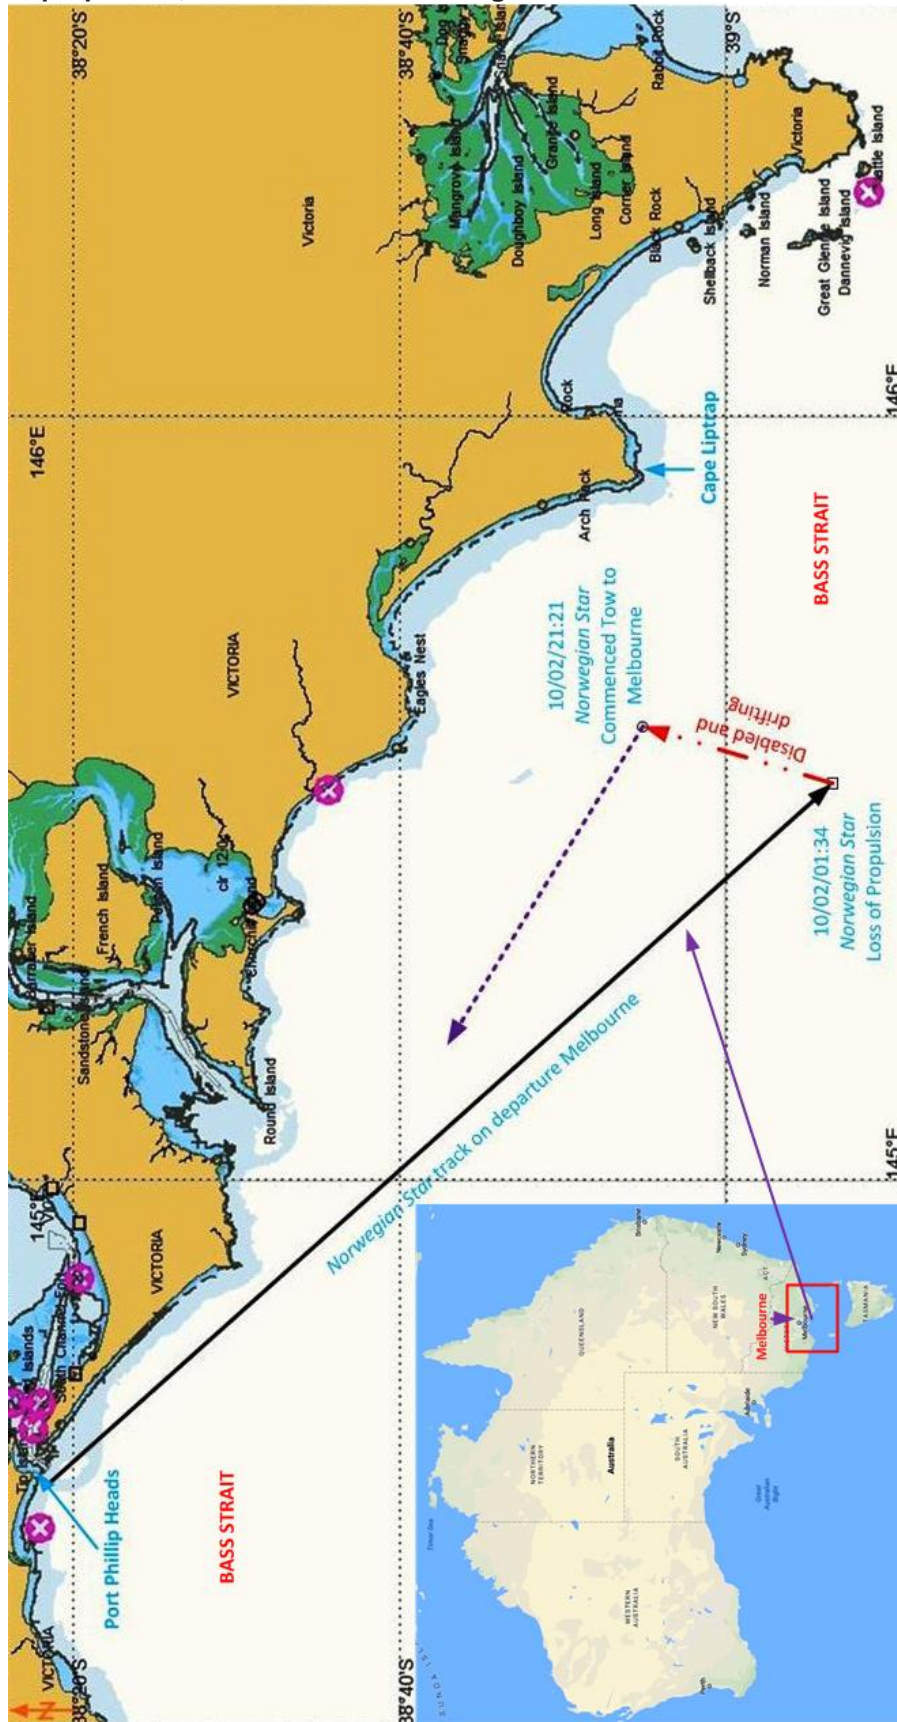
Figure 1: The track of *Norwegian Star* from Port Phillip Bay until its loss of propulsion, and its drift before being towed back to Melbourne

Norwegian Star departed Melbourne on the evening of 9 February 2017 bound for Dunedin, New Zealand with 2,113 passengers and 1,017 crew. The ship exited Port Phillip Heads (the Heads) at 2118⁵ and at 2133 dropped off the pilot and proceeded into Bass Strait (Figure 1).

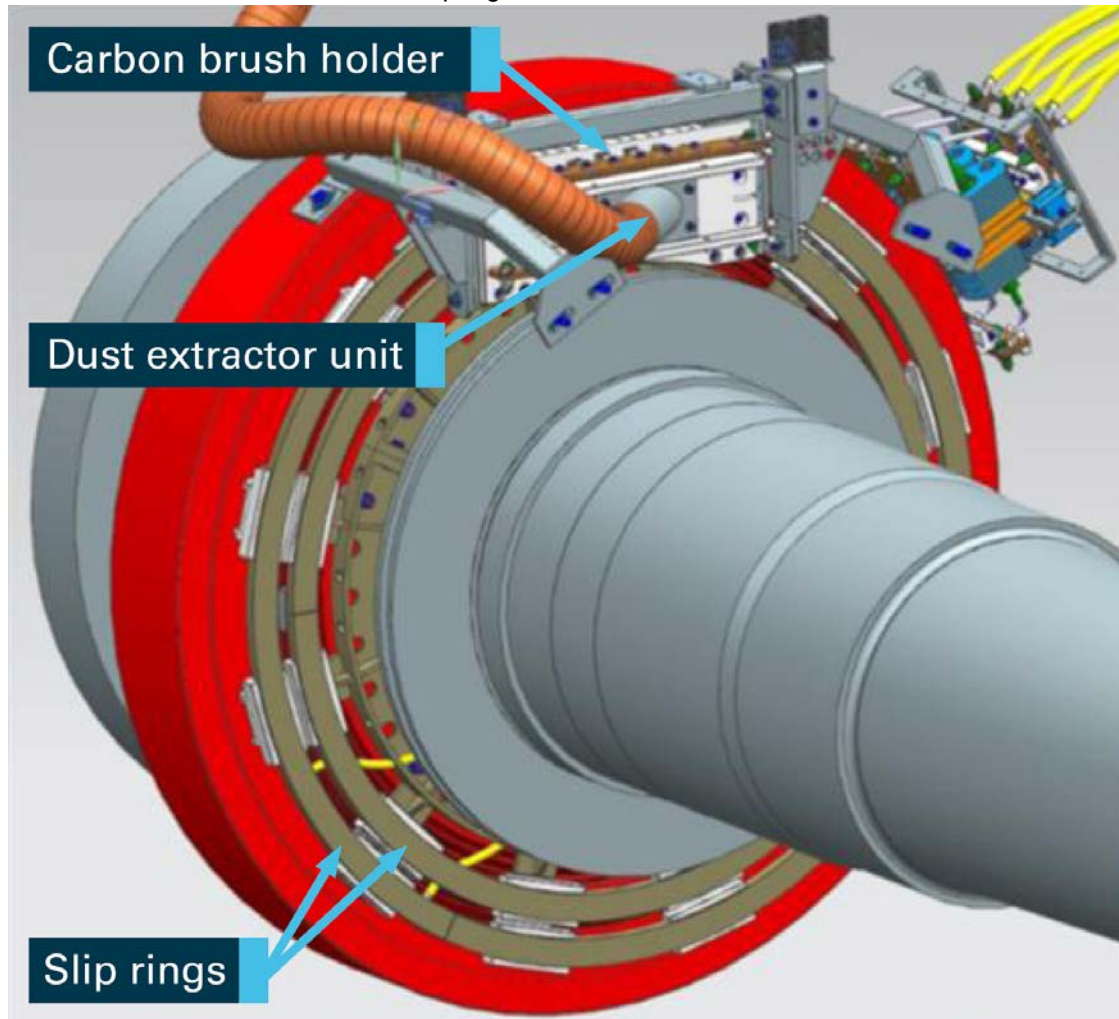
Figure 4: Modified starboard exciter unit with sliprings and brushes

When the brushless starboard exciter unit failed on 11 December 2016, NCLH (in consultation with ABB) decided to repair the unit by modifying it from a brushless system to a slipring unit with brushes. The modification to a slipring unit involved the installation of two concentrically mounted sliprings on the existing exciter rotor, and diode bridge assemblies, carbon brush assembly and dust removal unit mounted on the stator hub assembly (Figure 4). The effect of the modification was to bypass the defective exciter and supply the field of the synchronous motor directly from a new external variable DC supply.

Modified starboard exciter unit with sliprings and brushes
