Office of the Chief Investigator  
Transport Safety

**Marine Safety Investigation  
Report No 2010/14**

**Capsize of  
Vessel 'The Ultimate'  
Off Point Nepean  
12 December 2010**

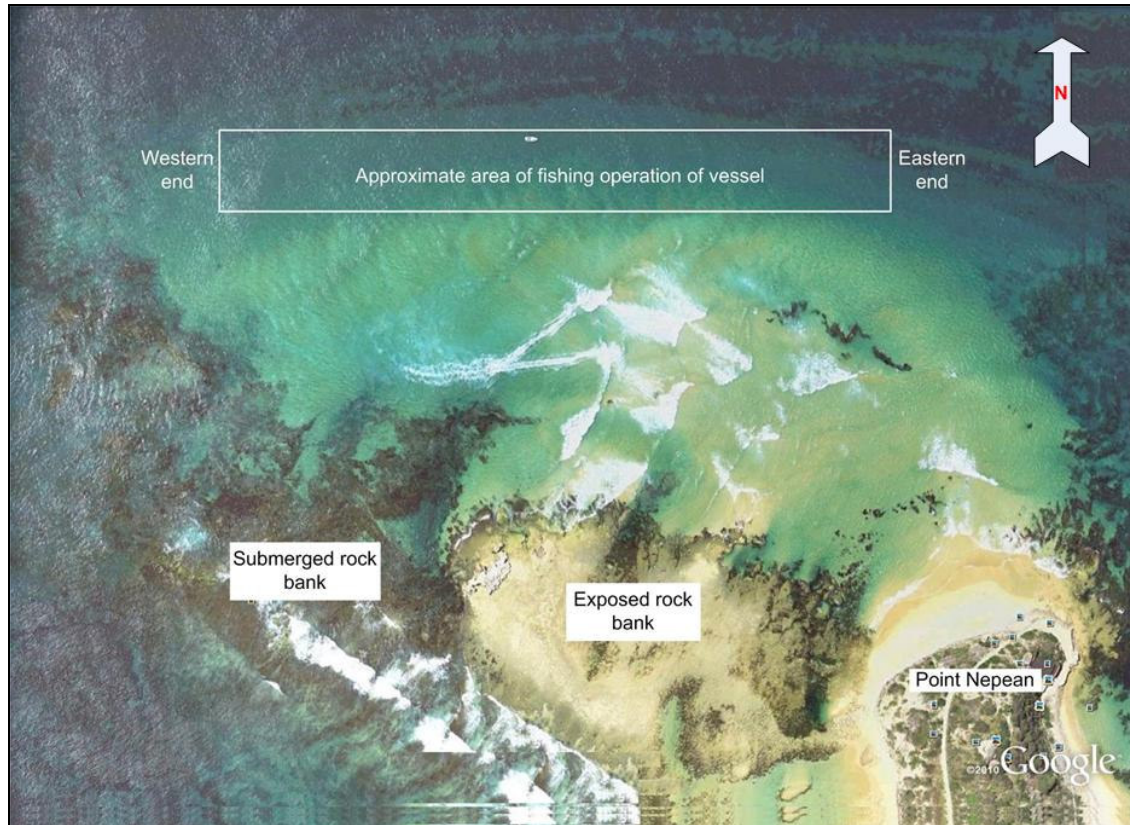
**Figure 2 – Aerial photo indicating approximate area of operation of vessel**

The vessel was operating in the area immediately north of the rock formations extending west of Point Nepean and was being manoeuvred approximately in the region indicated in Figure 2.

Prior to the incident, the vessel had conducted two runs between the easterly and westerly extremities of the indicated region. On its third run the vessel was heading in a southwesterly direction when a wave impacted the starboard bow/beam region causing it to capsize. The capsized vessel drifted onto a sand bar about 150 metres northwest of Point Nepean and came to rest, inverted on its canopy, facing east.

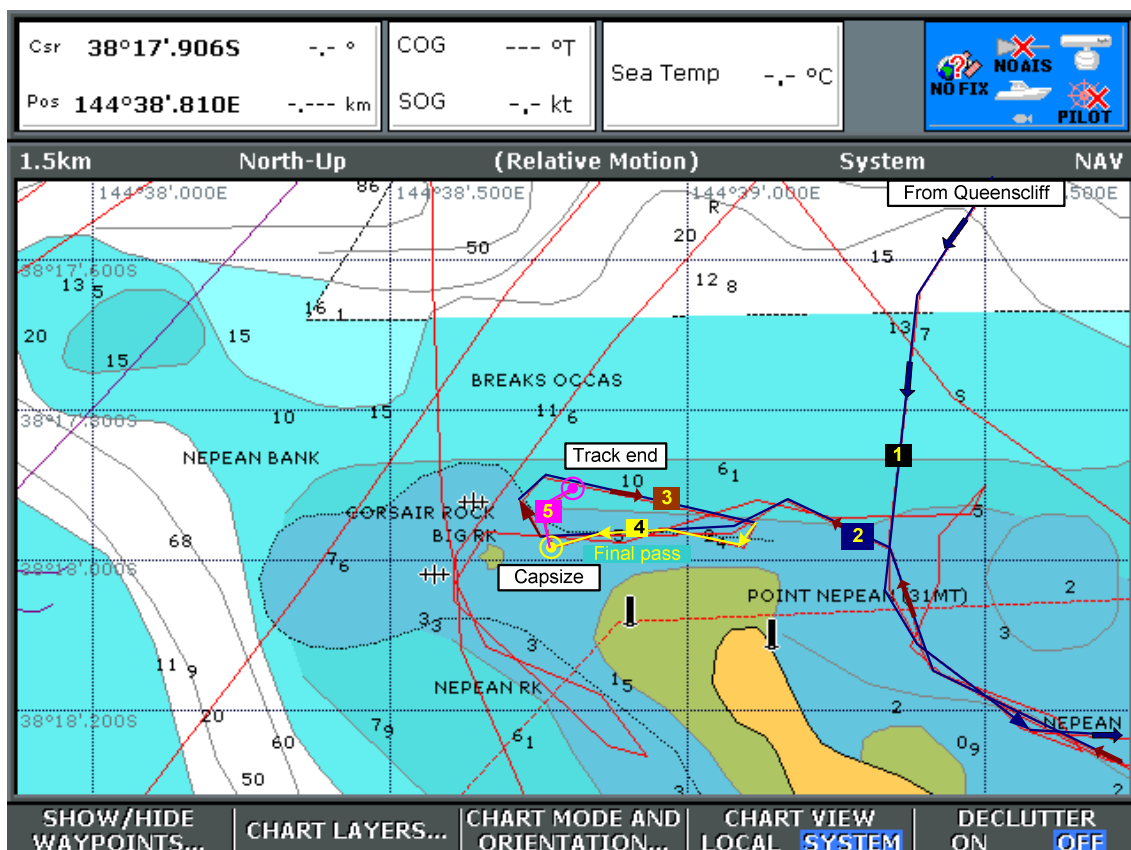
Figure 5 - Track representing the final charter voyage

The track data function was permanently enabled on the unit and showed multiple tracks in and out of Queenscliff Harbor. The image in Figure 5 shows a number of track lines (red lines) crossing through the area. These additional track lines have been made during different passages of the vessel and are probably not related to the final voyage.

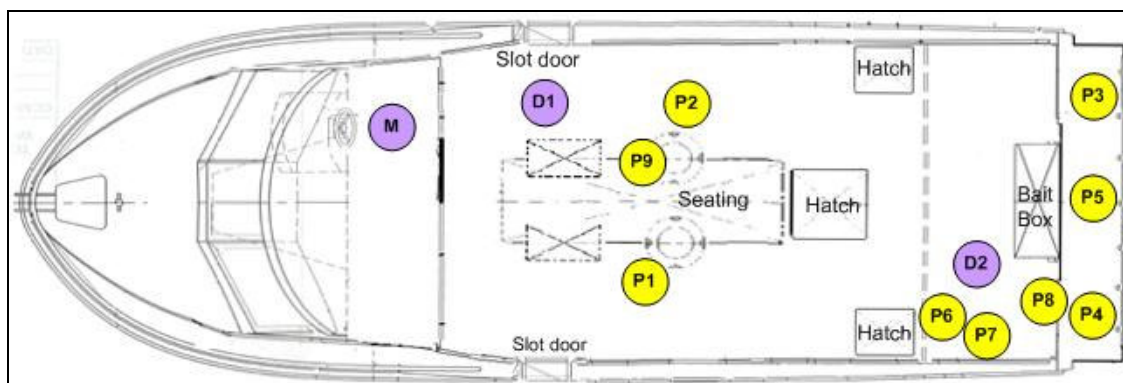
Figure 6 - Approximate positions of crew and passengers prior to capsize

With respect to the location of passengers on the vessel, the master explained that the deckhands ensured that the passengers were evenly distributed on the vessel.

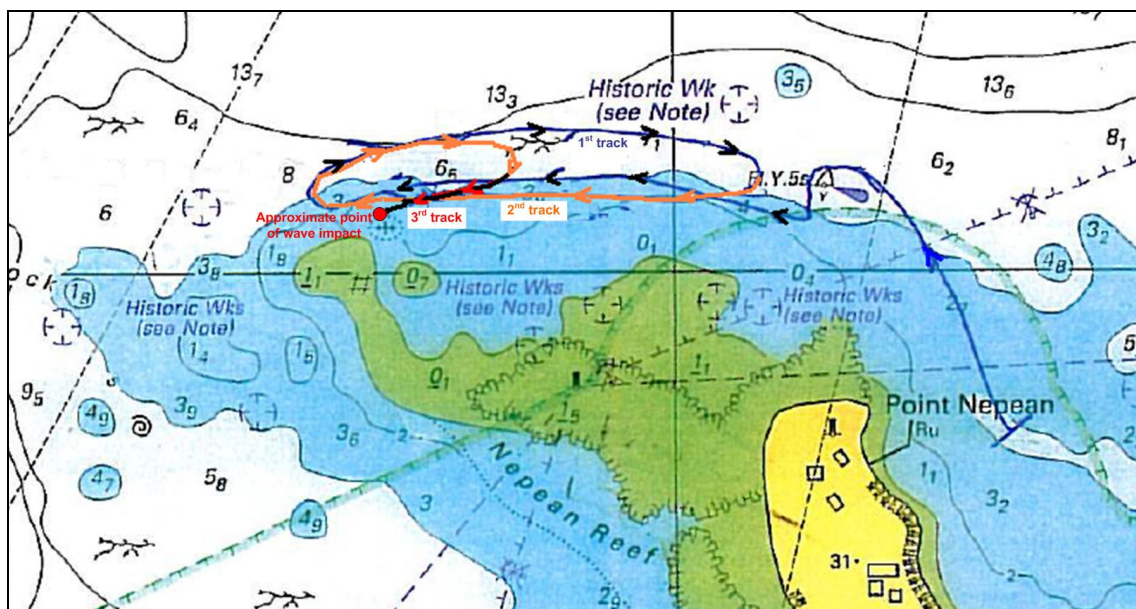
Figure 7 - Approximate track of The Ultimate as indicated by vessel master

The master said that he started tracking east along the Marine Park Line over three ledges that are common fish holds. He recalled that he did two passes and caught salmon on the second pass. He said that on the third pass he decided to cut his track short and follow his previous track where he caught the salmon, about 100 metres away from Big Rock. He said the vessel was travelling at about 3.5 to 4 knots and the engines were running at about 300 revolutions per minute when he noticed a full rolling ground swell of about 6 foot (1.8 metres) about 25 to 30 metres off his bow, which was not going to face up or form a breaking wave.. He said that he increased the engine speed to about 500 revolutions and the vessel was travelling at about 5.5 knots. He stated that he was preparing to manoeuvre the vessel over the swell when he noticed another smaller swell of about 4 to 5 foot (1.2–1.5 metres) coming from the beam of the vessel's port side. He said that he then noticed that the swell on his starboard bow had risen to about 10 to 12 feet (3.0–3.6 metres) and he put both motors to full throttle to punch through or go over the wave. He stated that a wave that was higher than the roof of the vessel, about 2.5 to 2.8 metres high and was still forming, hit the vessel. He said that he steered slightly to the port side before the wave from the port side hit the vessel and the combination of the waves turned the vessel onto its port side. He said that the vessel travelled about 30 metres on its port beam until eventually the wave engulfed the vessel and completely rolled it over. He stated that he tried maximum throttle to outrun the waves, but was not successful as he could not get enough power as the propellers were cavitating<sup>1</sup>.

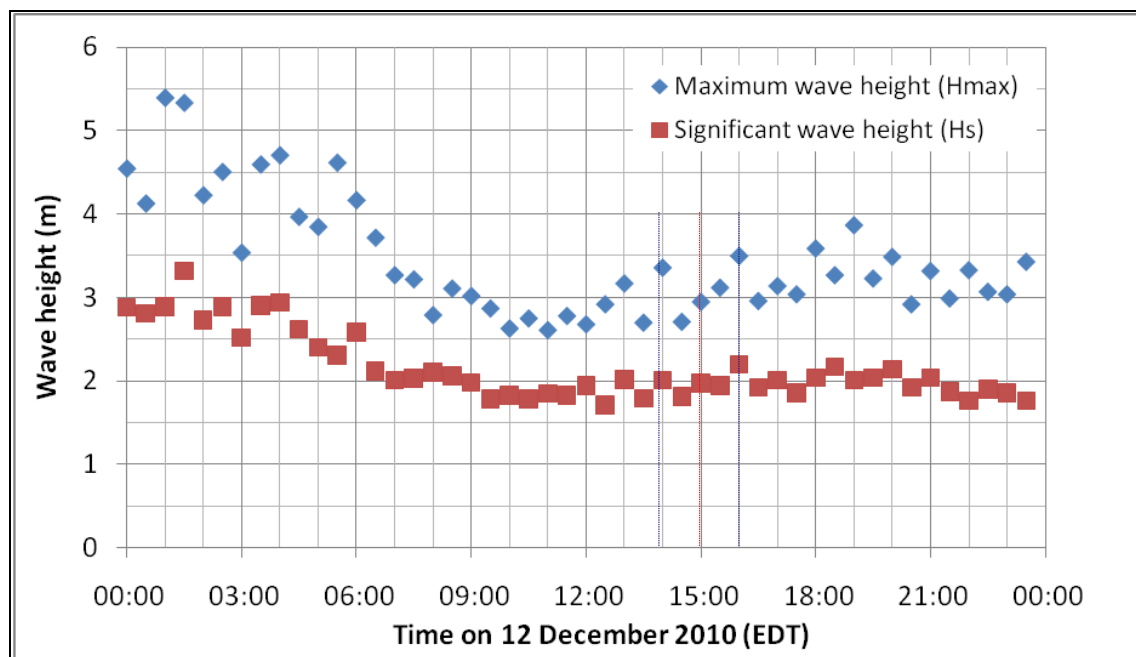
Figure 11 - Wave heights recorded by PoMC Wave buoy on 12 December 2010

The significant wave height<sup>9</sup> recorded on 12 December 2010 from 1400 to 1600 was about 2.0 metres. The spectral peak wave period<sup>10</sup> was approximately 12 seconds and wave direction was about 208 degrees.
