**Marine Safety Investigation  
Report No 2008/10**

**Collision  
Police Vessel VP02-08  
and Recreational Vessel LC873  
Near the entrance to Patterson River Port Phillip  
1 November 2008**

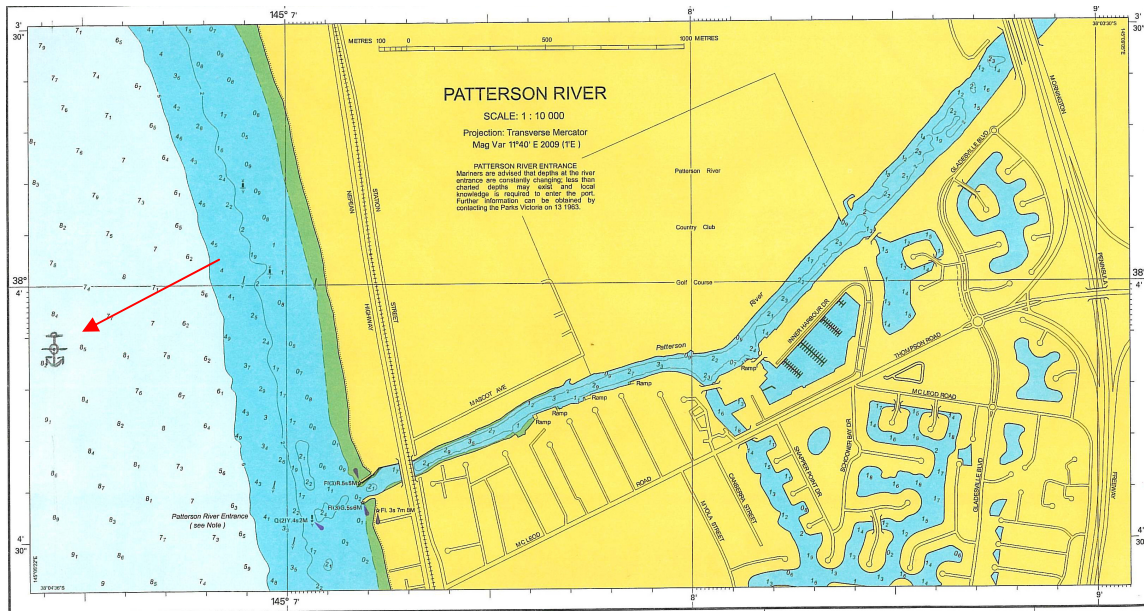
**Figure 6: LC873 anchor position near the entrance to Patterson River. (see Appendix A for larger scale chart of the area)**
