Office of the Chief Investigator
Transport Safety

**Rail Safety Investigation
Report No 2009/07**

**Derailment
Pacific National Train 9564
ABB Siding, Dandenong
1 June 2009**

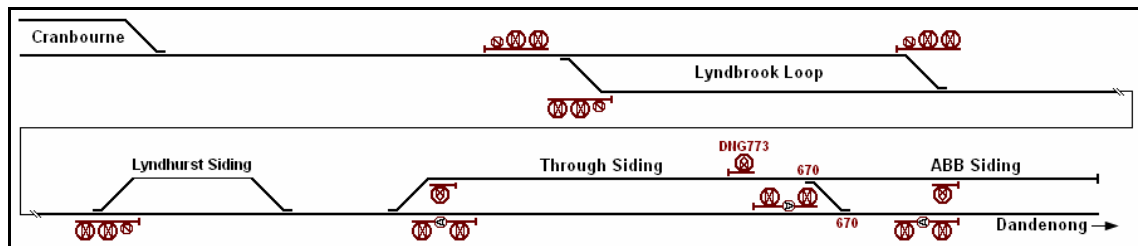
Figure 1 – Schematic of line Dandenong – Cranbourne

The rail line between Dandenong and Cranbourne is a single bi-directional electrified line forming part of the Melbourne suburban system. The sections are: Dandenong to Lynbrook Loop and Lynbrook Loop to Cranbourne. The Dandenong to Lynbrook Loop section has intermediate locations at the Through/ABB Siding and Lyndhurst Siding (see Figure 1). Route and signal settings are controlled and monitored by a signaller stationed at Dandenong.
