Office of the Chief Investigator
Transport Safety

**Rail Safety Investigation
Report No 2017/07**

Collision
Trams 6042 and Tram 6019
Nicholson Street, Melbourne
15 October 2017

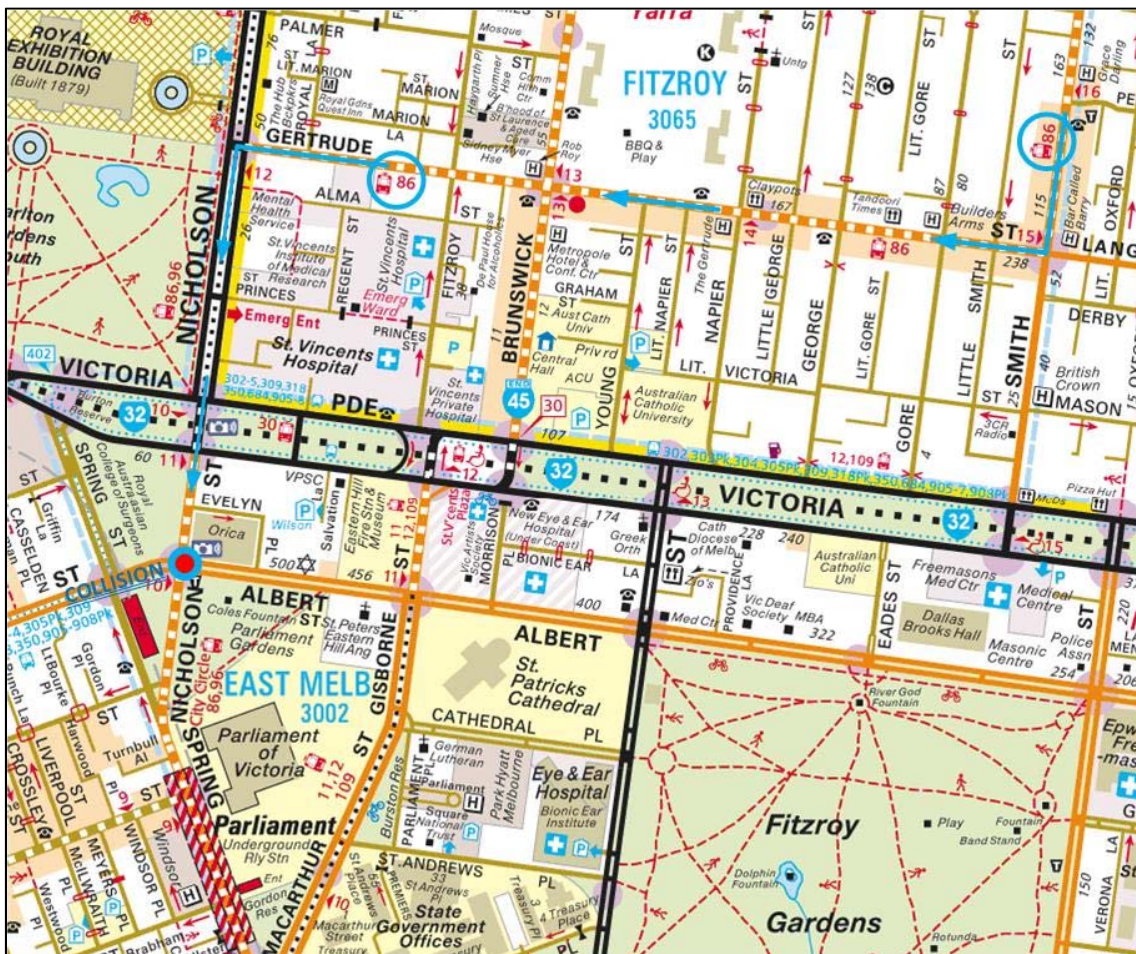
Figure 1: Route of Tram 6042 through to Nicholson and Spring Streets

Tram 6042 turned from Smith Street into Gertrude Street, travelling west towards Nicholson Street. The tram stopped at the intersection of Gertrude and Nicholson Streets, at which time Tram 6019 crossed ahead of it, travelling south on Nicholson Street towards the city. At about 2052 Tram 6042 turned into Nicholson Street and stopped briefly Stop 12 (opposite the museum). At this time Tram 6019 was stopped at St Vincent's Hospital (Stop 11), at the intersection of Nicholson Street and Victoria Parade (Figure 1).

Both trams resumed driving at about the same time. There were no passengers wanting to board or alight Tram 6042 at Stop 11 and the traffic lights had a 'proceed' aspect, so the driver continued driving across the intersection with Victoria Parade. At that time Tram 6019 was stopped at the traffic signals at the Albert Street intersection with Nicholson Street, about 130 m ahead.
