Office of the Chief Investigator
Transport and Marine Safety Investigations

**Marine Safety Investigation
Report No 2007 / 01**

Fire on board
Passenger charter vessel "Moonraker"
Popes Eye Marine National Park
14 January 2007

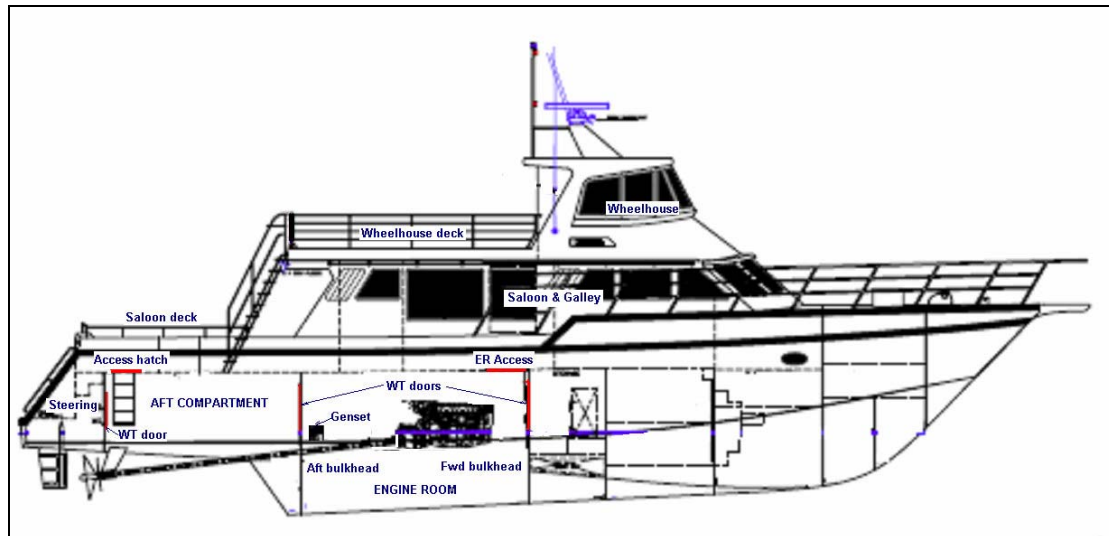
Figure 1 - General arrangement of Moonraker

(Figure 1). The master then released two dry chemical powder extinguishers in the vicinity of the area that was observed to be still smouldering.

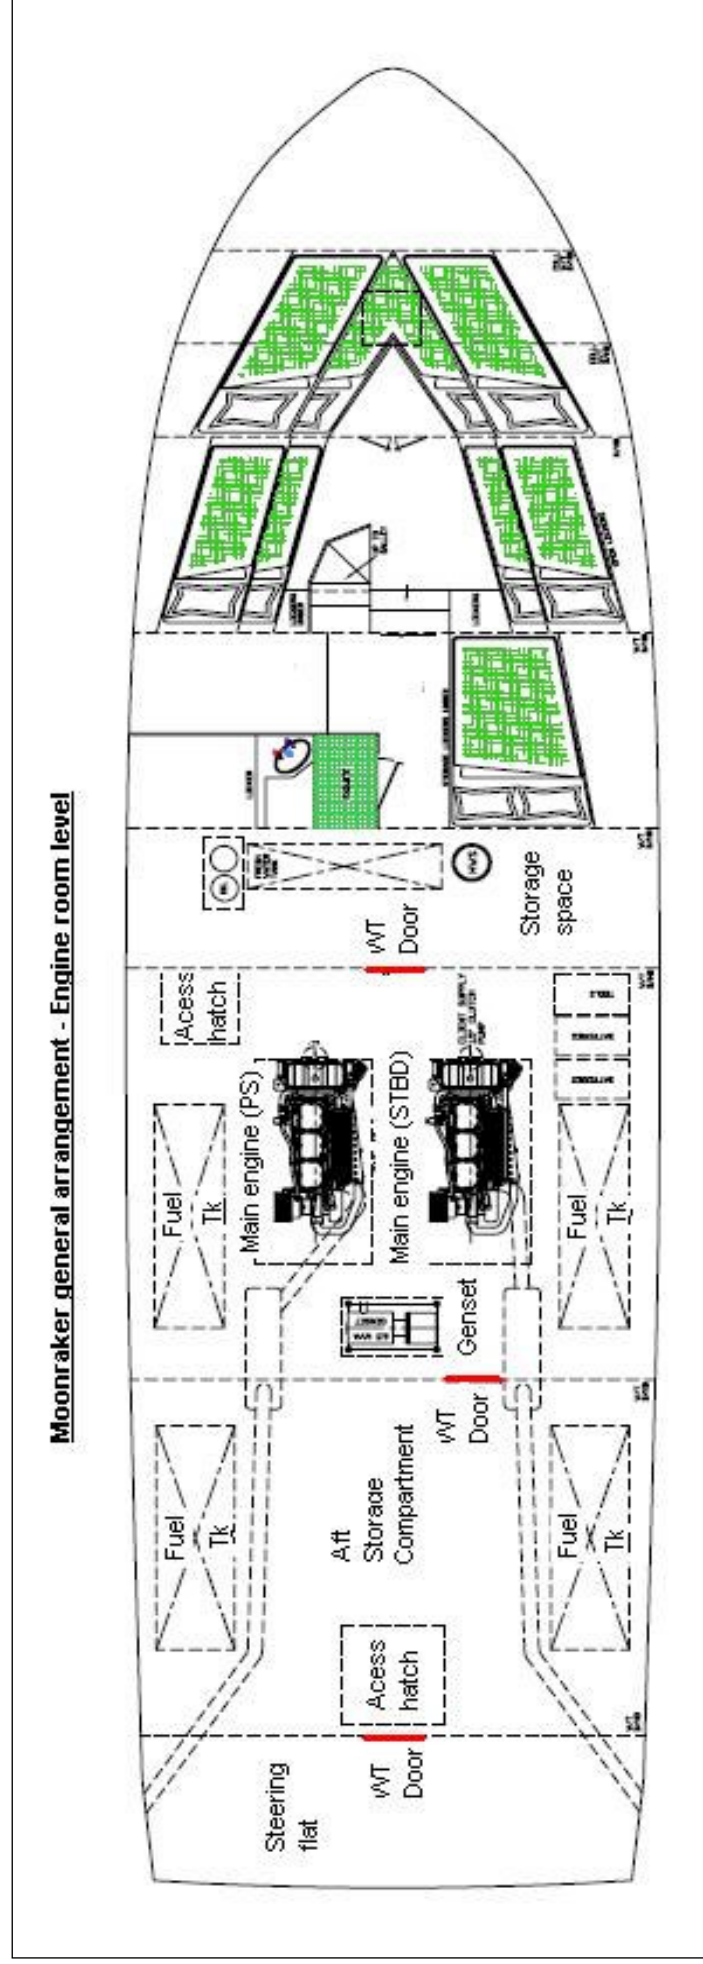
Figure 11 - General arrangement ER and adjacent spaces

The engine room has two means of access. One access is through a hatch and stairway located on the saloon deck adjacent to the forward watertight bulkhead of the engine room (Appendix B – Fig 11). The other access is through the aft watertight bulkhead that has a watertight door leading to the aft compartment.

The seat of the fire was observed to be in the vicinity of the bilge well, against the aft bulkhead.

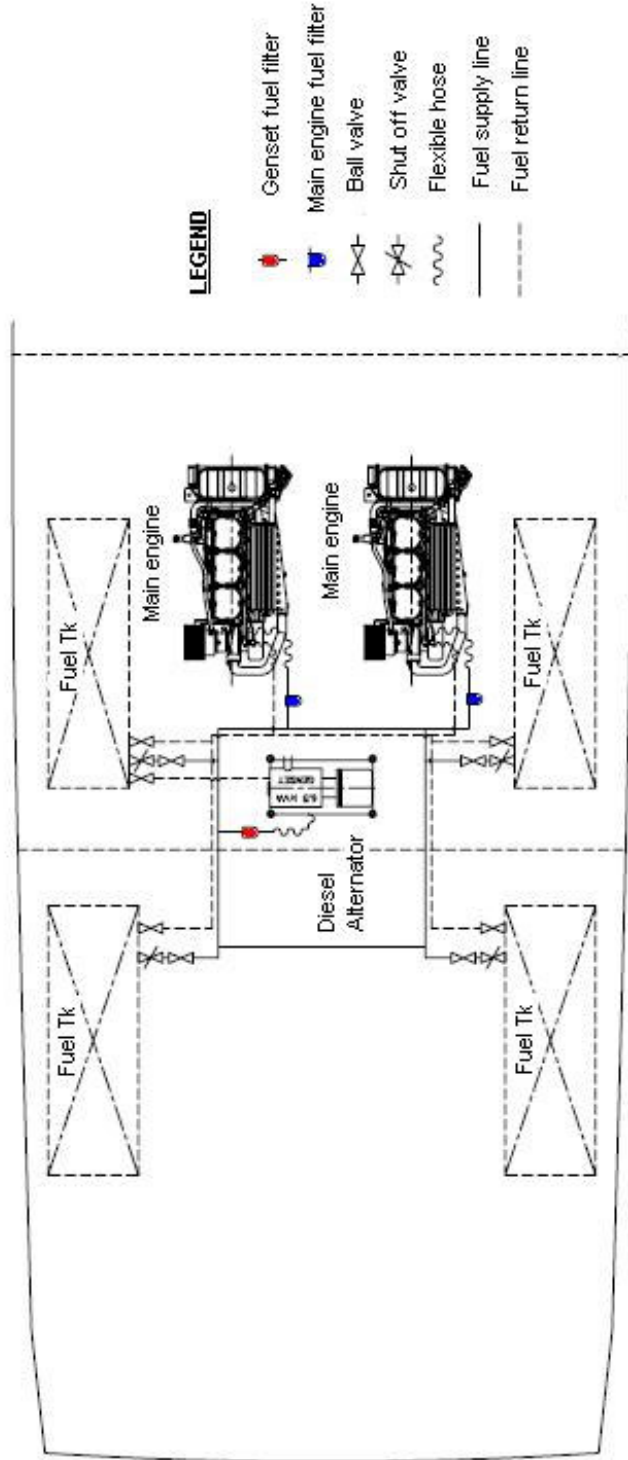
Figure 12 - Fuel tanks and filter arrangement

The most probable cause of the fire was determined to be a faulty electrical connection igniting residual diesel oil that had accumulated from a leaking fuel filter.

The vessel has four fuel tanks. Two fuel tanks of 1350 litres each are located in the aft compartment and two fuel tanks of 1250 litres each are mounted against the Port aft and Starboard aft sides of the engine room. Each fuel tank outlet leads through a fuel filter mounted on the aft watertight bulkhead to the two main engines (Appendix B – Figure 12).
