Office of the Chief Investigator
Transport and Marine Safety Investigations

**Rail Investigation
Report No 2008/11**

**Infrastructure Failure
Connex
Kensington/North Melbourne
6 November 2008**

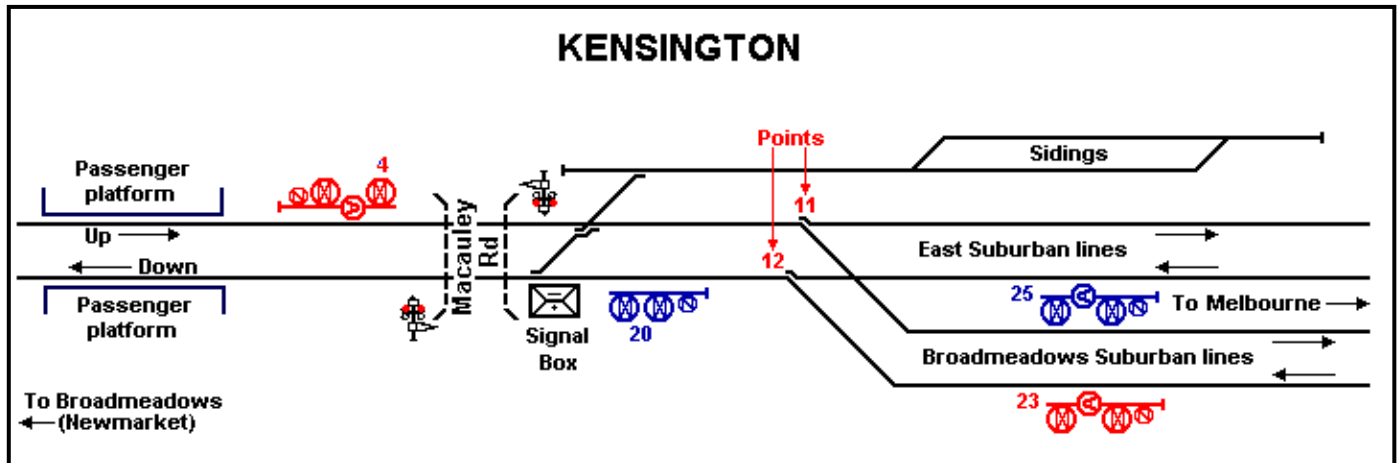
Figure 1 Signalling Diagram – Kensington 'Up' side.

As the technician was preparing to depart, the signaller reported trouble with № 12 points (loss of detection in Normal position). The technician checked the points and found them not properly positioned (blade not against stock rail). All other relevant equipment was checked and no fault found. The technician concluded the problem had been a 'soft-pull'⁶ by the signaller on the № 12 points lever and that the signaller had not checked for detection before 'pulling signals'. He stated that this is a recurring issue at the Kensington signalbox.

While the maintenance technician was standing-by at the Kensington Nos 11 and 12 points to carry out a final inspection in both Normal and Reverse positions (maintenance associated with 1st trigger event), the signaller reported that № 12 points were now locked at Normal and that he was unable to move the lever in the frame. The technician re-checked all equipment, found no fault, and reported a possible interlocking fault.

The signal maintenance technician at Kensington found a blown fuse for the 12 track circuit. This caused the № 12 points fault most recently reported by the Kensington signaller. Once replaced, full functionality was restored to all signal apparatus controlled from the Kensington signalbox.

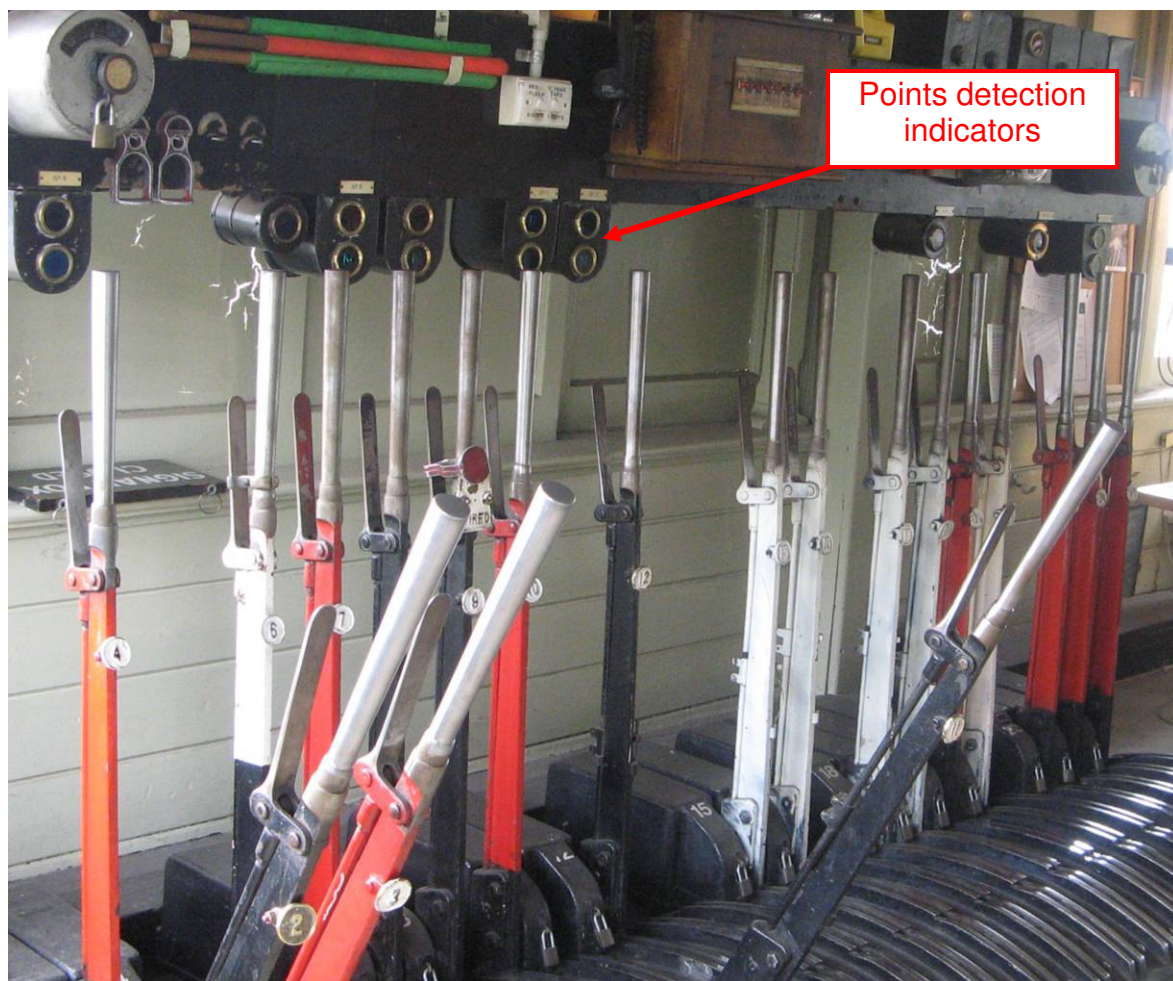
Figure 4 Kensington signalbox – lever frame.

The Kensington signalbox dates to 1887 however the 'cam-and-tappet' interlocking lever-frame was installed in 1918. The lever-frame contains 19 levers for the manual operation of points and the electrical operation (switching) of various signals, plus one set of level crossing active protection equipment (flashing lights, boom barriers and pedestrian gates and bells). Some components of the mechanical interlocking equipment between North Melbourne and Newmarket, which includes Kensington, are in excess of 100 years old.

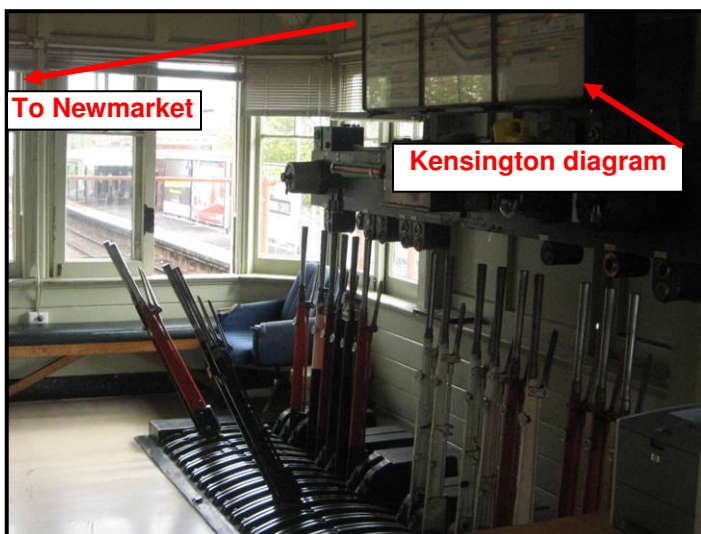
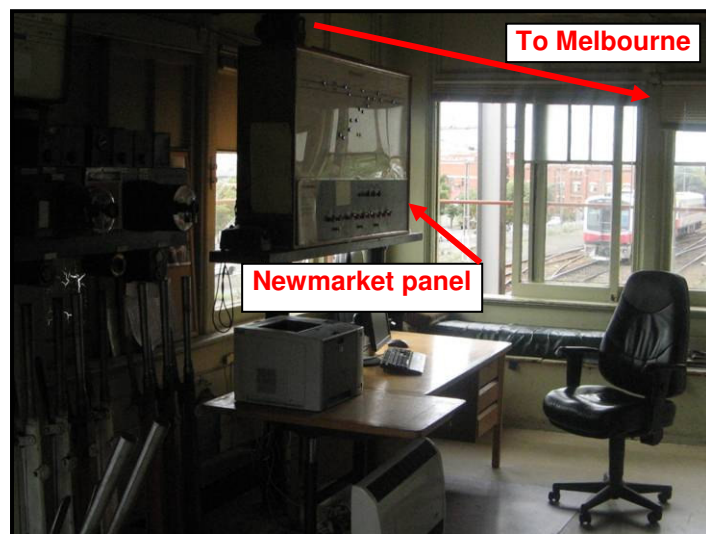
Figure 9 Kensington signalbox; Track indication display panels.

The Kensington illuminated diagram and co-located Newmarket control panel present conflicting display protocols to the signaller. While the older Kensington illuminated diagram graphically displays track circuits that are lit when the track is *not* unoccupied, the opposite is the case for the diagrammatic Newmarket panel which displays track sections via an illuminated lamp when the track *is* occupied (see Fig. 10).

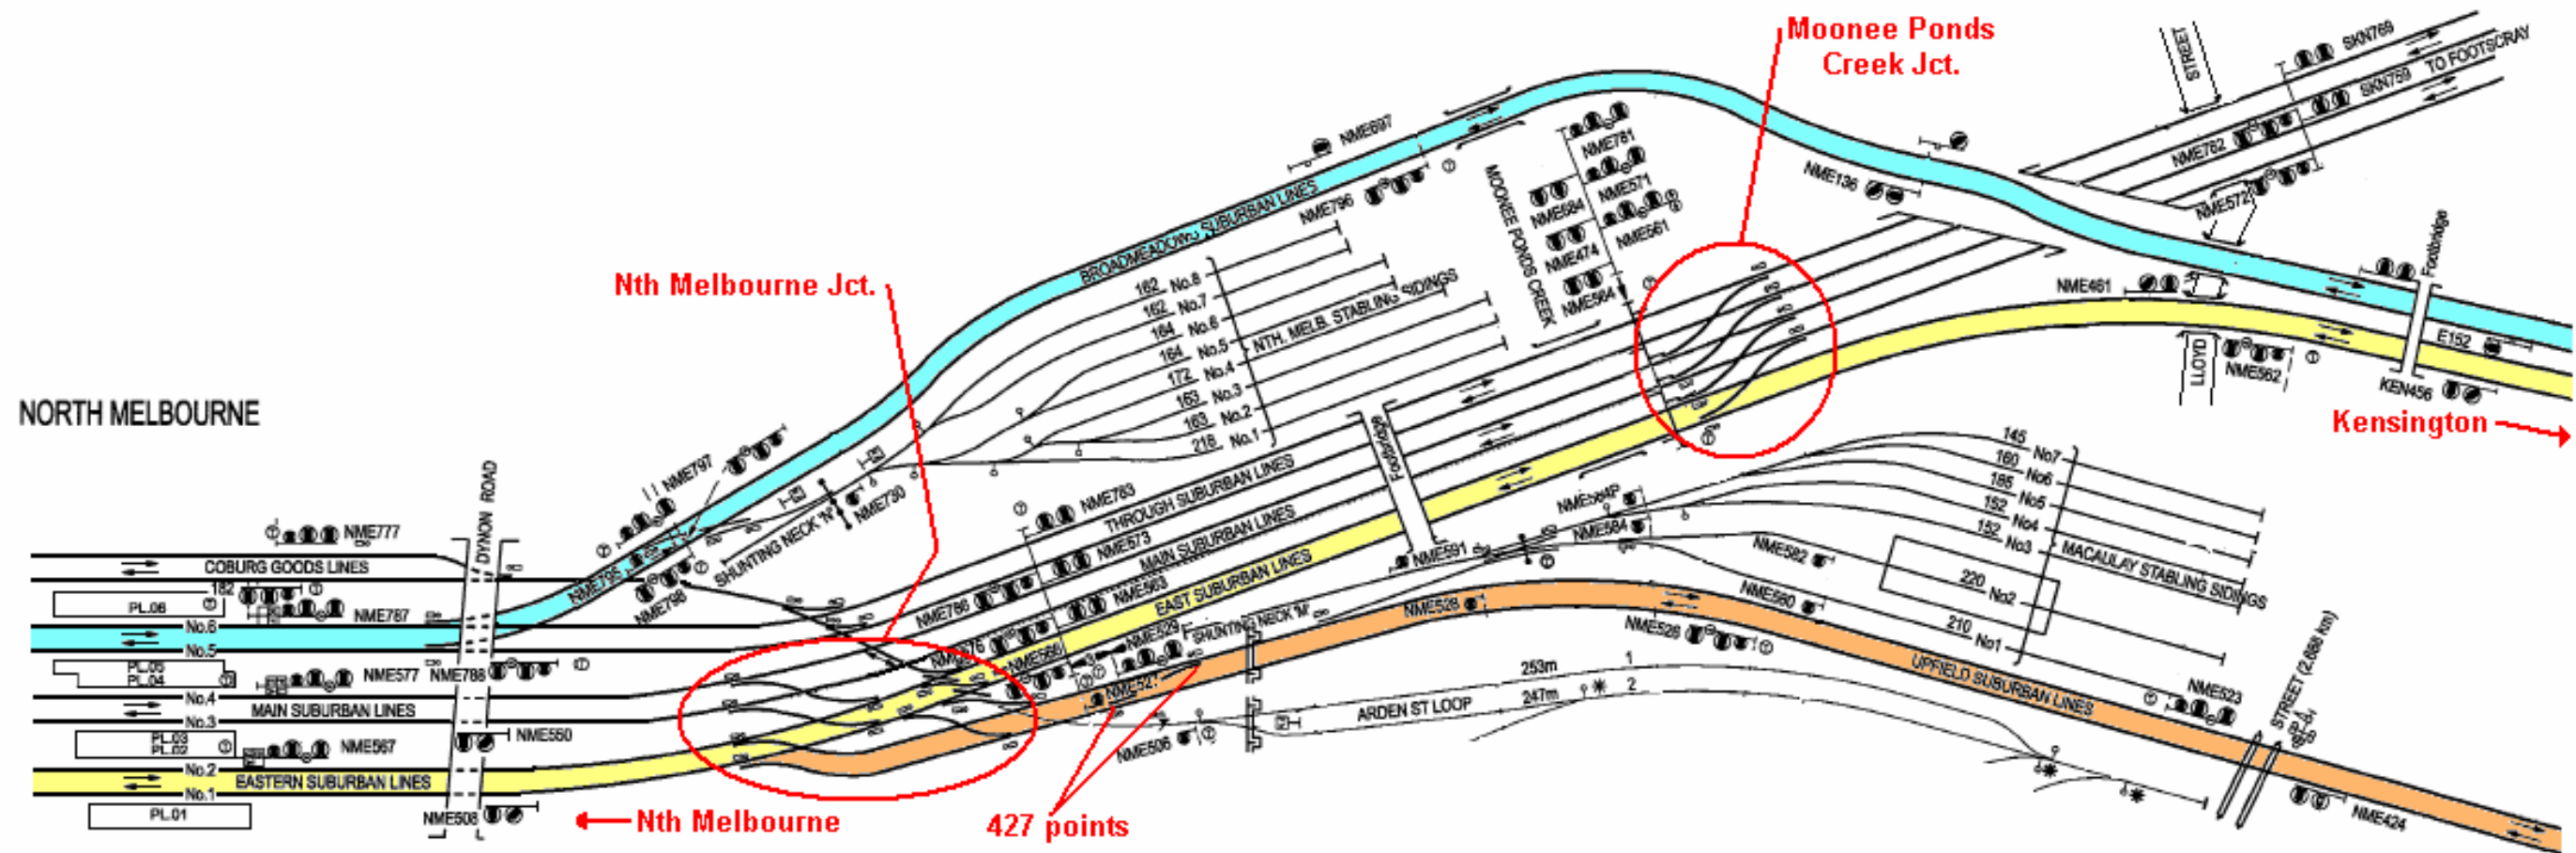
Appendix D: Signalling diagram and track chart – Nth Melbourne and Macaulay

№ 427 points (serving the crossover on the Upfield Suburban (US) lines adjacent to dwarf signal NME527; see orange line, Appendix D) were reported 'Out-of-Correspondence/Failed-to-Reverse'. This required Metrol to issue Caution Orders for train movements past various Home signals protecting movements both to-and-from the US lines and North Melbourne Station. The requirements for issuing Caution Orders and the need for trains to operate under these provisions over distances of up to 640 metres caused significant delays to each affected train. These delays impacted upon other train movements to-and-from the ES lines and North Melbourne Station, delaying and in some cases halting trains on the Up ES line between Kensington and North Melbourne and also between Footscray and North Melbourne. Passengers detrained in mid-section from several of the trains halted between Kensington and North Melbourne.

№ 427 points (see point 11) self-rectified while maintainers were in attendance. No fault was found. Traffic resumed on the Upfield lines.
