**Marine Safety Investigation
Report No 2009/12**

**Breakaway from Berth
MT Leyte Spirit
Gellibrand Pier Melbourne
21 August 2009**

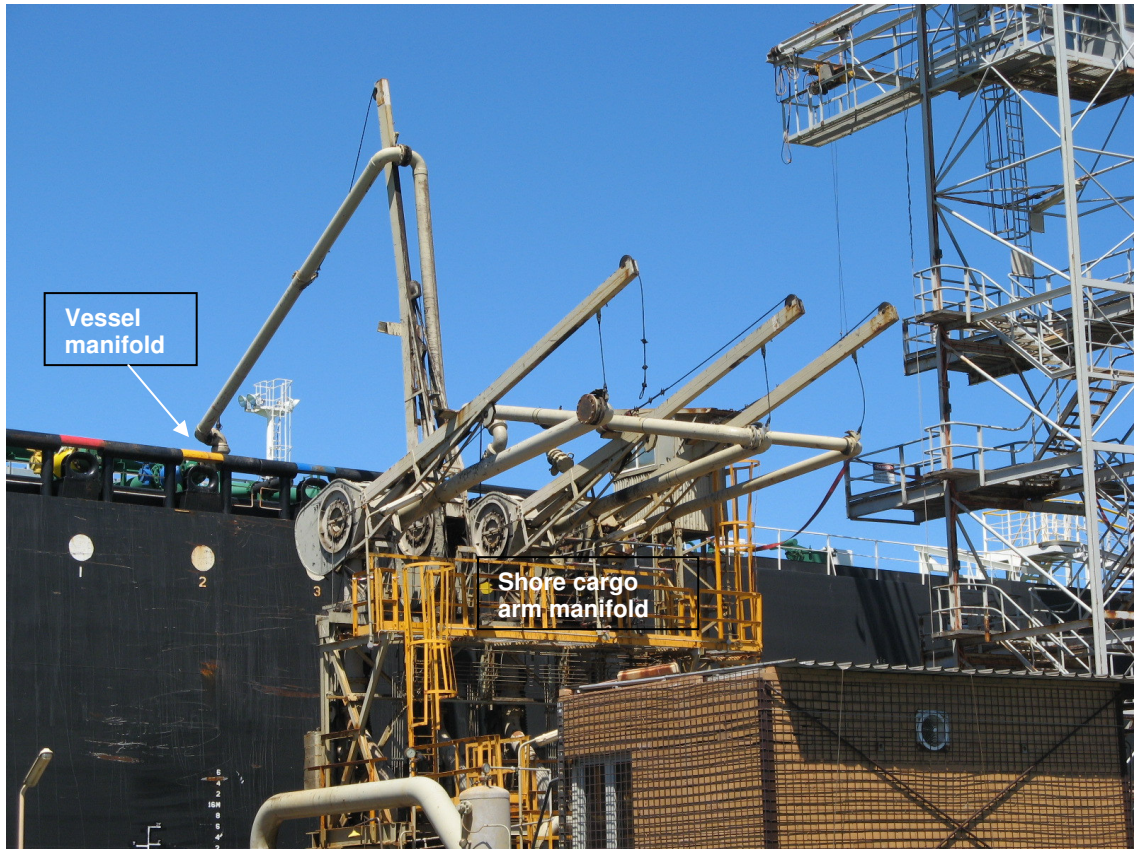
Figure 2 – Shore cargo arm connected to vessel's manifold (The vessel pictured is not Leyte Spirit)

To effect discharge, the terminal cargo arm (articulated steel hose pipe) was connected to the vessel's cargo manifold and the discharge rate was set at 2,200 cubic metres per hour.

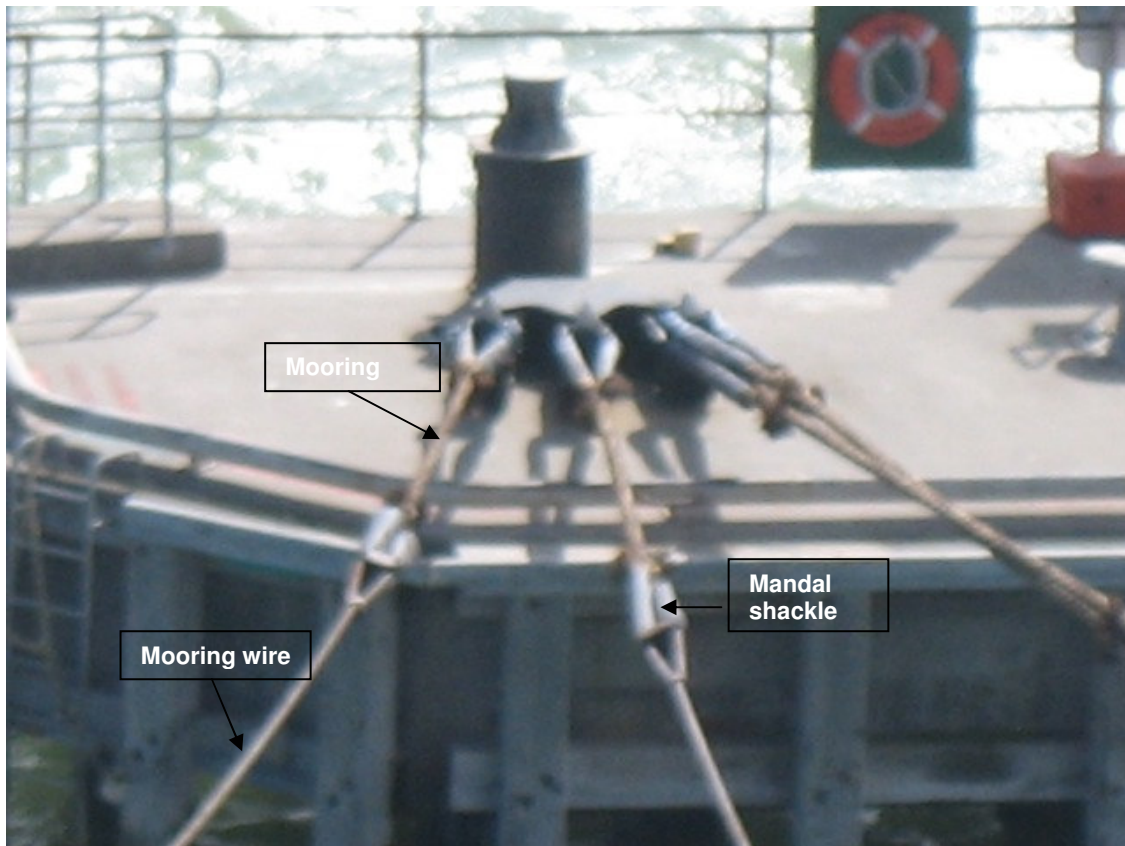
Figure 6 – Mooring lines

The end of each mooring wire (Figure 6) is connected to a synthetic fibre rope (mooring tail) of length 11 metres, diameter 80 mm and 120 tonnes minimum breaking limit. The shackle connecting the wire to the fibre rope had a breaking strength of 120 tonnes.

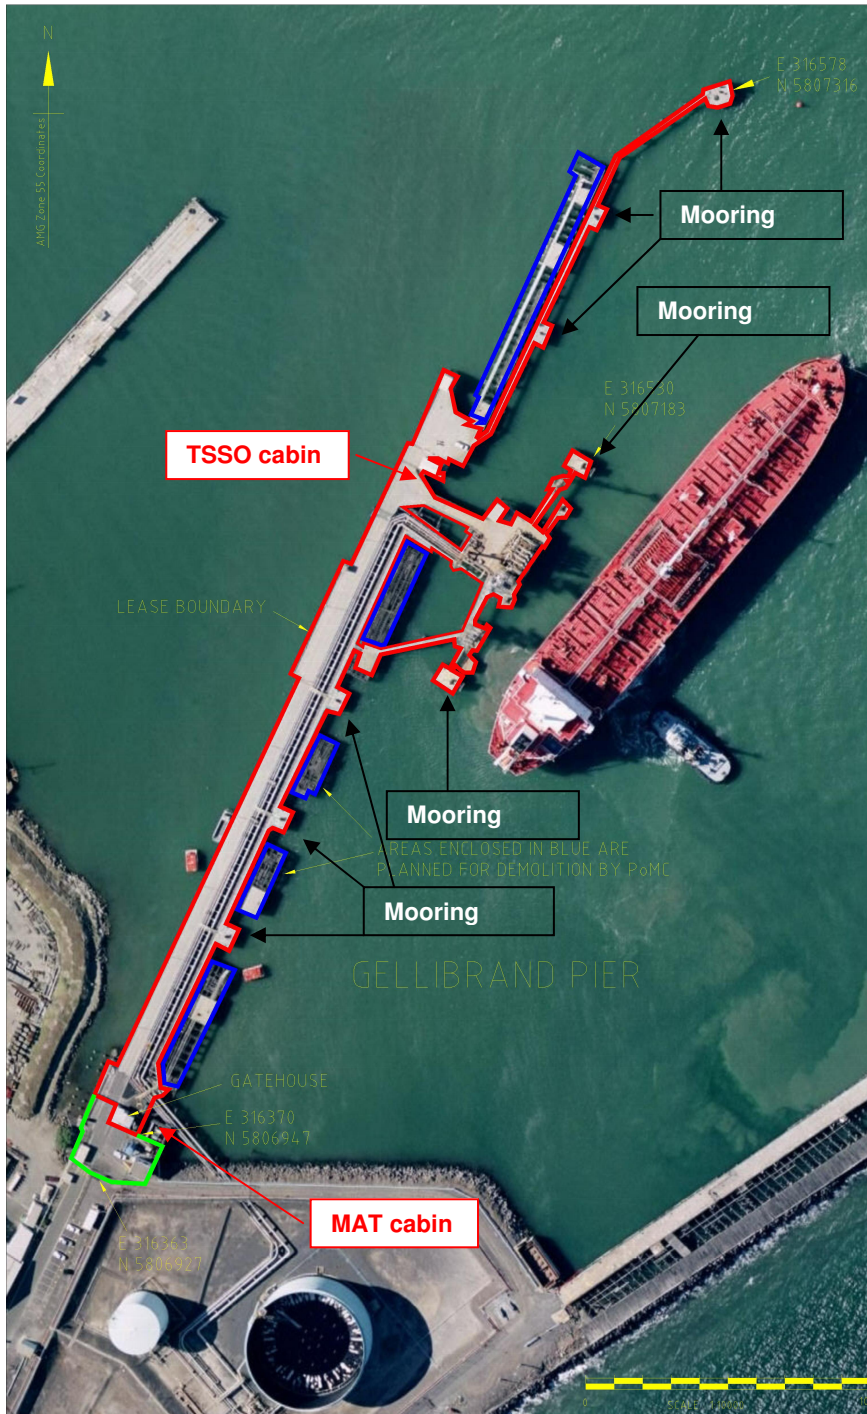
Figure 9 – Aerial view of Gellibrand Pier (The vessel pictured is not Leyte Spirit)

Gellibrand Pier is a crude oil berth in the Port of Melbourne. It is located in Hobson's Bay at Williamstown (Appendix B). The berth is a typical tanker berth consisting of a finger pier with a crosswalk, connecting to the loading platform which holds the gangway tower and the terminal cargo arm manifold. The pier and the berthing infrastructure is owned by the Port of Melbourne Corporation and leased to Mobil Refining Australia Pty Ltd. Mobil owns, maintains and operates the cargo working equipment and is responsible for all cargo operations at the terminal.

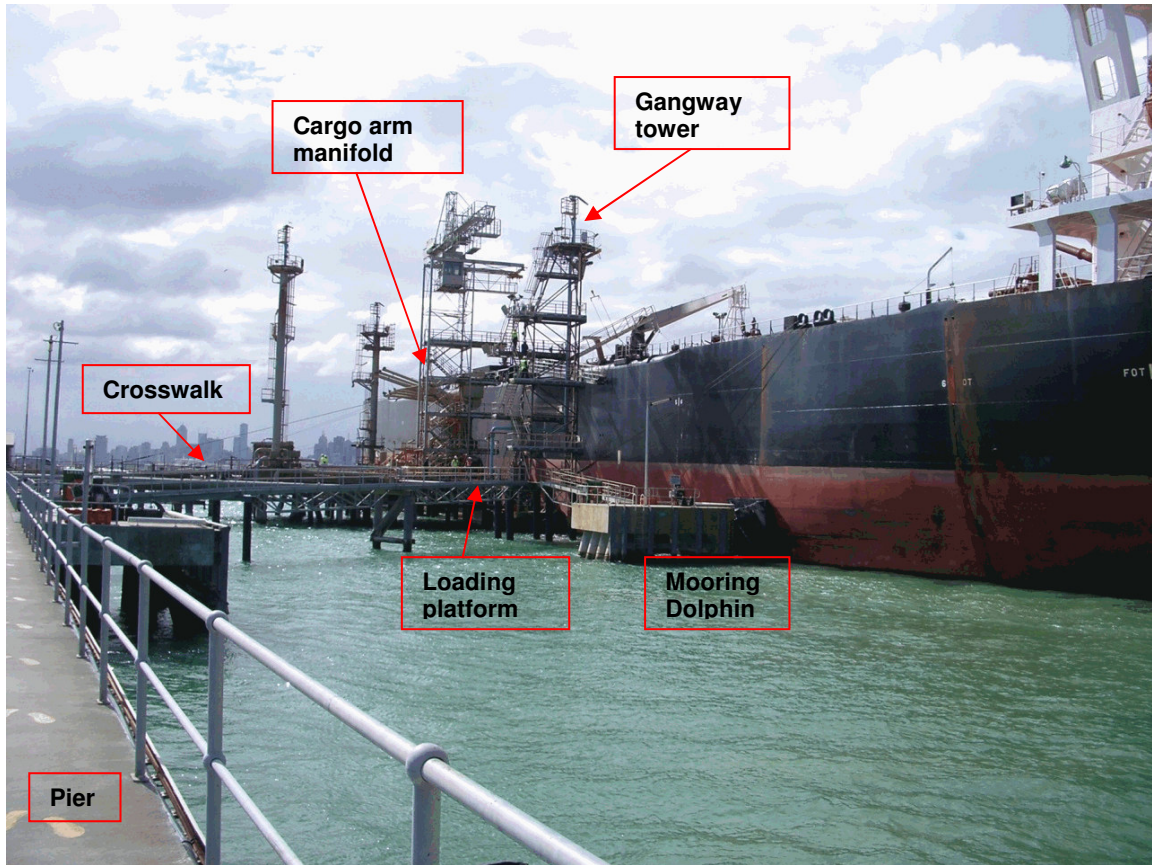
Figure 10 – Gellibrand Pier

The loading platform houses the cargo arm manifold and tower and the gangway tower. The manifold has four articulated cargo arms. The pipelines run from the terminal manifold along the crosswalk to the pier and thence along the pier to the storage tanks located outside the terminal. On either side of the loading platform is a rigid concrete mooring dolphin. When berthed, the vessel rests alongside the loading platform and the dolphins, on a heading of about 033° True.

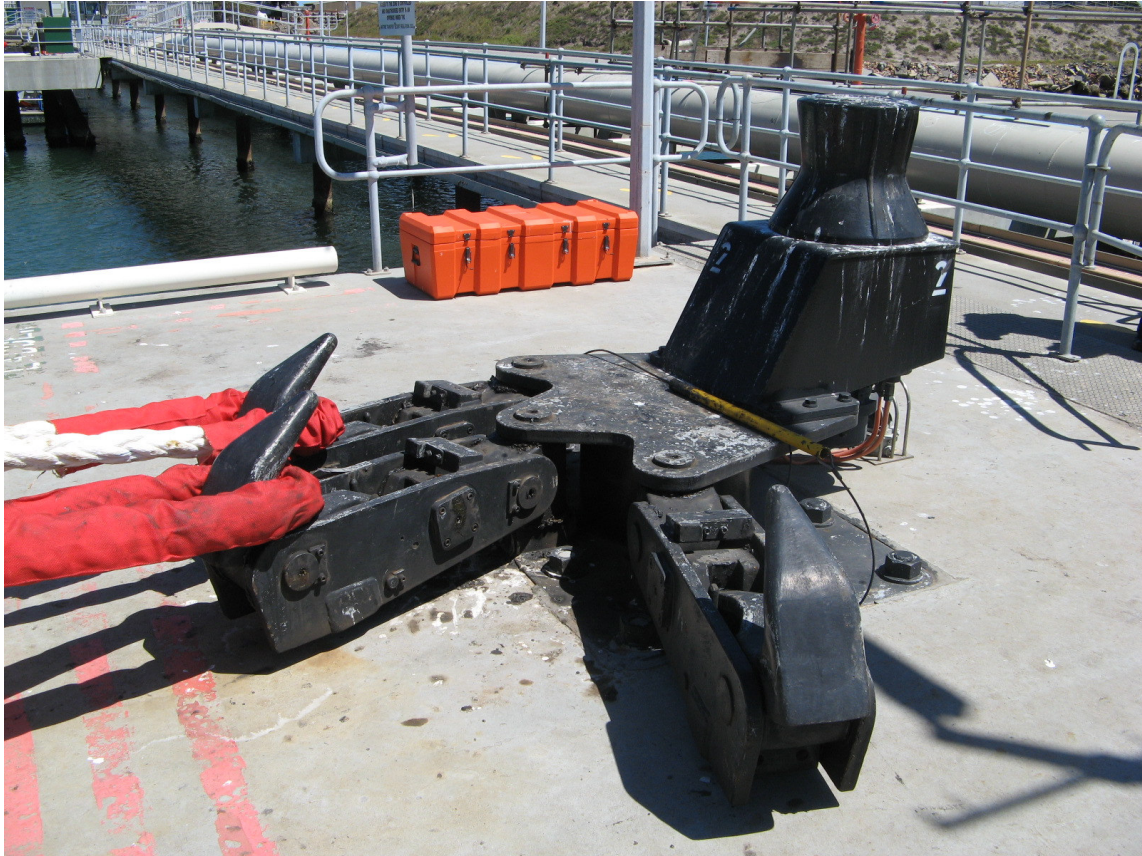
Figure 11 – Capstan with triple swivel hook assembly

There is also a series of mooring points constructed along the length of the pier (Figure 9). Each mooring point and mooring dolphin has a capstan with a triple mooring swivel slip hook (Figure 11) to secure the vessels' mooring lines.
