Office of the Chief Investigator
Transport Safety

**Rail Safety Investigation
Report No 2019/01**

Collision
Tram No 3535 and Tram No 3532
St Kilda Junction, Melbourne
13 February 2019

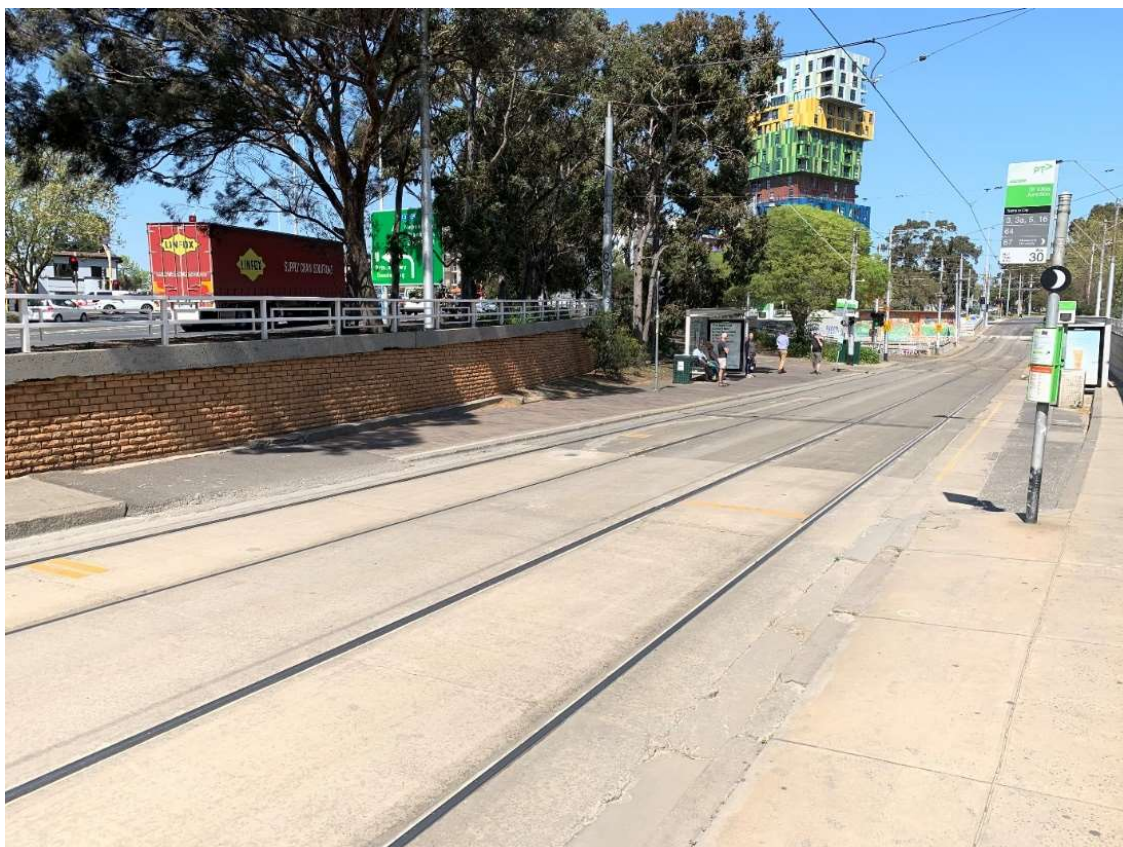
Figure 4: The tram stop at St Kilda Junction

Tram stop 30 at St Kilda Junction is located on the city side of the ramp to Queens Way and services passenger drop-off and pick-up for both outbound and inbound trams. The platform at St Kilda Junction tram stop for outbound trams accommodates one tram at a time. Trams arrive and depart the tram stop about every two to three minutes (Figure 4).
