Office of the Chief Investigator  
Transport and Marine Safety Investigations

## Rail Safety Investigation

# Brief Report

Tram to Tram Collision

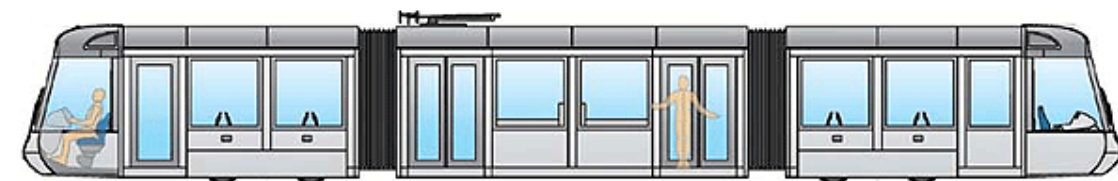
Figure 1. C Class tram.

Tram 3032 - was an Alstom built three-section low floor C class tram seating 40 with a tare weight of 28.6 tonnes, a width of 2.65 metres and a length of 22.98 metres.

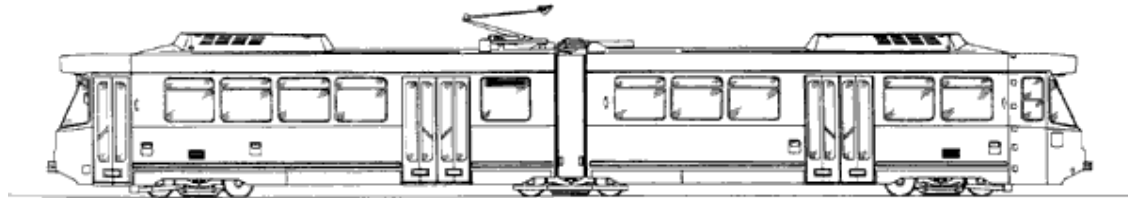
**Figure 2. B2 Class tram.**

Tram 2103 - was a Commonwealth Engineering Pty Ltd built three-door B2 class articulated light rail vehicle seating 76 with a tare weight of 34.0 tonnes, a width of 2.77 metres and a length of 23.63 metres.
