Level crossing collision between truck and passenger train 8753

Phalps Road, Larpent, Victoria | 13 July 2016

ATSB Transport Safety Report
Rail Occurrence Investigation
RO-2016-009
Final – 28 June 2019

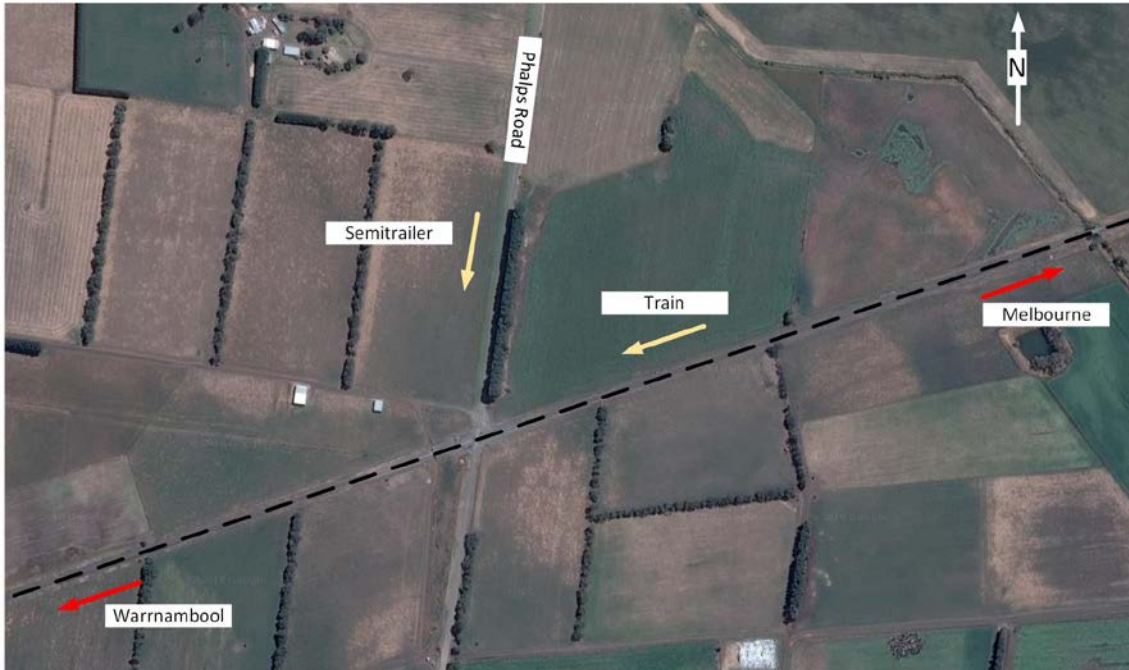
Figure 2: Overview of truck and train approach to the Phalps Road level crossing

At around 1540, the truck was travelling south along Phalps Road at mostly between 40 and 50 km/h⁴ and the train was travelling west (Figure 2).

When the train was about 520 m from the level crossing, the locomotive driver commenced sounding the locomotive’s country horn.⁵ At this point the train was travelling at about 109 km/h. The locomotive driver reported observing a truck appear from behind a line of trees along Phalps Road and stop at the level crossing.

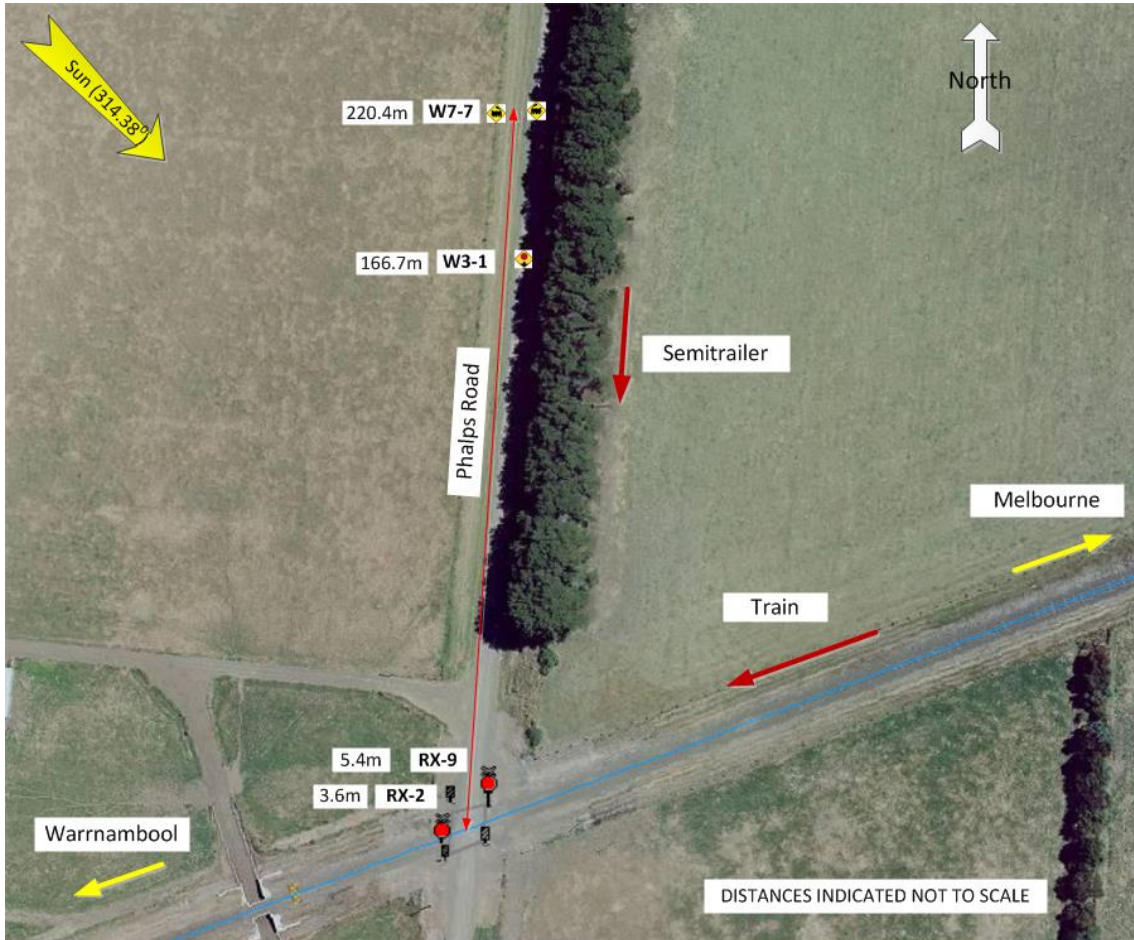
Figure 5: Signage on approach to Phalps Road level crossing from the north

Drivers of west-bound trains had a direct, straight-ahead view of the level crossing but their view of road traffic on Phalps Road approaching from the north was obstructed by a line of trees along the eastern edge of the road (Figure 5).

At the time of the collision, the weather was fine with good visibility. The sun was behind the truck driver and did not affect his observations (Figure 5).

The signage provided on Phalps Road approaching the level crossing was consistent with AS 1742.7:2016. Warning signage on the northern approach included *Railway Crossing Ahead (W7-7)* signs located 220 m before the crossing and a *Stop Sign Ahead (W3-1)* sign as the second warning sign (Figures 6 and 7). The W3-1 sign was located about 167 m in advance of the crossing, within the 120-180 m specified in the Australian Standard.

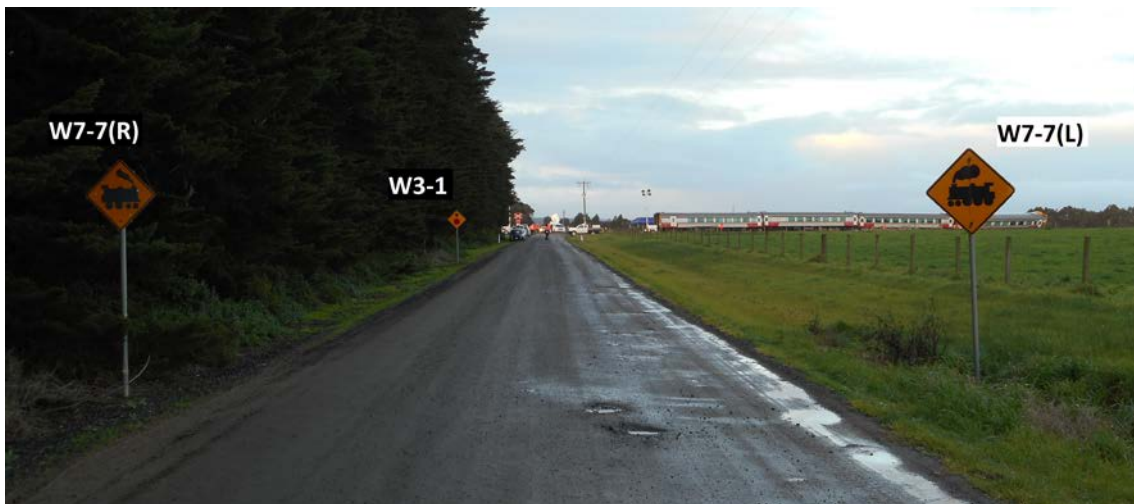
Figure 6: Signage on Phalps Road approaching from north.

The image shows the view for a road-user about 250 m from the crossing. The Railway Crossing Ahead signs (W7-7) are in the foreground, and the Stop Sign Ahead sign (W3-1) beyond.
 Source: Chief Investigator, Transport Safety (Vic)

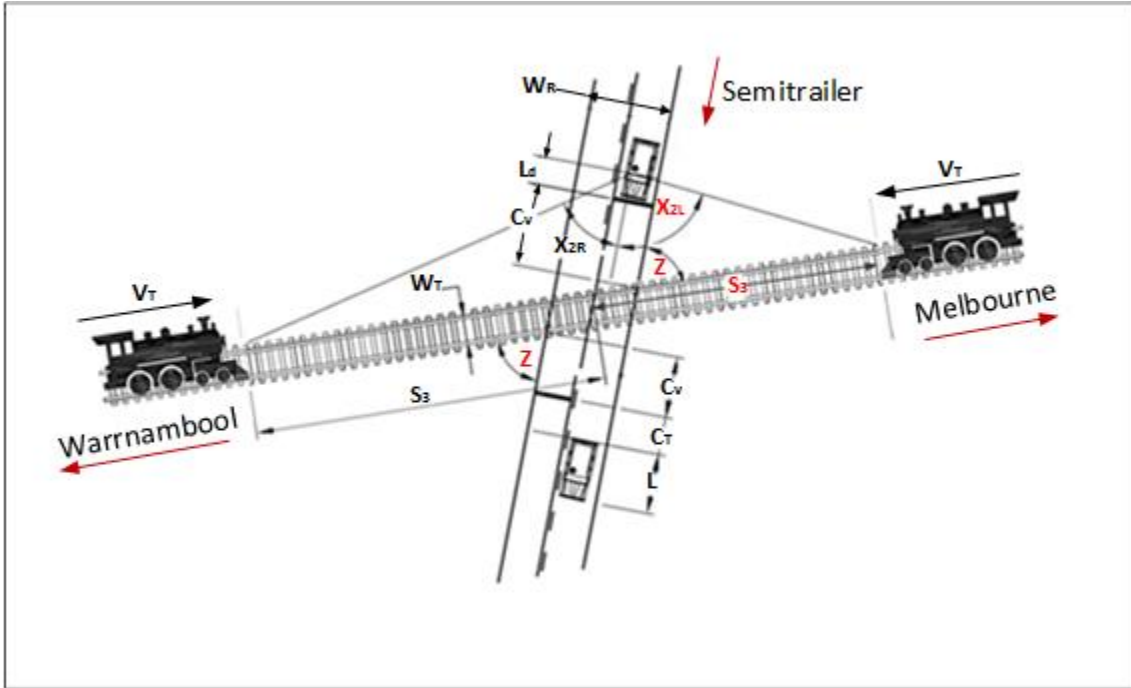
Figure 9: Sighting distances and angles as defined in AS 1742.7:2016

| | Post-incident survey | ALCAM 2009 survey | Difference in surveys |
|--|---|---|---|
| Acute angle to left (Z, Figure 9) | 63° | 56° | 7° |

To achieve the required sighting distance of 537 m looking to the driver’s left, the required sighting angle (X_{2L}) was 116 degrees (Figure 9). This exceeded the maximum of 110 degrees, specified in the Australian Standard, for level crossings protected by passive controls.¹³

A driver typically needs to be able to look parallel along a track to check for approaching trains. Therefore subtracting the AS1742.7:2016³⁵ maximum viewing angle (to the left) of 110 degrees from 180 degrees gives a nominal minimum road-to-track crossing angle (Z in Figure 9) of 70 degrees. Crossings with an acute interface angle (to the left) of 70 degrees or greater would typically comply with the viewing angle requirement of the standard and those with lower values would generally not meet the standard.
