Collision between passenger train and truck

Woodvale, Victoria | 19 December 2014

ATSB Transport Safety Report
Rail Occurrence Investigation
RO-2014-024
Final – 25 September 2015

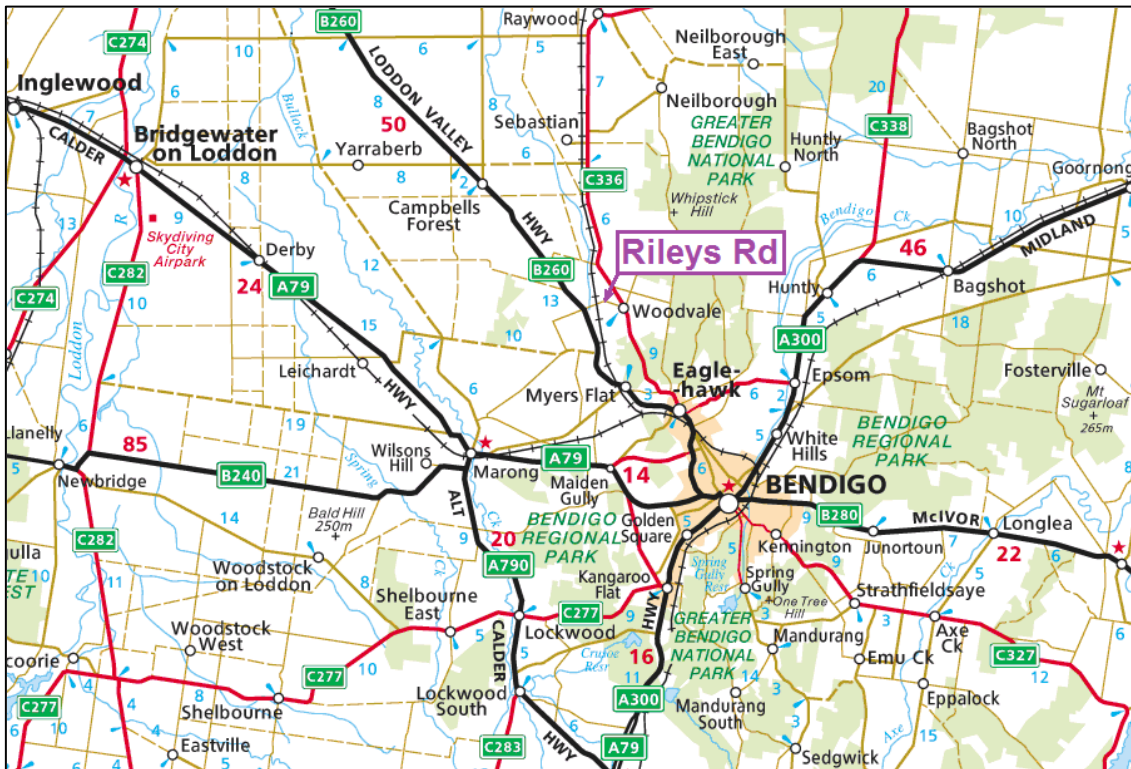
Figure 1: Location of incident

Train No 8042, had departed Swan Hill at 1250 and at 1445 was approaching the Rileys Road level crossing at the track speed of 100 km/h with the locomotive driver having observed the truck approaching from the right. The locomotive event recorder indicated that the driver sounded the locomotive warning horn at about 400 m from the level crossing, in a manner consistent with normal operating requirements, and then again for approximately 5 seconds commencing when the train was about 200 m from the crossing.

Around this time the truck driver commenced to brake heavily. The truck then continued, leaving a predominantly single-tyre skid mark along the gravel surface for about 85 m.

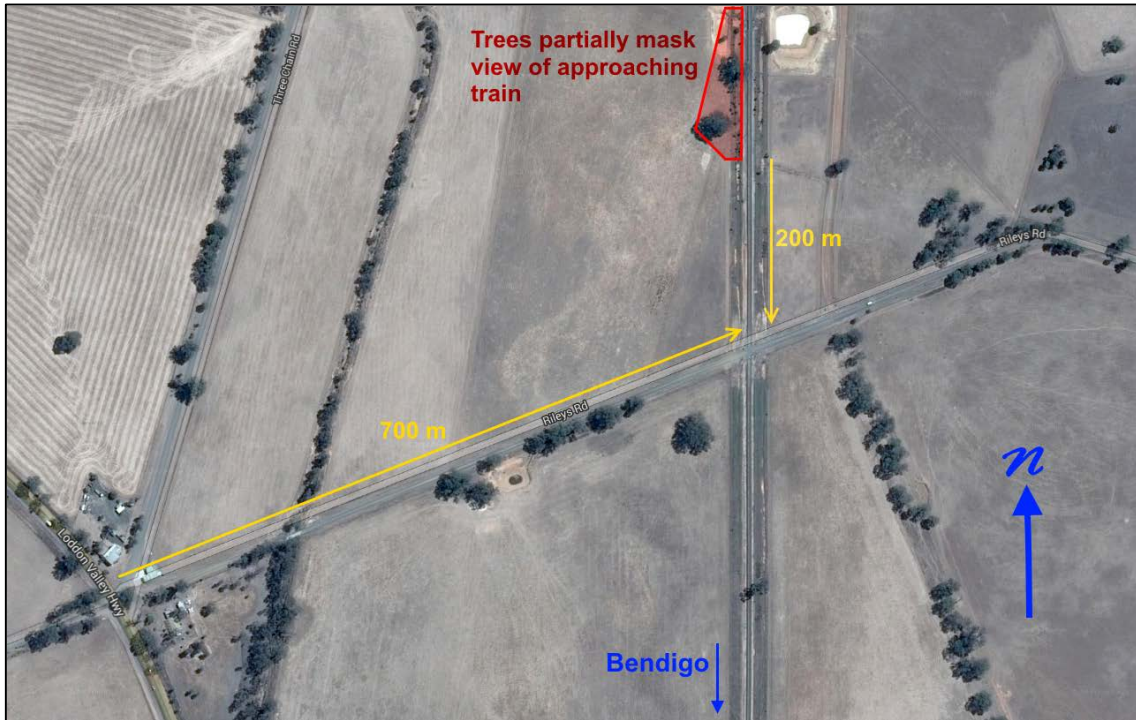
Figure 6: Aerial view of location - Rileys Road level crossing

Arboricultural advice was sought in relation to the trees growing in the rail reserve (Figure 5). The River Red Gum trees (*eucalyptus camaldulensis*) were in a group of around 40-50, growing in an area approximately 300 m long and 30 m wide. The stand of trees displayed height (1-9 m)¹ and 'breast-height'² trunk diameter characteristics consistent with ages of between 1 and 8 years. Situated along a drainage line subject to areas of seasonal standing water, the trees were judged to be in good condition and displaying vigorous growth. Expected growth rates of juvenile-to-young (1-15 years) River Red Gum growing in an ideal situation with good conditions is 1 to 1.5 m per year, and in most conditions the annual juvenile height growth rate will slow as the tree matures. If left standing, the trees in their current position can be expected to thrive and add good annual diameter and height.
