# Derailment of passenger train ST23

Wallan, Victoria on 20 February 2020

**ATSB Transport Safety Report**

RO-2020-002

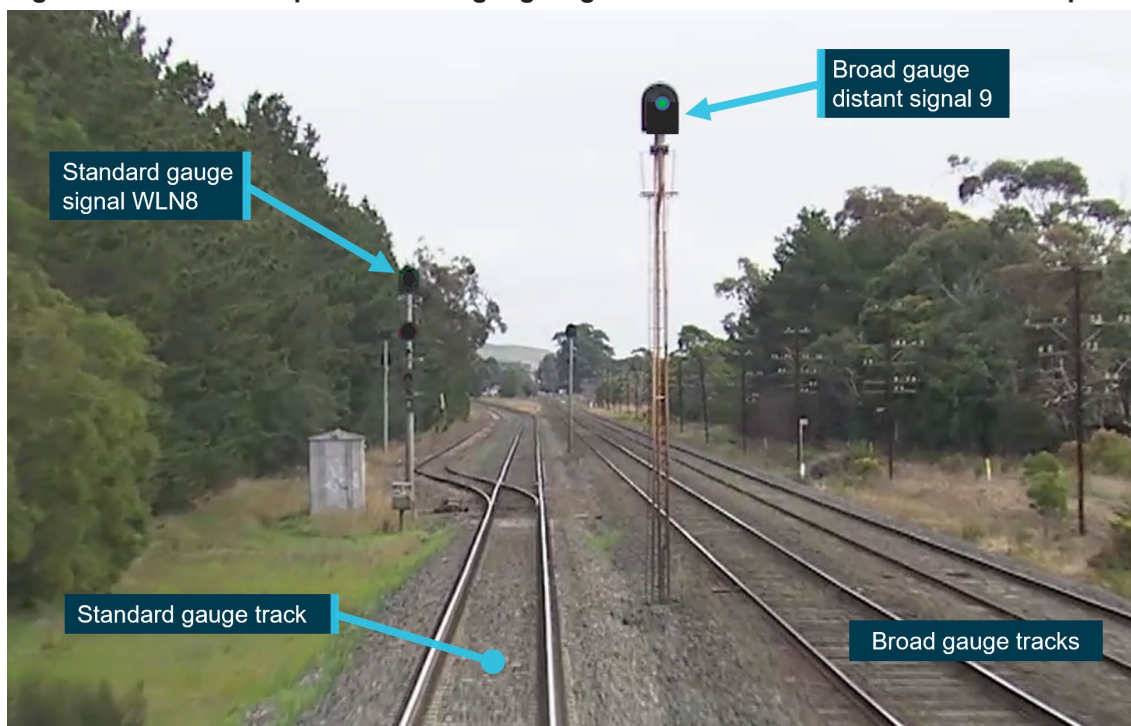
**Figure 12: Probable aspect of broad-gauge signal at the northern end of Wallan Loop**

A broad-gauge distant signal was located about 45 m to the north of WLN8 and was probably indicating a proceed (green) aspect at the time ST23 passed (Figure 12).<sup>50</sup> This broad-gauge signal did not apply to the operation of ST23, which was running on the standard-gauge line.

The figure shows the approach to the Wallan Loop turnout. The image has been modified to show the extinguished state of standard gauge signal WLN8 and the probable proceed (green) indication of broad-gauge distant signal at the time of the derailment. In this image, the points are set for the straight and the black cross is not fitted to the base of signal WLN8 as the image was taken prior to the signalling failure.

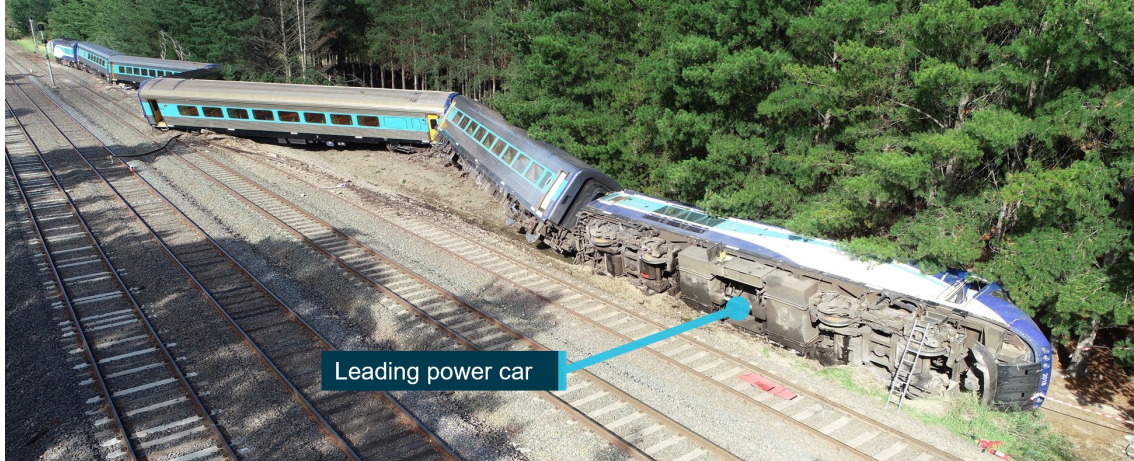
Figure 13: Train ST23

The derailed train came to rest in a concertinaed arrangement and the leading power car had overturned onto its left side (Figure 13). The 5 passenger cars had derailed and were at various angles of incline. The rear power car was upright and still on track.

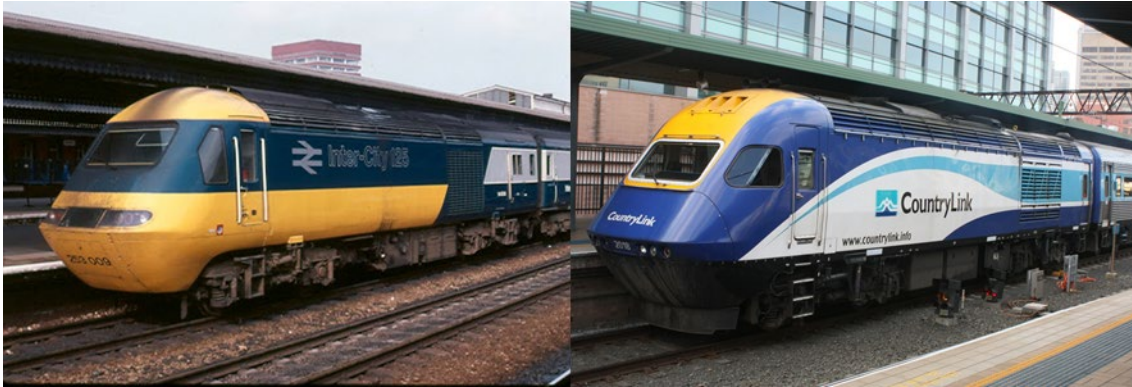
**Figure 20: HST (left) and XPT (right)**

The XPT was based on the HST design and had similar form and structural configuration (Figure 20). There were differences in the cab internal layout, window arrangement and driver's cab side door detail.

In the Ufton Nervet derailment, the leading power car came to rest on its left side with severe abrasions down the side of the car but with the whole-body structure substantially intact. There was structural failure at the top of a left leading pillar, this being the frame to which the left-side driver’s cab door was latched (Figure 21). The cab door had separated from the door frame and earth and ballast had entered the cab through the door aperture. In both the Ufton Nervet and Wallan derailments, the loss of the side cab door (when the power car overturned) resulted in material entering the cabin and impacting the occupants.

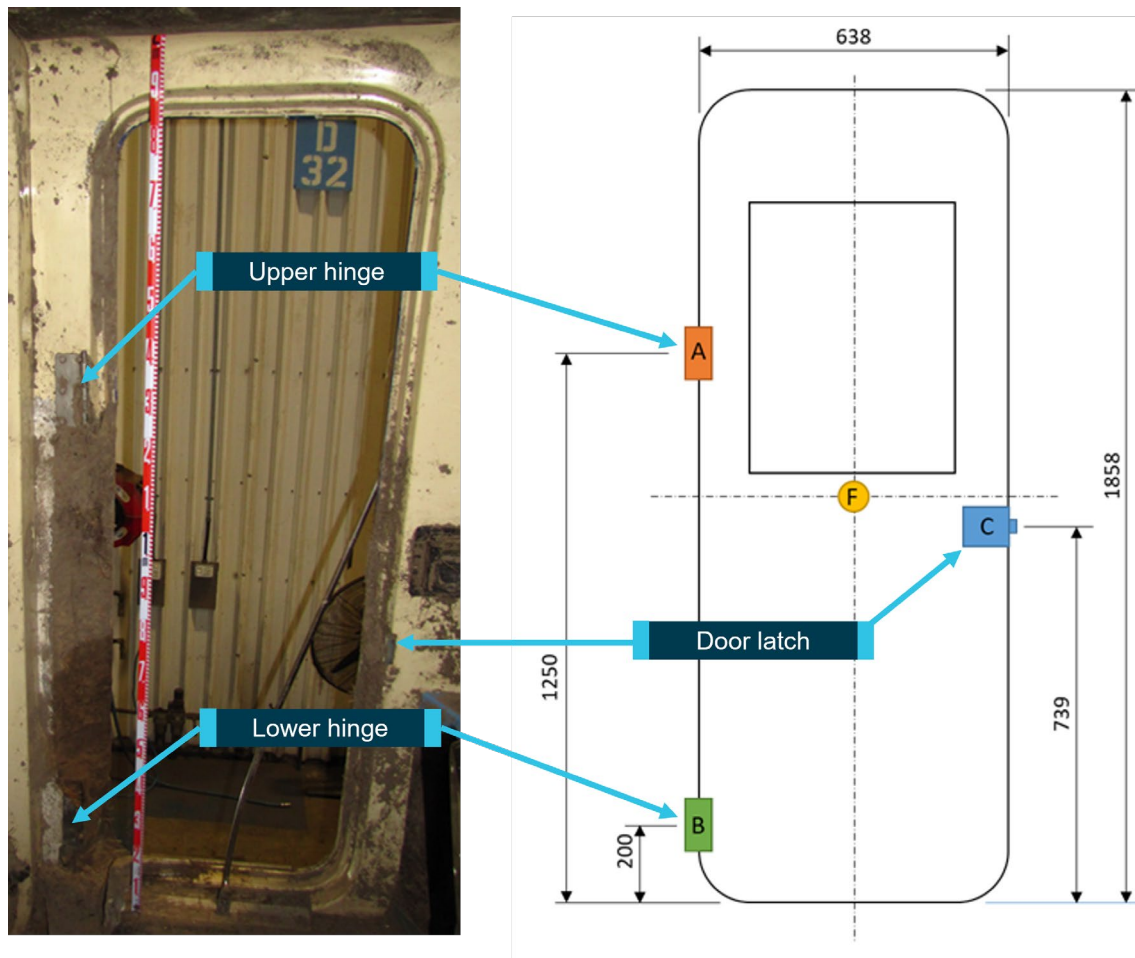
Figure 25: Inside view of cab door opening and fitting locations (dimensions in mm)

To evaluate the upper-hinge behaviour under defined loads, simplified loading was assumed. The external force was assumed to be an even pressure acting over the entire door, as used in design standards. This was converted to a point load (F) applied at the centroid of the door’s external surface, and resolved into balanced forces acting on the attachments in the frame from the external door surface (Figure 25).

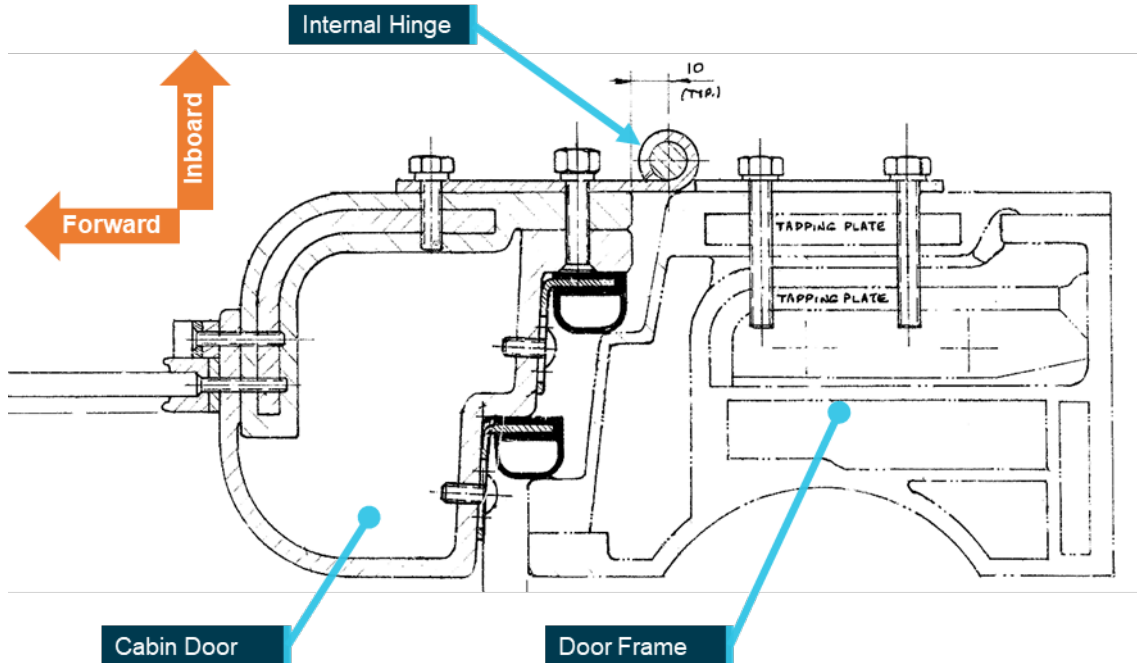
**Figure 26: Door and doorframe section drawing**

The glass fibre composite cab door was a plug shape that rotated inward on the hinges mounted on the inner rear edge of the door frame. The door hinges were fabricated from 3 mm thick stainless steel, and attached to the door frame by bolts into tapping plates (Figure 26).
