Collision of passenger train 8185 with level crossing gates

Lydiard Street North, Ballarat, Victoria, on 30 May 2020

Rail Occurrence Investigation (Systemic)

RO-2020-007

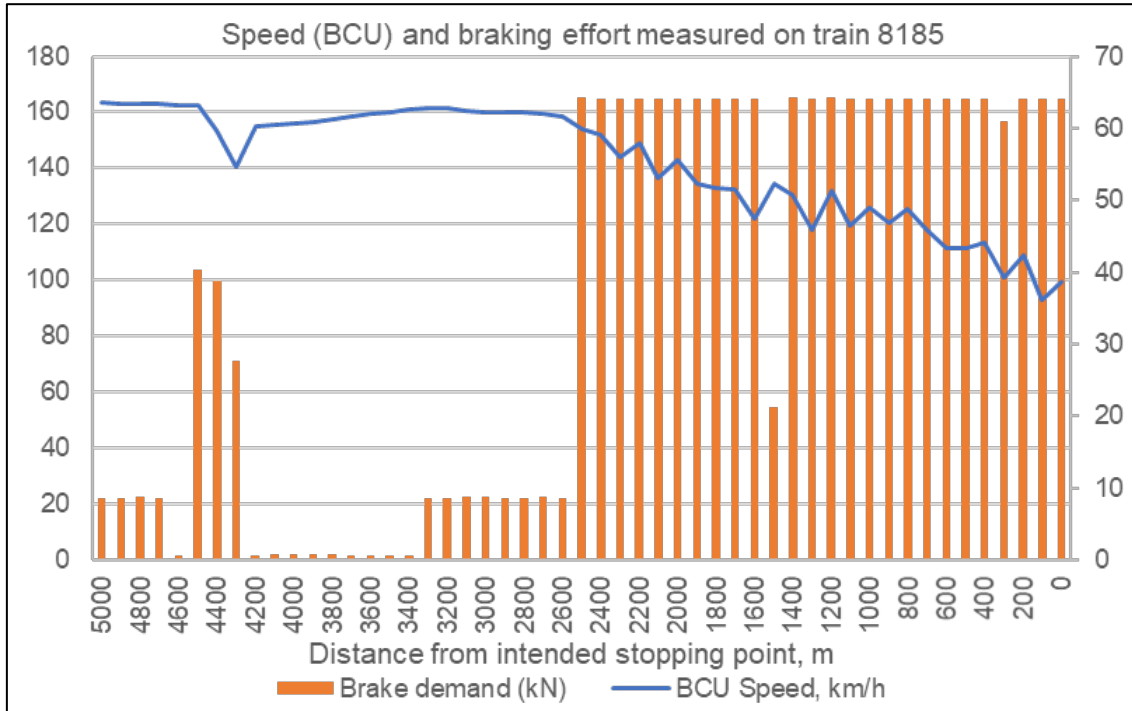
Figure 11: BCU speed²¹ and brake demands from the intended stopping point

A graphical representation of the brake demand shows the first two braking periods, followed by the 22 s period of no braking, and then the continuous braking through to the collision (Figure 11). The term ‘brake demand’ refers to the total (load compensated) braking request transmitted from the brake control unit that is converted to a brake cylinder pressure. The range of brake demand was between 0 and 64 kN.²⁰

This graph is drawn from train data logger records. There is some inaccuracy in logged distance information during the sliding event, in addition to the known limitations of the BCU speed.
 Source: CITS, from VLocity event recorder data

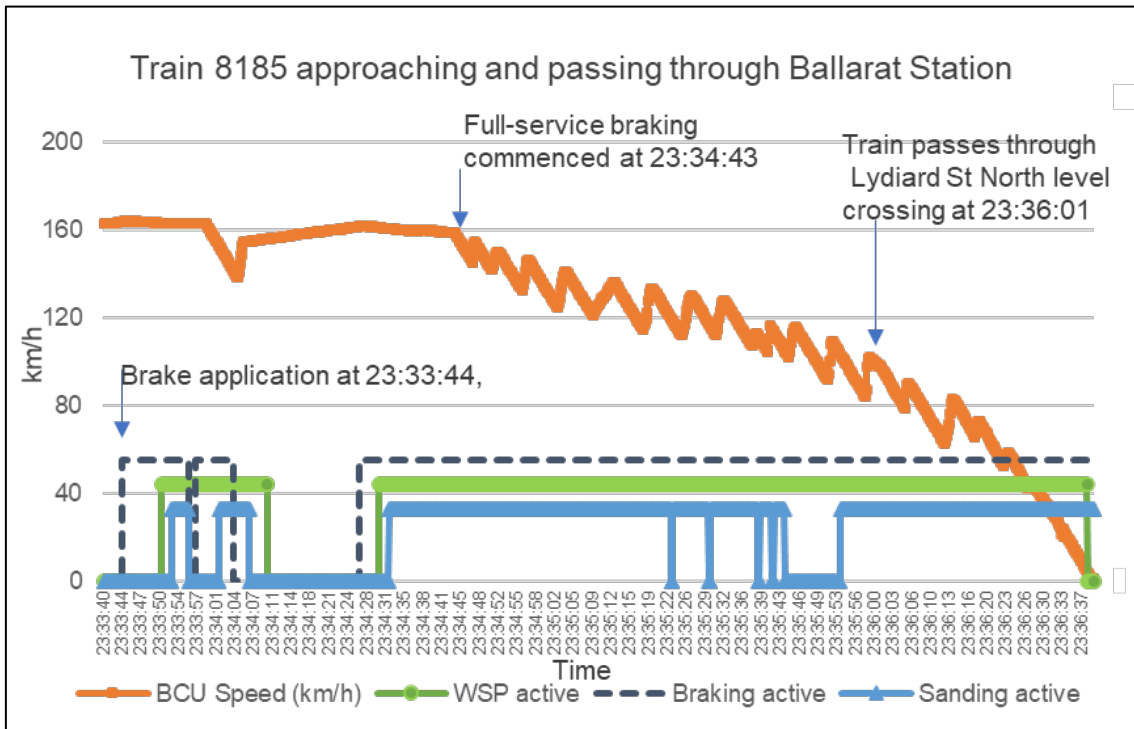
Figure 12: Graph of event recorder information from car 1270 of train 8185

The train was fitted with wheel slip/slide protection (WSP) and sanding systems to manage traction and braking in slippery rail conditions (refer braking system description). During all three described periods of braking on the approach to Ballarat, the WSP and sander systems automatically activated (Figure 12).²⁷

The figure shows WSP and sanding activity through each phase of braking. It also shows the saw-tooth behaviour of the BCU speed in the periods of heavier braking, and in particular during the full-service application from 23:34:43. Source: CITS, from train 8185 car 1270 event recorder data

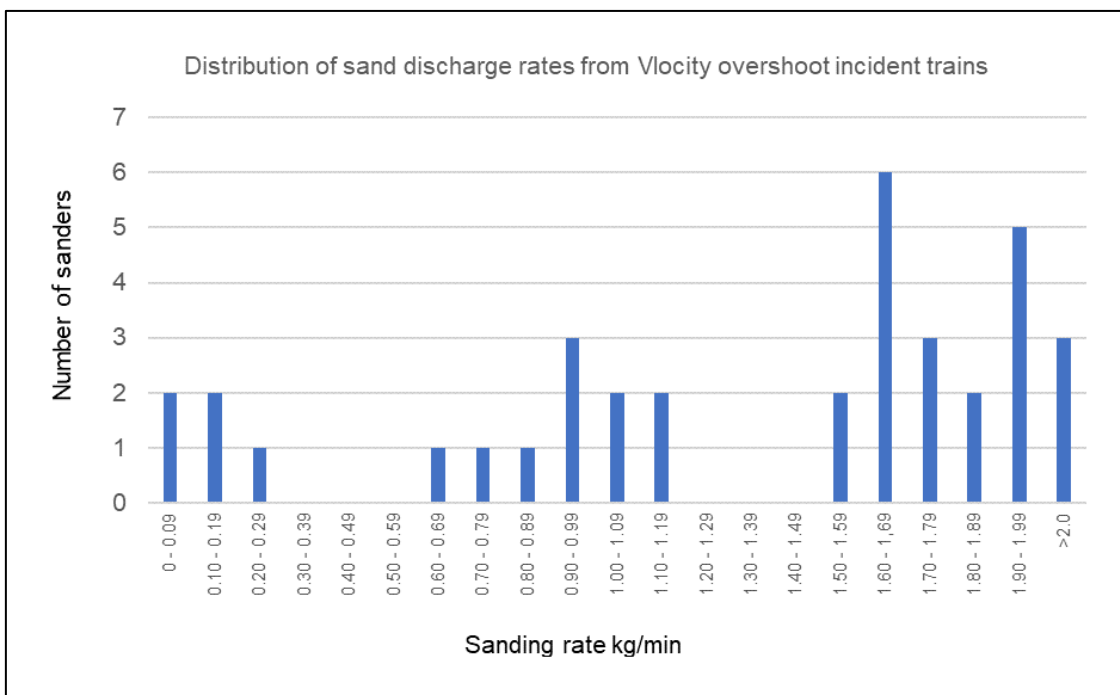
Figure 25: Sand flow rates for a sample of 36 sanding units on VLocity trains

There was a wide distribution of flow rates between 0 and 2 kg/min (Figure 25).

The bar chart shows the distribution of flow rates across the 36 sanders tested. The sanders were those fitted to nine trains involved in overruns between April 2010 and June 2020. The tests were conducted July 2020
 Source: CITS, based on Bombardier test data

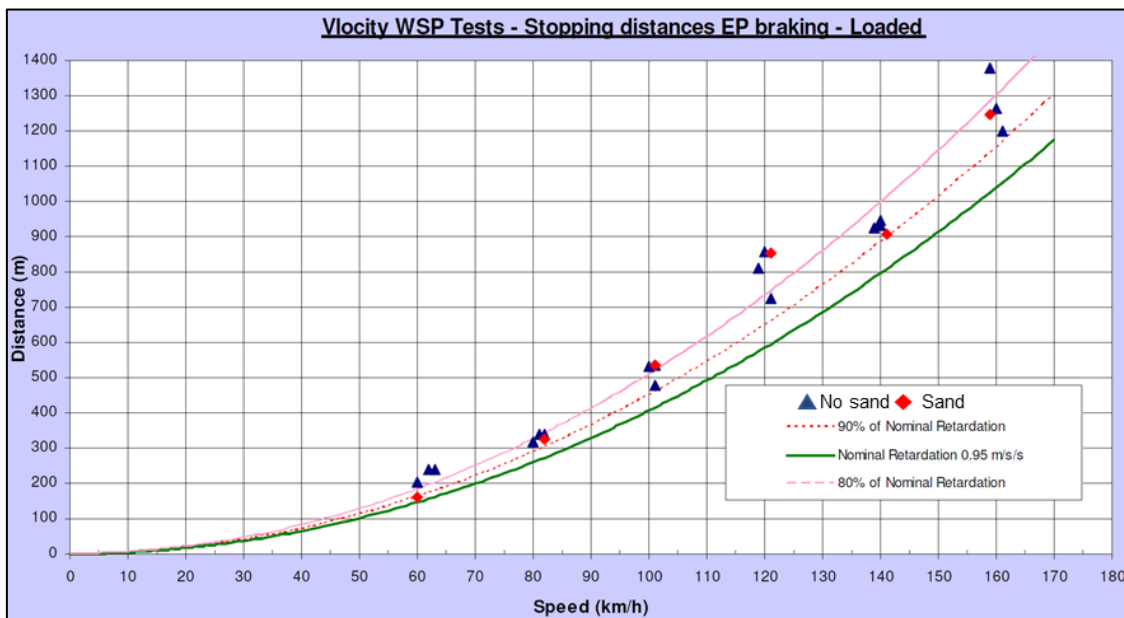
Figure 28: VLocity slip/slide type test results from 2008, friction braking scenario

As would be expected, braking (stopping) distances during the low adhesion type tests exceeded stopping distances for braking on dry track (Figure 28). The longest recorded stopping distance from 160 km/h for the loaded, friction only braking test scenario was about 1400 m. This equates to a retardation rate of 0.71 m/s² or about 75 per cent of the dry retardation rate.

This graph shows the outcome of individual tests for the gross (loaded) and friction (only) brakes scenario. For each starting speed, there were 3 tests without sand (relying on the WSP system only), and one test with sanding activated.
Source: Bombardier test data

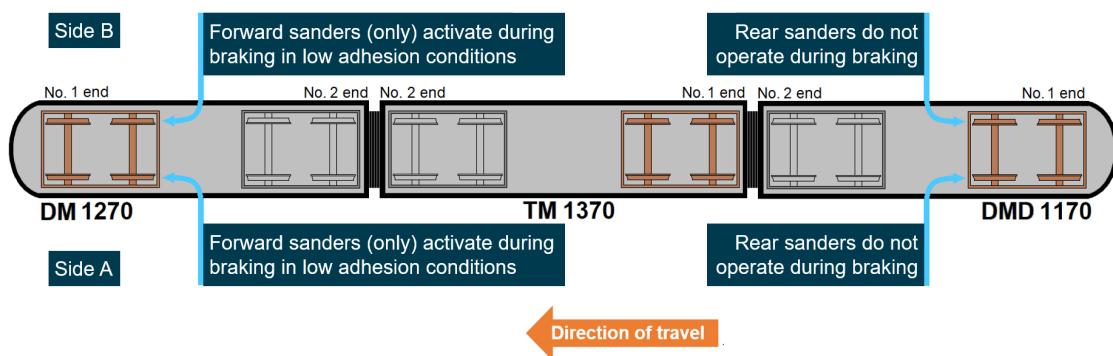
Figure 29: Train 8185 sanders activation during braking

The VLocity three-car set was fitted with sanding devices on its lead and trailing cars. During braking, by design only the sanders on the leading car operated to dispense sand (Figure 29). The nozzles on these sanders were located behind the leading bogie of the lead vehicle, with the outlet facing toward the rear wheels of the leading bogie.

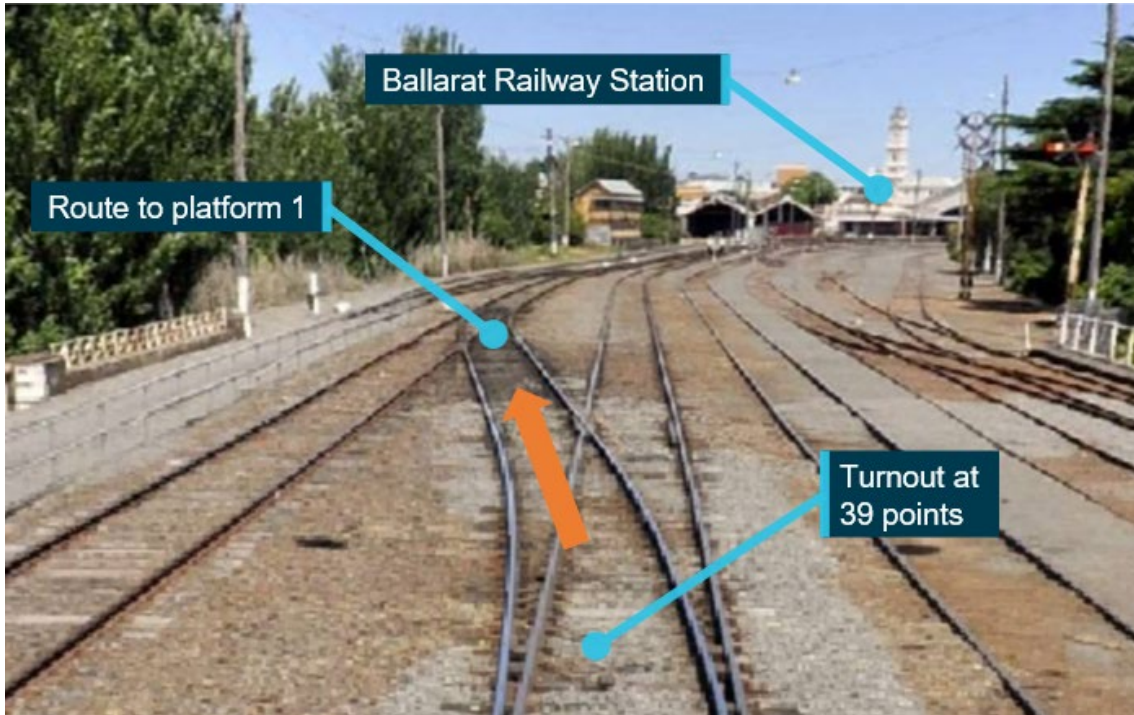
Figure 31: Route taken by train 8185 via 39 points towards platform 1

Train 8185 passed over 39 points on the approach to Ballarat Railway Station at a speed estimated to be in the range of 110 – 119 km/h. The turnout was rated for 40 km/h operations and routed trains to platform 1 at Ballarat Railway Station (Figure 31). The train crew recounted being thrown around when the train passed over the points.

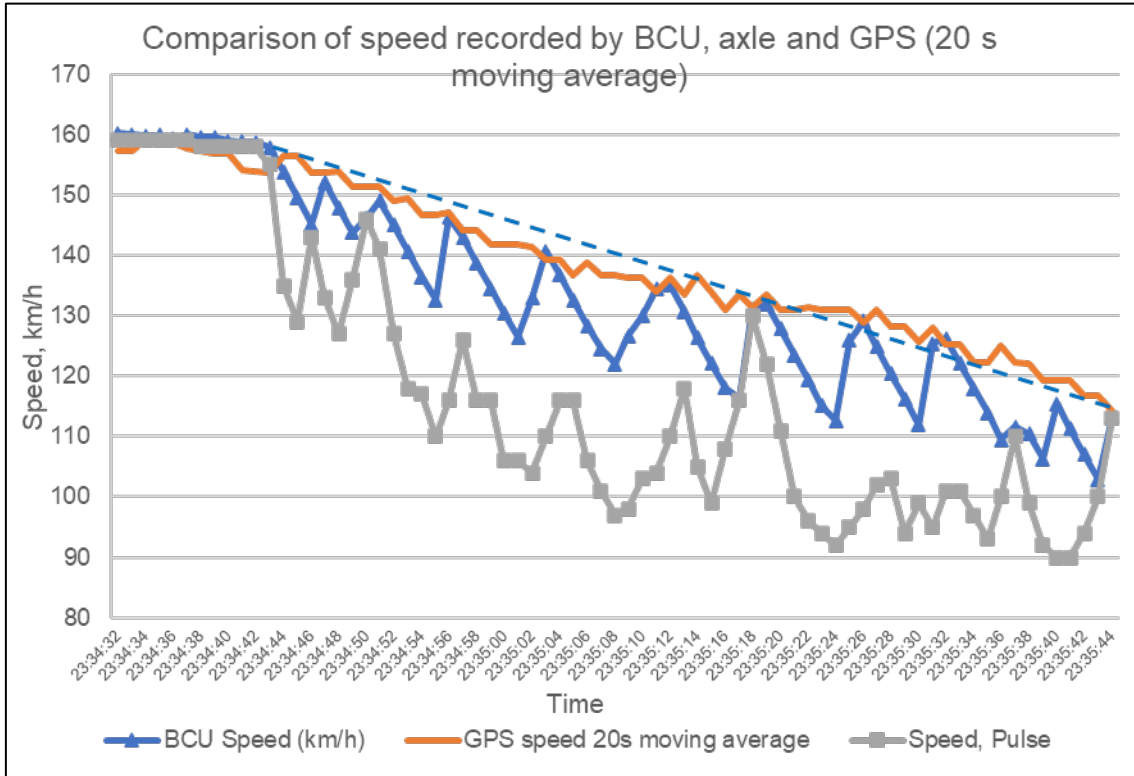
Figure 34: BCU, pulse and speed estimated from GPS, from 2.5 km to 450 m from intended stopping point at Ballarat Railway Station.

For this period, a train retardation of about 0.2 m/s² (represented by the slope of the blue dashed line) was achieved compared to a full-service braking rate in dry conditions of 0.95 m/s² (Figure 34).

The figure shows a comparison of the BCU speed with pulse speed and the speed estimated from GPS recordings. The pulse speed is the speed recorded by one of the third axle on car 1270, whereas the BCU speed represents the speed of the fastest rotating axle on that car. The dashed line represents an estimate of the average reduction in speed over the period.
Source: CITS, based on train 8185 event recorder and GPS data

The level of adhesion has been estimated as the ratio of the longitudinal force and normal force (weight). Considering grade, available adhesion experienced by train 8185 was estimated to probably be between 0.02 and 0.03 on the approach of train 8185 to Ballarat Railway Station. This reflects very low to extremely low levels of friction and compares to a required adhesion at the wheel-rail interface for full-service braking retardation of at least 0.1.

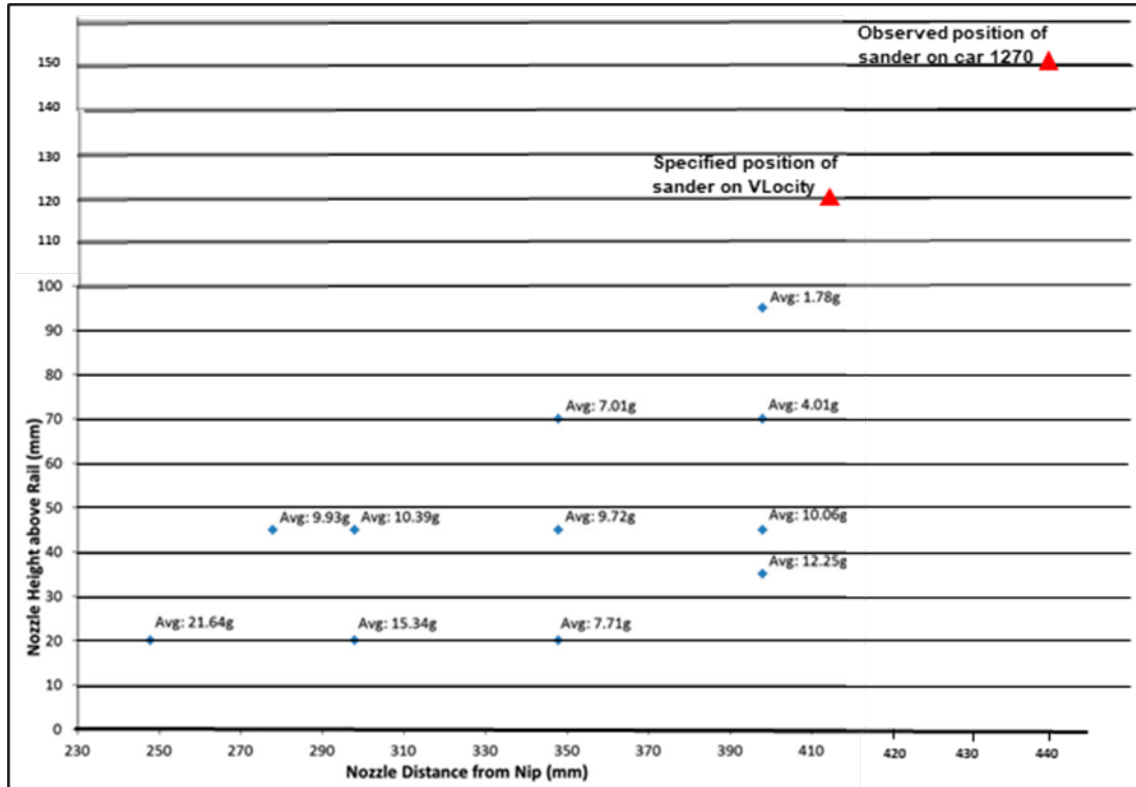
Figure 35: Mass of sand deposited on rail for different nozzle positions

The height and distance of the nozzle from the wheel-rail contact point was found to influence the proportion of the sand reaching the interface (Figure 35).

The specified position for the VLocity discharge nozzle and the actual position of the nozzles on car 1270 of train 8185 were plotted alongside the test results for reference. Direct qualitative comparison with the test results was not possible given the difference between test conditions and the sander orientation on car 1270.

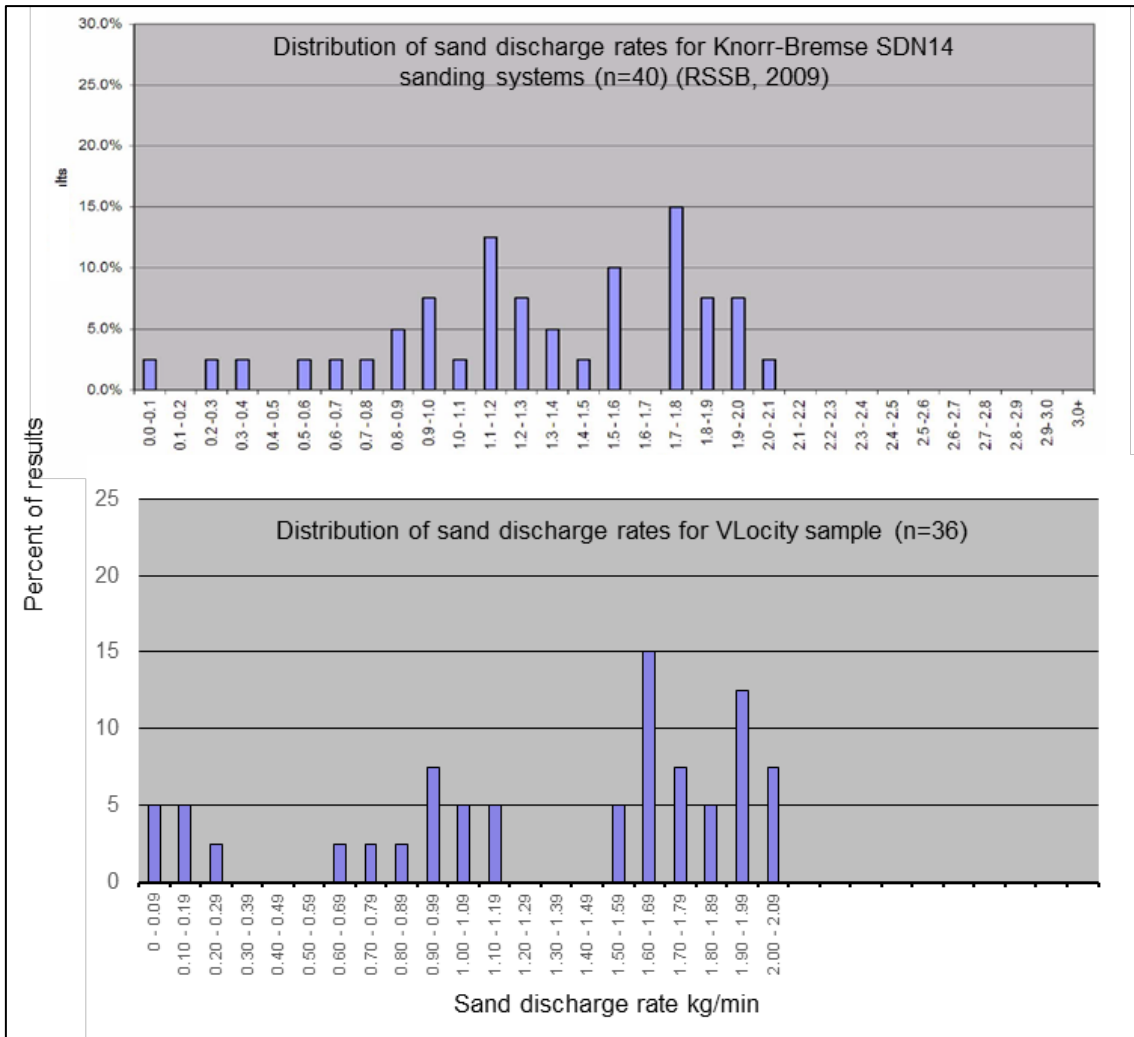
Figure 36: Comparison of sanding rates - RSSB (2009) and Bombardier tests on VLocity

The RSSB test result distribution was compared with the 36 tests conducted by Bombardier in July 2020 on nine VLocity sets (Figure 36). The mean discharge rate from 330 RSSB tests was 1.148 kg/min, that was similar to the VLocity mean of 1.236 kg/min. Figure 36 shows the distribution of sanding rates for SDN14 units which are equivalent to those installed on VLocity trains.

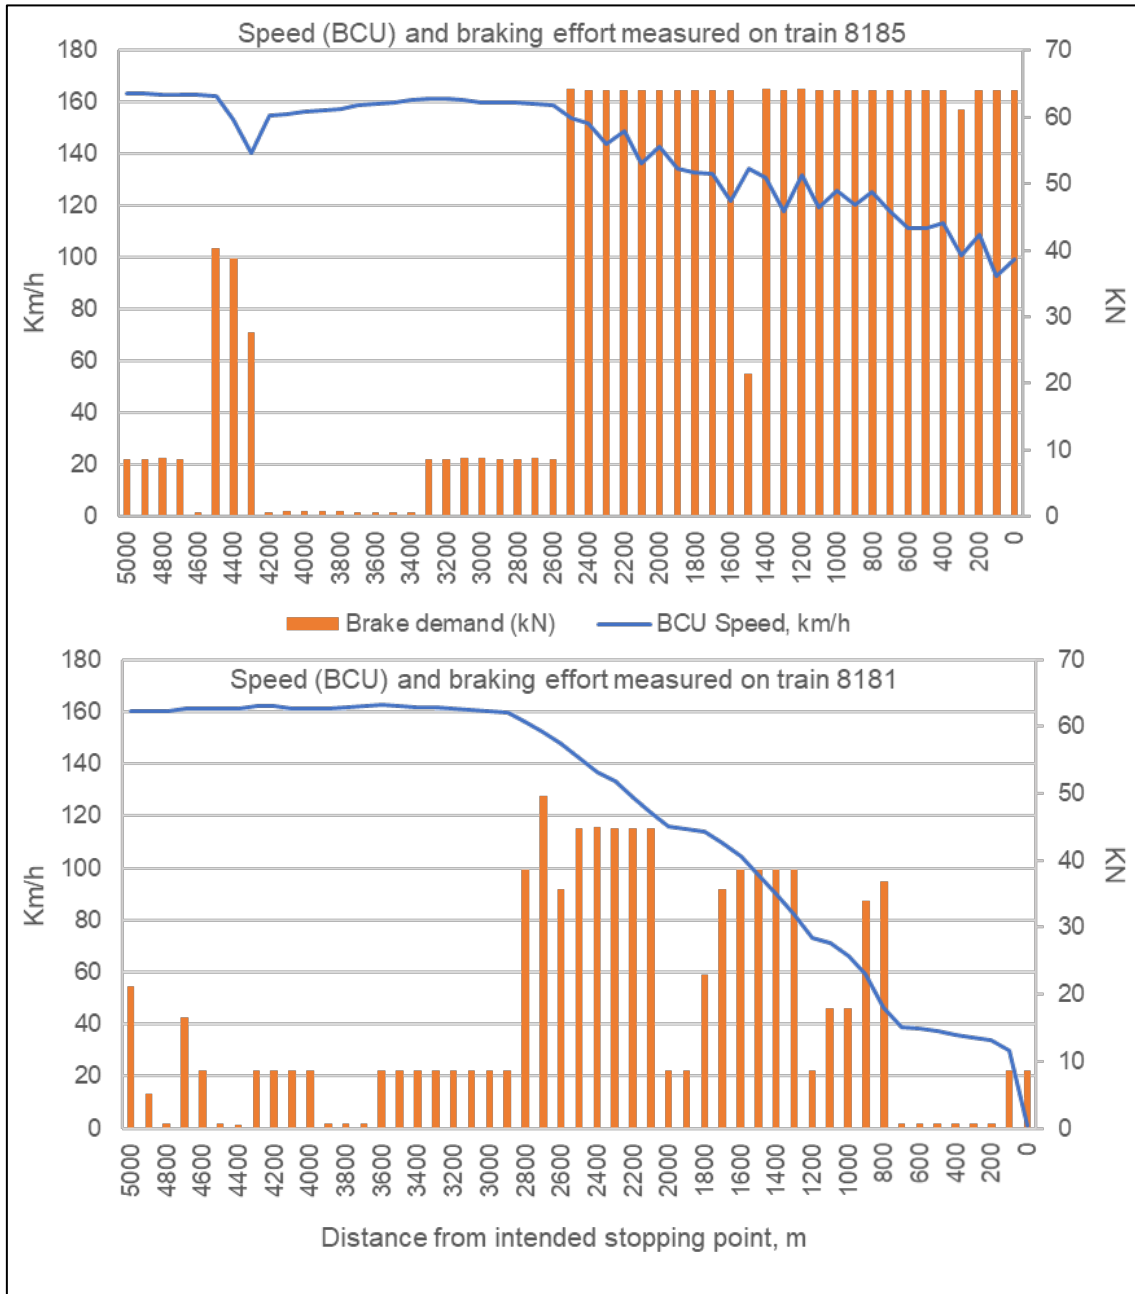
Figure 37: Speed (BCU)⁶⁷ and braking profile comparison of trains 8185 and 8181

The approach of train 8185 into Ballarat was compared with the previous train that evening, train 8181 (Figure 37). Both trains were three-car VLocity trains and braking on both was initiated about 5 km from the intended stopping point, and when the trains were travelling at around 160 km/h.

⁶⁷ The speed graphed is that of the fastest rotating axle on car 1270 (the BCU speed). For train 8185, this speed did not represent the actual train speed at the points when all axles were sliding.

The approach of train 8181 and its arrival at the station were unremarkable and no activation of either the WSP system or of sanding was observed. The train speed was reduced in increments as the train approached the 40 km/h-limited crossover that directed the train onto the track for the № 1 platform. Between 2.8 km and 800 m from the station stop, brake applications were between 70 per cent and 20 per cent of a full-service application, except for a short application at about 80 per cent.⁶⁸ During this period, the average retardation of train 8181 was about 0.4 m/s², with a peak retardation of about 0.6 m/s². The train coasted to the platform for a normal stop.
