# Derailment of freight train 3XW4

Newport, Victoria | 30 October 2013

**ATSB Transport Safety Report**  
Rail Occurrence Investigation  
RO-2013-026  
Final – 13 January 2016

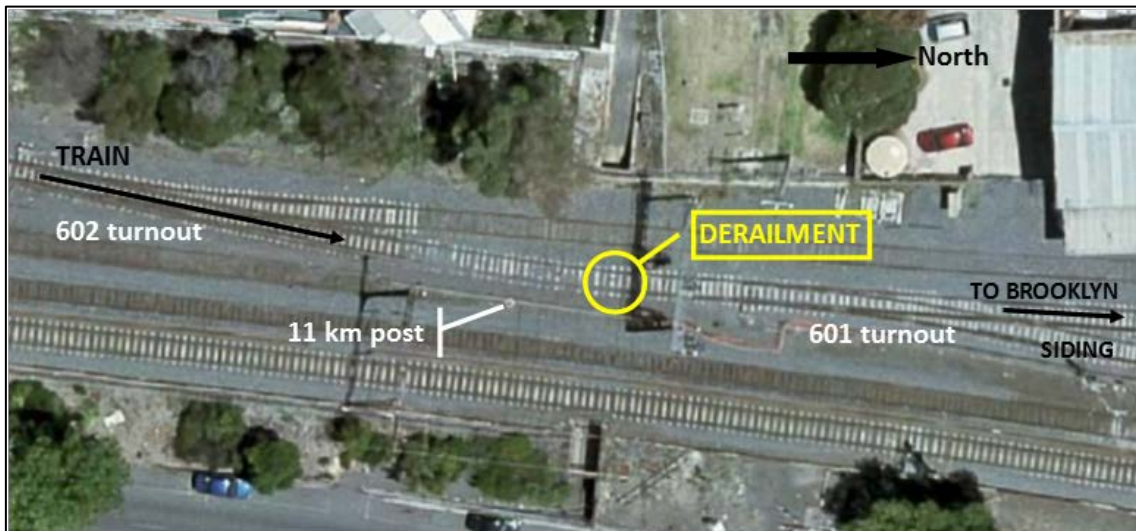
**Figure 2: Track layout, shown after restoration works**

The train was travelling on dual-gauge track and being routed from the inter/intrastate goods line through 602 and 601 turnouts towards Brooklyn. The derailment occurred between these turnouts (Figure 2).

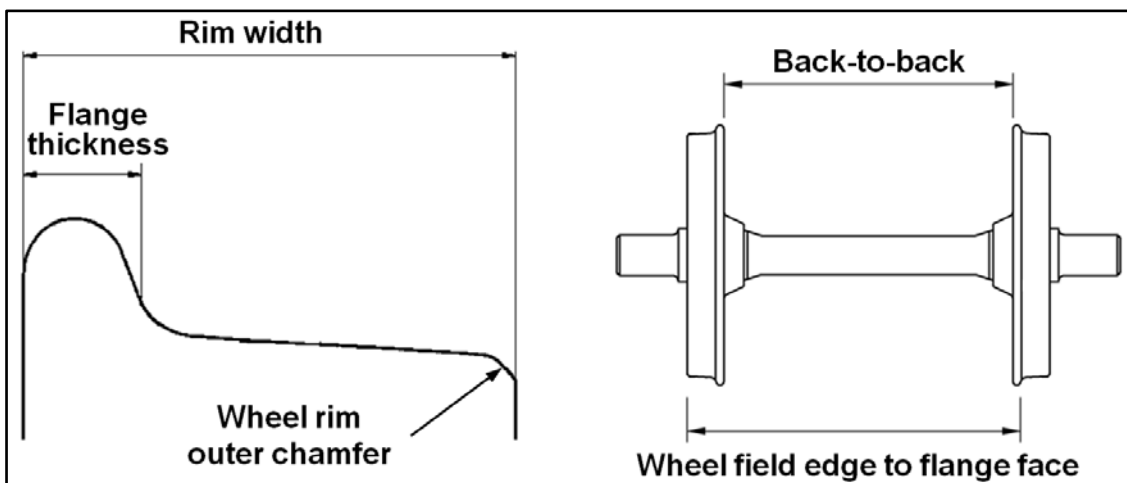
**Figure 9: Definition of wheelset and wheel rim dimensions**

The wheelset dimensions that are critical to ensure compatibility with track gauge are rim width, flange thickness and wheelset back-to-back distance (Figure 9).

For the wheel to drop inside the rail, the 'wheel field edge to flange face' distance (Figure 9) must be less than track gauge. Post-derailment measurements indicated that for the narrow wheel type, the effective width of tread remaining on the common rail running surface at the point of derailment would have been about 20 mm in no load conditions. This assumes a reduction in effective width by the chamfer or rounding of the rim outer edge.
