Derailment of freight train 7MC1

Wallan, Victoria | 4 November 2017

ATSB Transport Safety Report
Rail Occurrence Investigation
RO-2017-016
Final – 6 March 2019

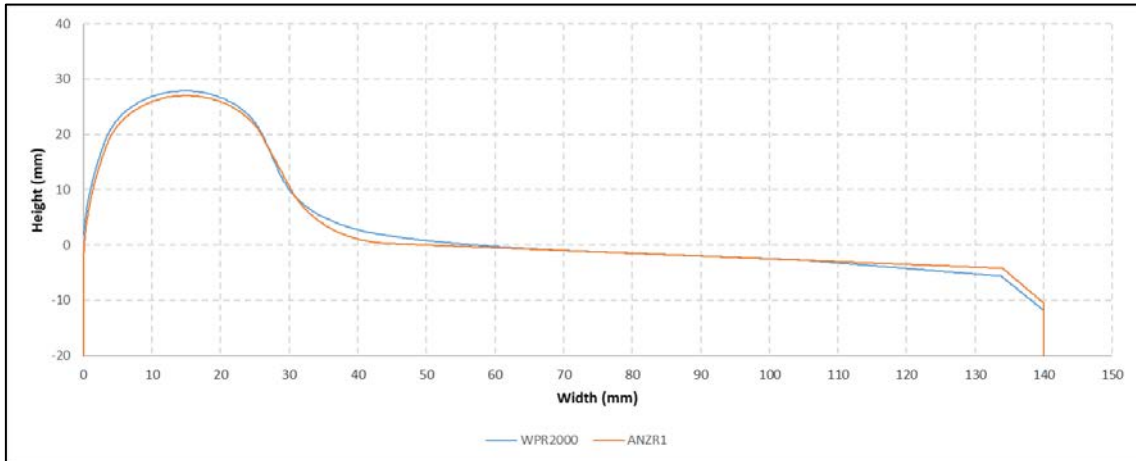
Figure 11: Comparison between the WPR 2000 (blue) and ANZR-1 (red) wheel profiles

The WPR 2000 wheel profile is a worn wheel profile that was designed to increase wheel life compared to the ANZR-1 through limiting wear of the wheel flanges (Figure 11). It achieved this by utilising a more conical tread profile that generates a larger rolling radius difference between the wheels on a common axle. This increased the wheelsets ability to steer through curves and hence placed less load on the wheel flange.

While the increased steering capability of the WPR 2000 wheel profile offered less flange wear, it had been shown in use to lower the critical speed¹⁹ for some combinations of wagon type and rail profile leading to undesirable dynamics known as hunting²⁰. The ATSB understands that the flatter tread profile of the ANZR-1 was generally less susceptible to hunting and therefore the preferred profile for freight rolling stock operating on the ARTC Defined Interstate Rail Network (DIRN). It was also an option on other track where it could be demonstrated that a vehicle was experiencing bogie instability.

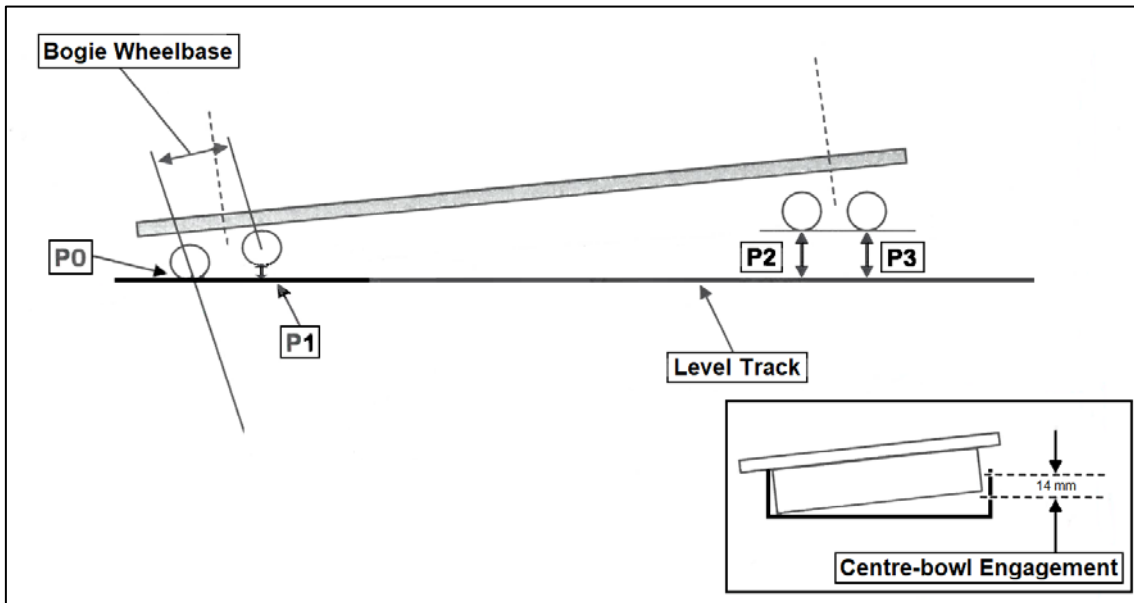
Figure 12: Test configuration for twist type testing, and centre-bowl engagement criterion

The twist test examined potential wheel unloading in response to track twist. Twist was simulated by packing wheels on one side of the wagon (Figure 12). For the type testing of the LAQY wagons, the packing used was P1 = 18 mm, P2 = 86 mm and P3 = 86 mm. The wheel unloading (the reduction in wheel load) was measured for the leading wheel (P0).

During this twist test, a maximum wheel unloading of 23% was measured, compared to the requirement of ‘...the loss of absolutely no more than 60% of the static wheel load for any wheel’. The measured engagement of the vehicle centre plate within the bogie centre casting was 14 mm, equal to the minimum permitted (Figure 12).

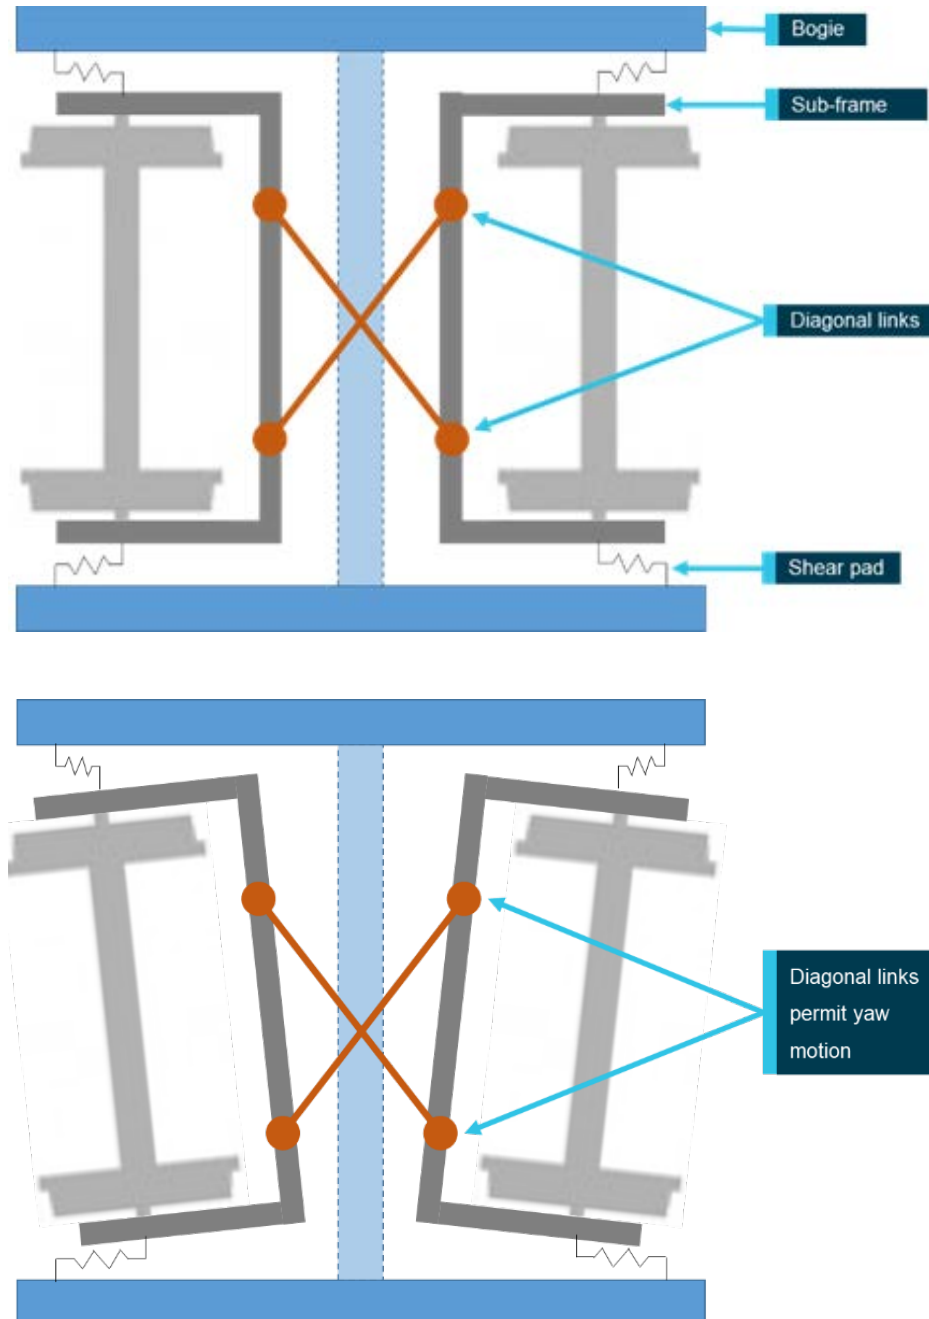
Figure 16: The principle behind the steering bogie

Scheffel's design mounted the wheelsets to sub-frames that were diagonally linked and utilised rubber shear pads (springs) to permit motion between the sub-frame and bogie frame. Configured in this way, the design permits yawing of the axles in response to wheelset steering forces, allowing them to adopt a 'radial' configuration that greatly improves curving performance (Figure 16). The design also resists shear motion between the two wheelsets and is therefore said to have good resistance to hunting.

The magnitude of response of the steering mechanism is dependent on several factors including the wheel profiles used, with the resulting wheelset steering forces having an influence on the performance of the steering mechanism.
