Rendered expanded polystyrene clad wall system AS 5113 external wall fire spread test

Fire test witness and review report

Report number: EP205417

Client: Victorian Building Authority

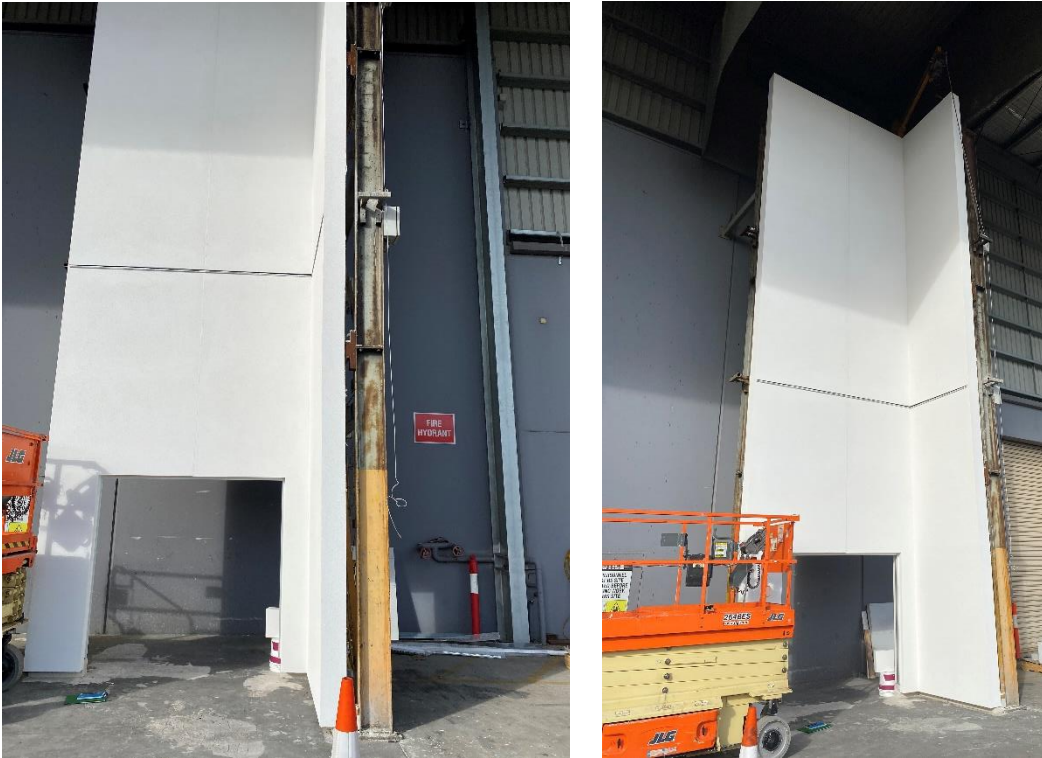
Figure 3. Front face of main wall and wing wall during CSIRO inspection of completed construction at Warringtonfire.

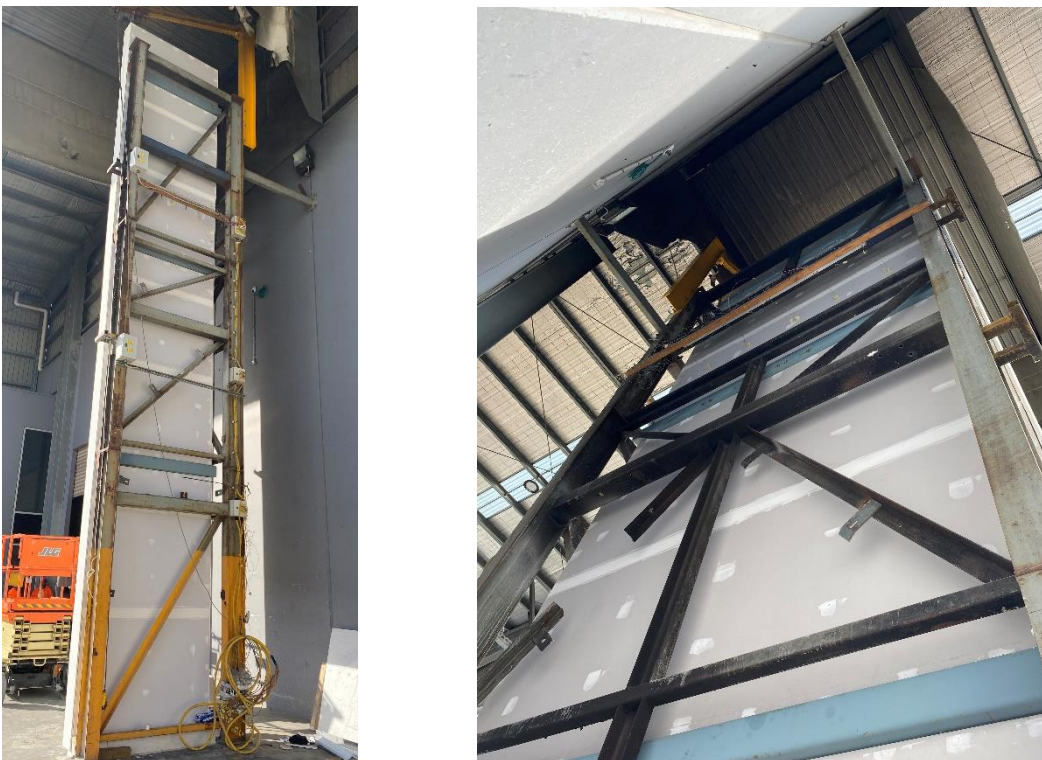
Figure 4. Rear of wing wall (left) and main wall (right) during CSIRO inspection of completed construction at Warringtonfire.

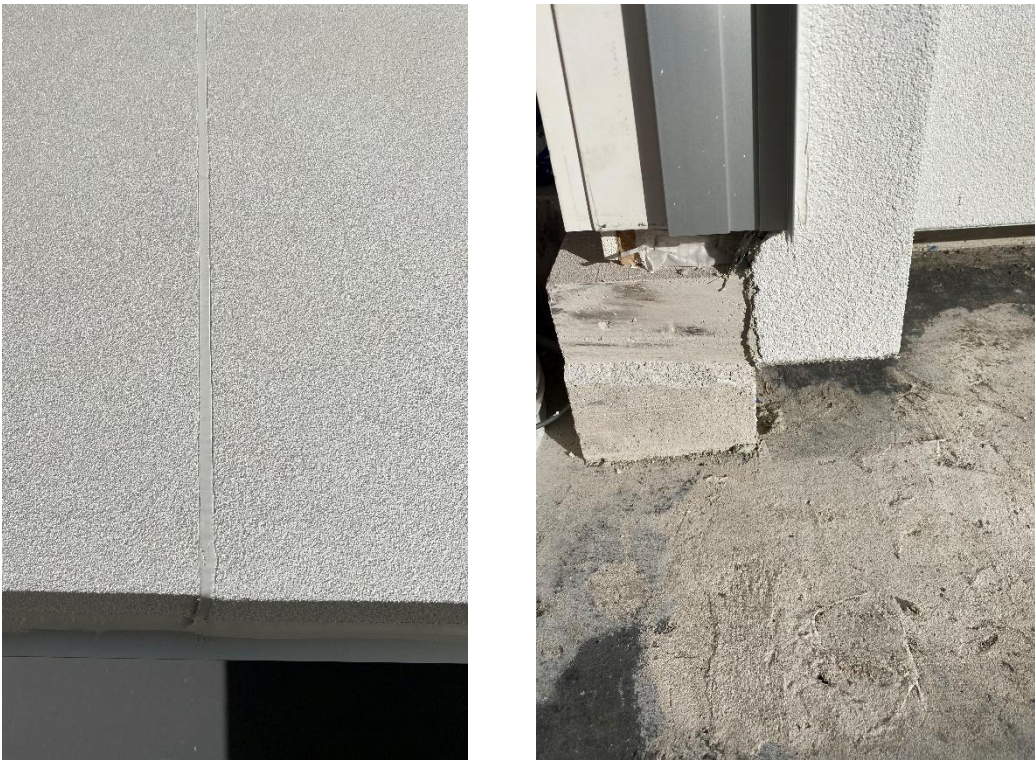
Figure 5. Vertical construction joint (left) and edge of combustion chamber (right) showing simulated timber window reveal and Hebel block simulating slab edge) during CSIRO inspection of completed construction at Warringtonfire.

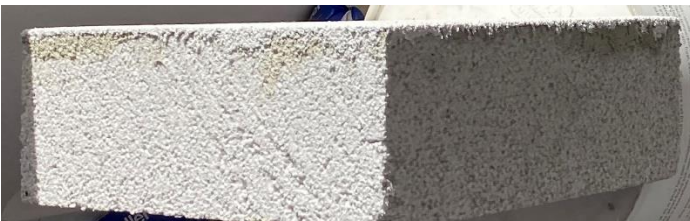
Figure 6. Cut section of 100 mm thick EPS with 1 mm base coat render to one side (left over section not installed to specimen) during CSIRO inspection of completed construction at Warringtonfire.

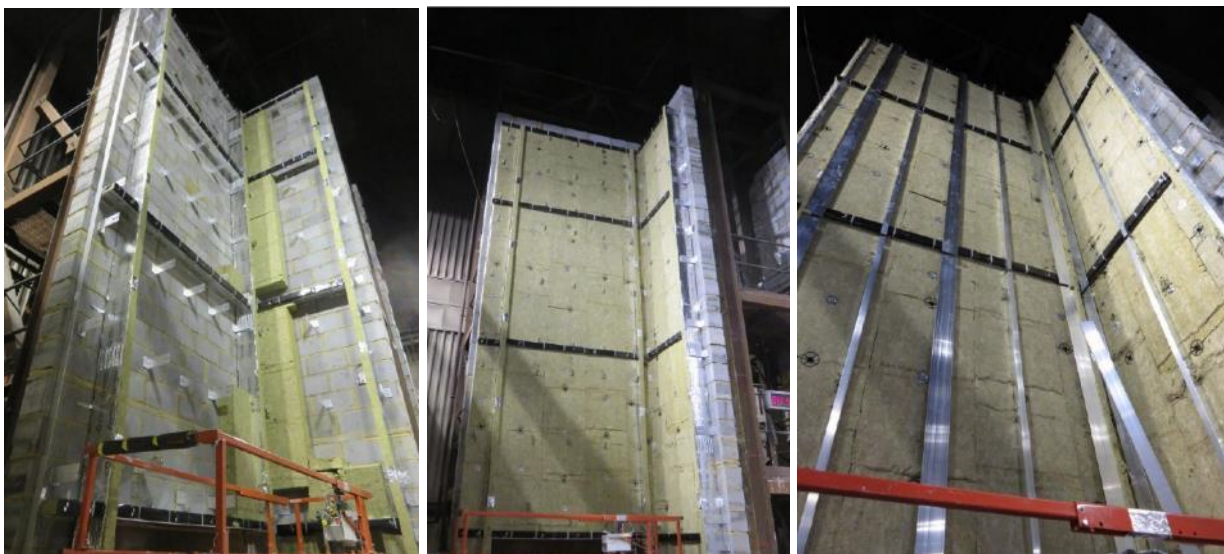
Figure 14 Left – Horizontal and vertical cavity barrier installed through entire depth and aluminium cladding support brackets bolted to masonry wall (MW insulation being installed to wing wall), Centre – cavity barriers and MW insulation installed, Right – Aluminium railing sub structure installed (all photos taken from BRE test report.

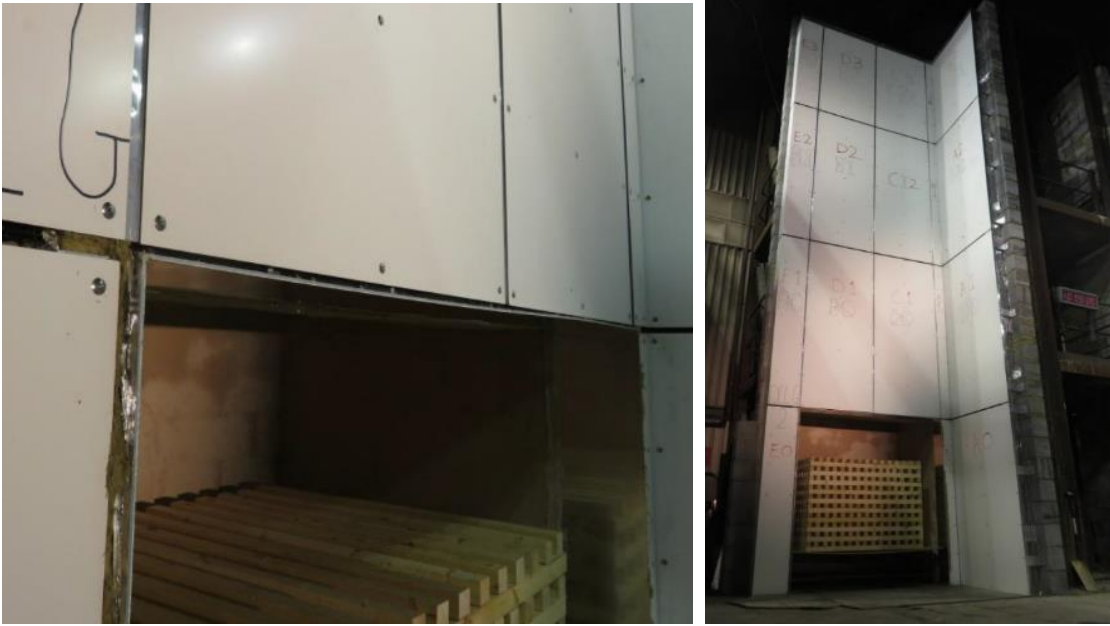
Figure 15. Left – Aluminium window pod, combustion chamber and ACP joints and fixing detail. Right – complete façade system prior to test (all photos taken from BRE Test report
