# Collision of truck with passenger coach

Western Highway, Pentland Hills, Victoria on 21 September 2022

**OCI Transport Safety Investigation Report**

BUS/22-1519

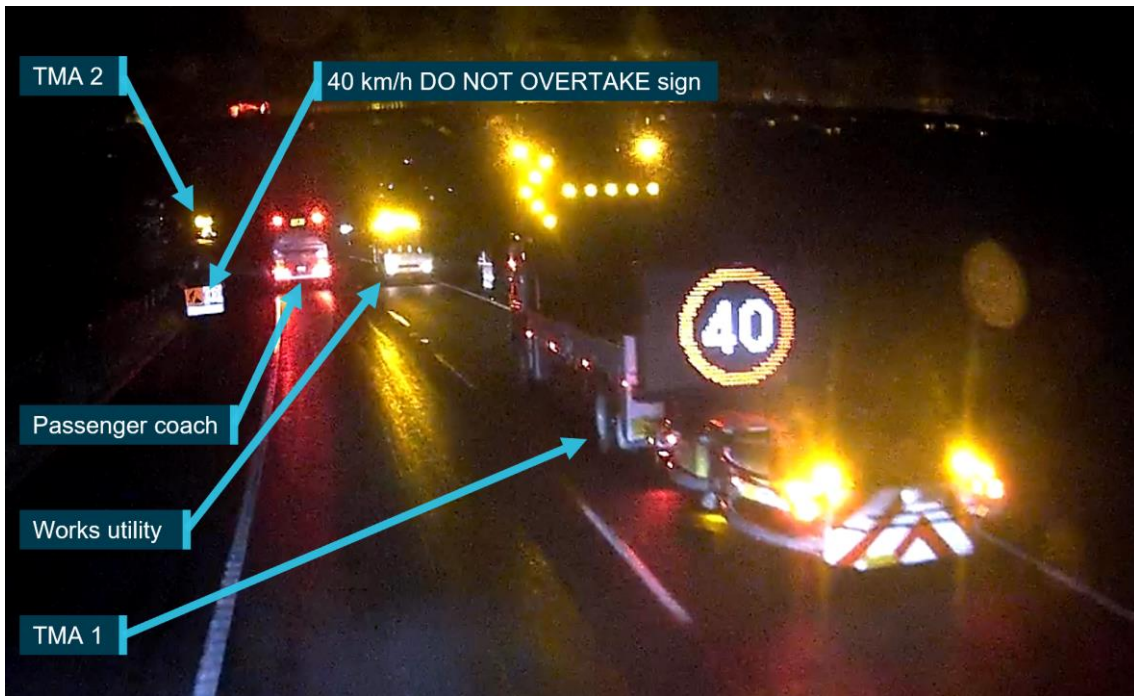
**Figure 4: Passenger coach passing TMA 1**

Dashcam footage from another truck following the passenger coach showed the coach apply its brakes as it approached the 80 km/h speed zone. At about 0315, the passenger coach was observed to hold its speed under braking as it approached and passed to the left of the works utility (Figure 4). It was then observed to approach TMA 2 with its brake lights still illuminated and was travelling at or below 40 km/h. The truck following the coach was in a B-double configuration and was maintaining a safe distance behind.

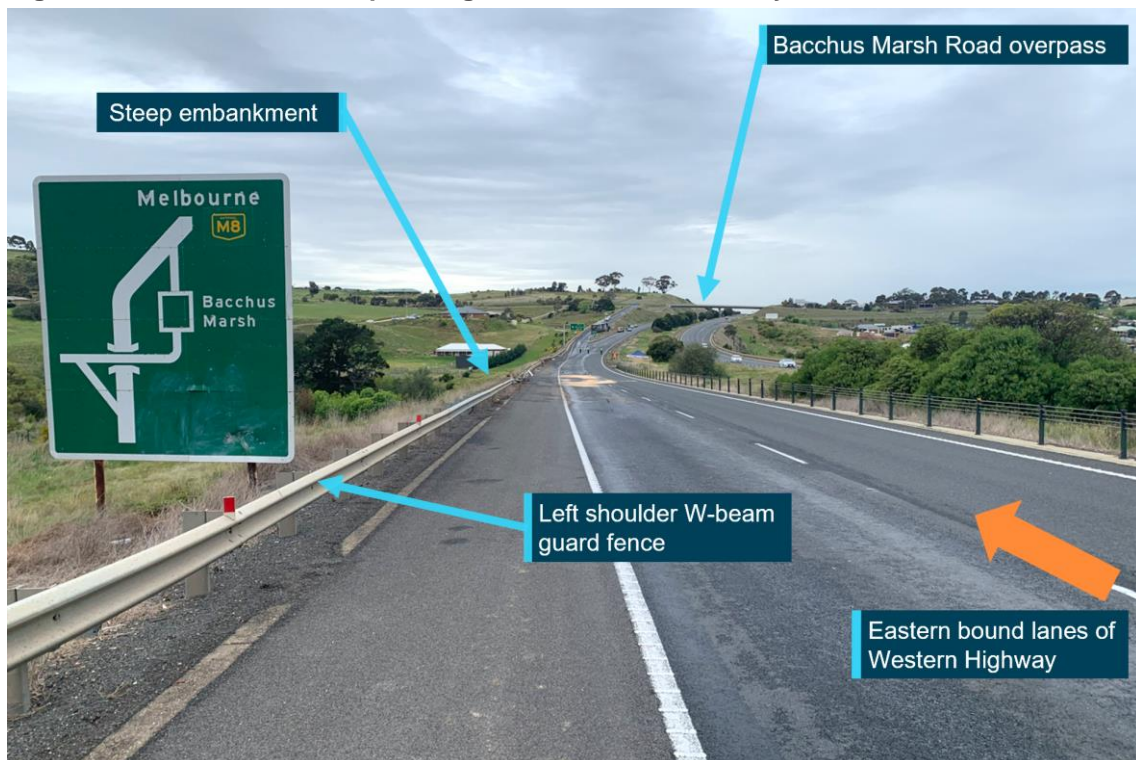
**Figure 7: location where the passenger coach left the freeway**

The incident occurred on the east bound lanes of the Western Freeway in Pentland Hills, about 740 m west of the Bacchus Marsh Road overpass. At this location, the freeway was a dual carriageway with the 2-lane eastbound carriageway separated from the westbound carriageway by a median strip flanked with wire-rope safety barriers. The left shoulder of the eastbound carriageway had a tactile edge line and was bordered by a W-beam guard fence system that protected traffic from a steep embankment covered with grass and small shrubs (Figure 7).

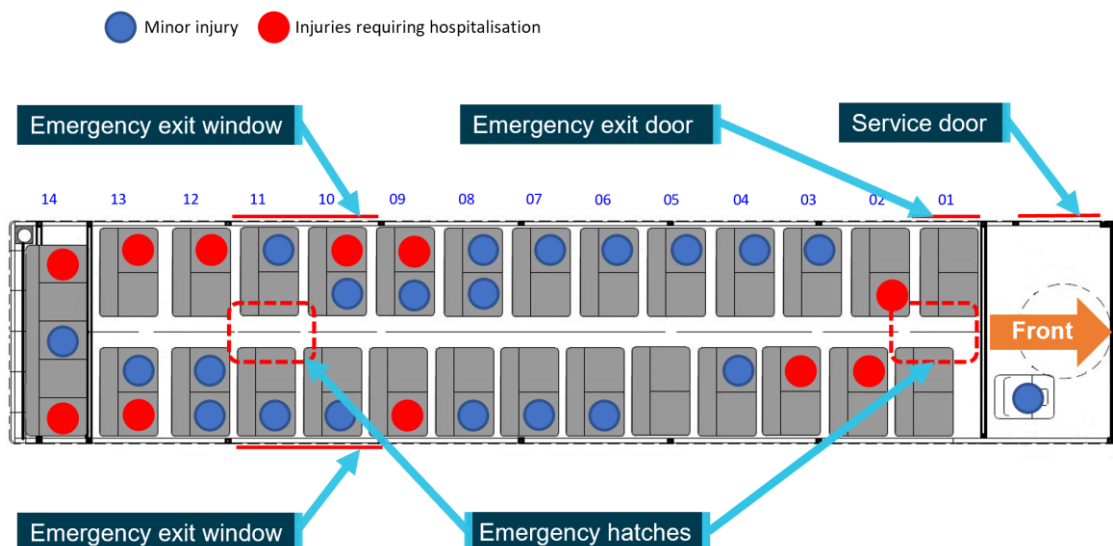
**Figure 12: Seating position of driver and passengers**

Eleven of the passengers suffered injuries that required hospital treatment. The remaining passengers either attended hospital for assessment and were not admitted or were assessed by paramedics at the incident site. Of the 11 passengers that suffered injuries requiring hospitalisation, 6 were seated on the left side of the passenger coach and 5 on the right side. Four passengers were fully ejected from the passenger coach prior to it coming to rest, 3 of them suffered injuries requiring hospitalisation. The passengers and driver that remained within the passenger coach after it came to rest exited via the emergency hatches in the roof or the front windscreen, which had partially separated from its frame during the rollover. The driver and passenger seating positions are shown in Figure 12.

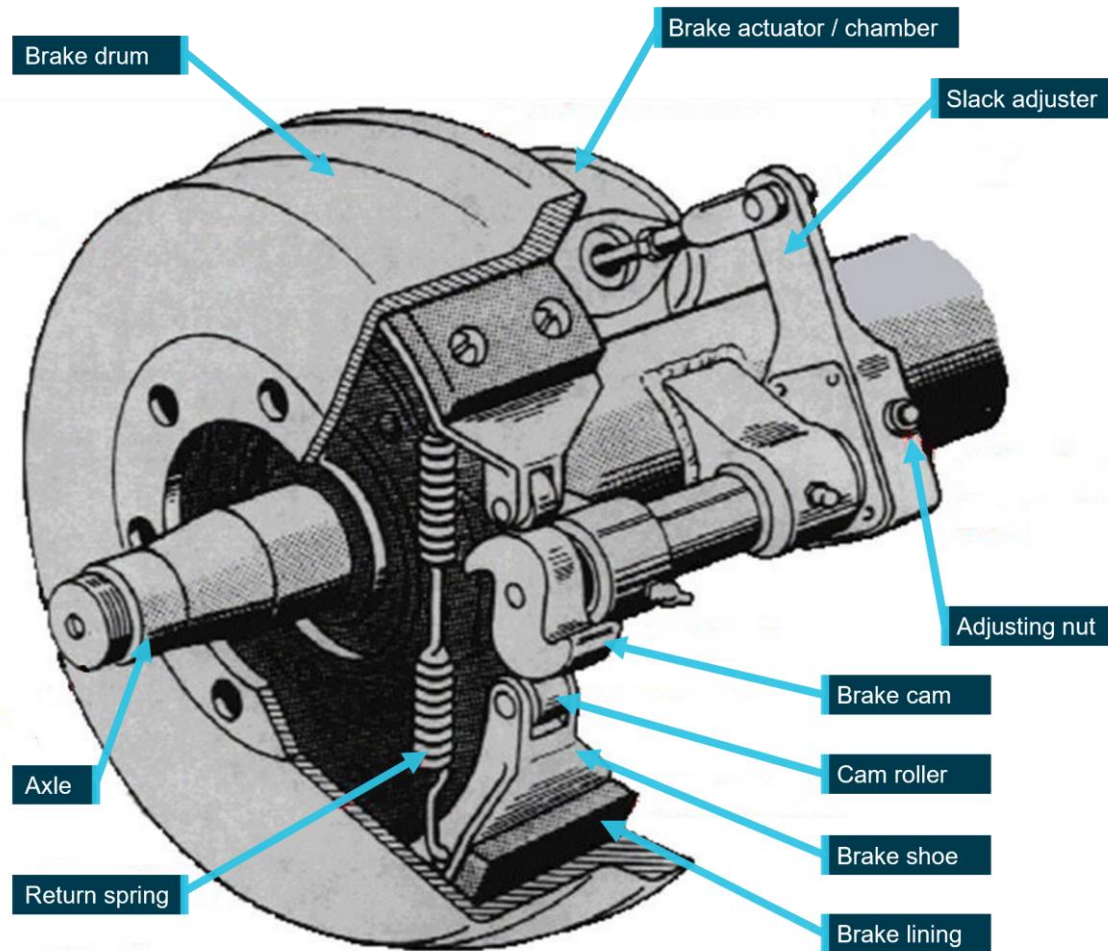
Figure 14: Heavy vehicle drum brake general arrangement

The brake system on all 6 axles of the trailer combination consisted of air activated drum brakes with manual slack adjusters (Figure 14). A post-incident inspection found that although each of the drum brake assemblies had sufficient brake lining material, all were out of adjustment leading to ineffective braking performance. The air brake actuator on the driver side third axle was noted to have broken away from the axle mount bracket. The condition of the bracket fracture surface and the actuator piston indicated that the actuator had probably broken away from the axle some time prior to the incident.

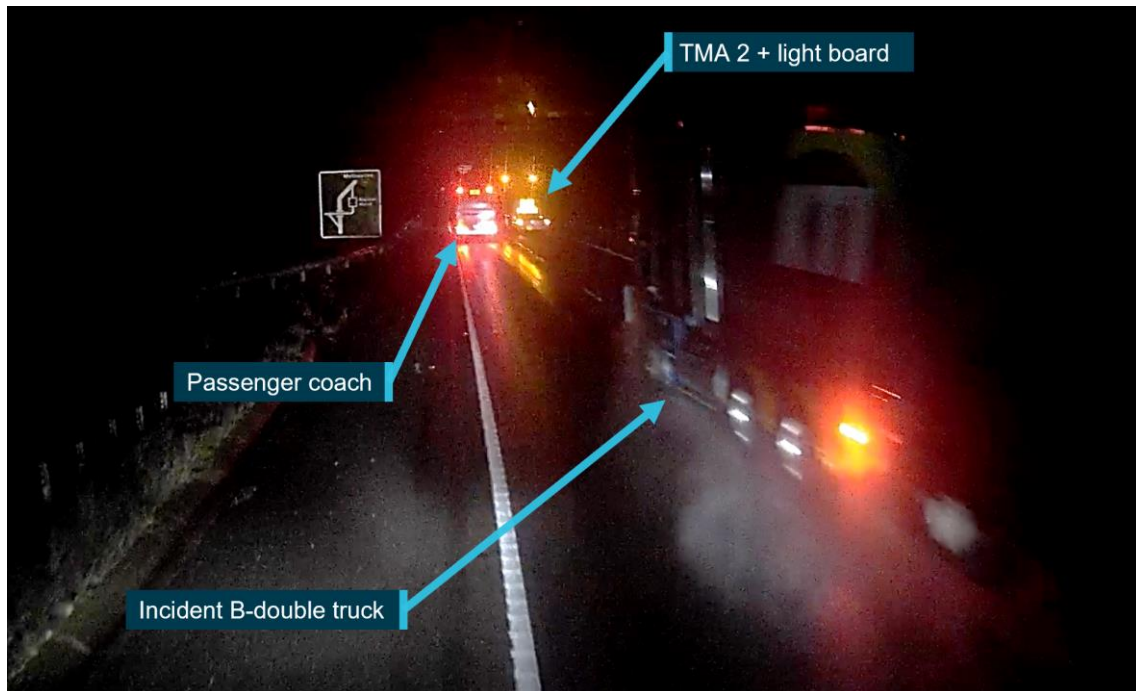
Figure 18: Dashcam footage of Incident truck

A B-double truck immediately following the passenger coach at the time of collision was equipped with a forward-facing camera that recorded both high definition video and audio. Footage from the camera started at about 2 km west of the collision point and recorded the rear of the passenger coach up to the point where the B-double truck was overtaken by the incident truck (Figure 18) which went on to impact the rear of the passenger coach. The B-double truck fitted with the dashcam was able to adequately slow to the reduced speed limit and maintain a safe distance behind the passenger coach.

*This image shows the incident truck overtaking the truck that was following the passenger coach.*  
Source: Dashcam footage annotated by the Office of the Chief Investigator
