Collision of truck with school bus

Exford Road, Exford, Victoria on 16 May 2023

OCI Transport Safety Investigation Report

BUS/23-809

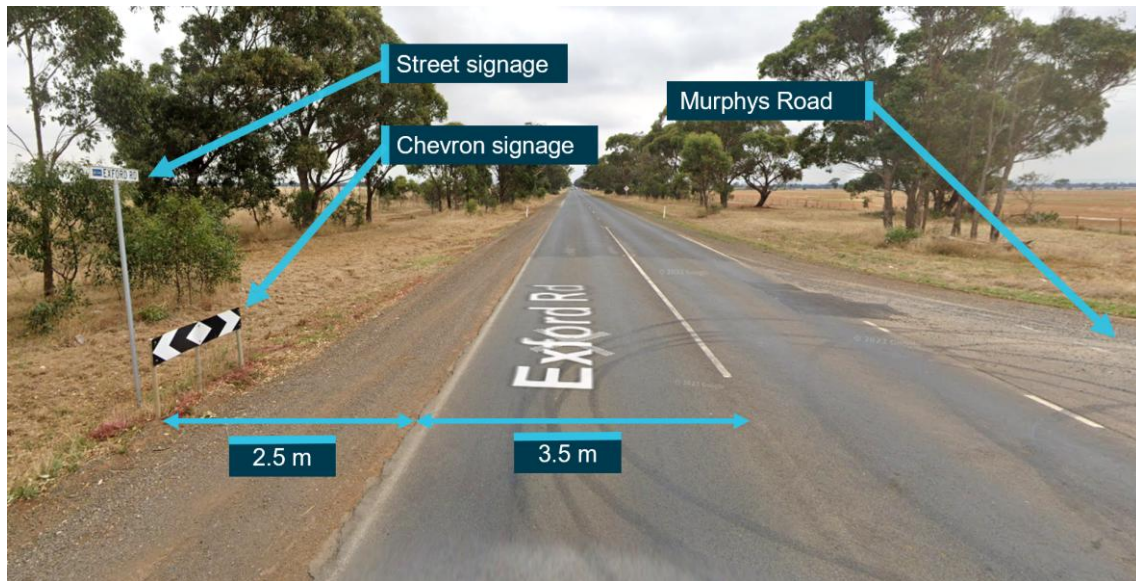
Figure 7: Murphys Road - Exford Road intersection

The road at the incident intersection consisted of a spray seal surface.⁴ Although the road surface showed some signs of wear, there were no obvious significant defects. The road shoulder adjacent to the intersection with Murphys Road was unsealed with an average width of 2.5 m. The verge to the left of the shoulder was lined by small shrubs and trees with a road signage post and warning chevron sign opposite Murphys Road (Figure 7).

- The Exford Road pavement surface was flush (or worn). A recommendation was made to investigate the skid resistance of the pavement surface and resurface if necessary.
- The intersection was inconspicuous from the Exford Road approaches due to the roadside tree line at the verge of the road concealing the opening of the intersection. A recommendation was made to consider various physical and visual controls such as kerb installation and additional warning signage.
- The southern shoulder on Exford Road at the intersection was unsealed making it difficult for vehicles to pass to the left of vehicles turning right into Murphys Road. Roadside signage on the shoulder was also highlighted as a potential hazard to passing vehicles. A recommendation was made to consider widening Exford Road at the intersection, providing a right turn lane treatment and relocate signage.

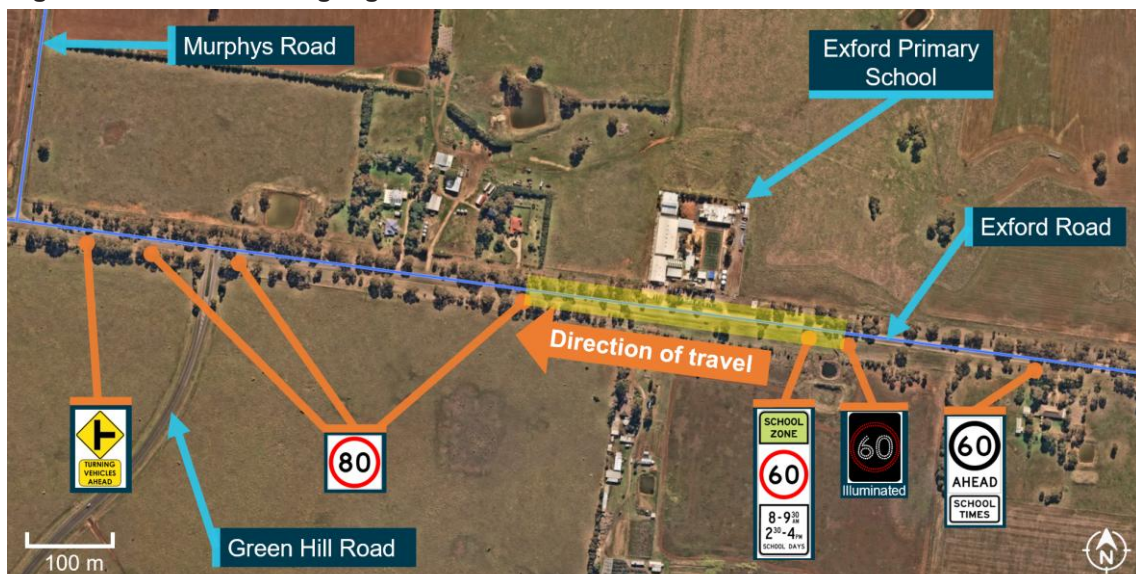
Figure 8: Exford Road signage and school zone

A 60 km/h school zone was active outside the school from 0800 to 0930 and 1430 to 1600. The zone spanned about 150 m either side of the school and was denoted by the standard school zone road signage and an illuminated speed sign on either end of the approach. An 80 km/h road speed limit applied either side of the zone. On the approach to the Murphys Road intersection, there was a right turn warning sign positioned about 95 m to the east on Exford Road (Figure 8).

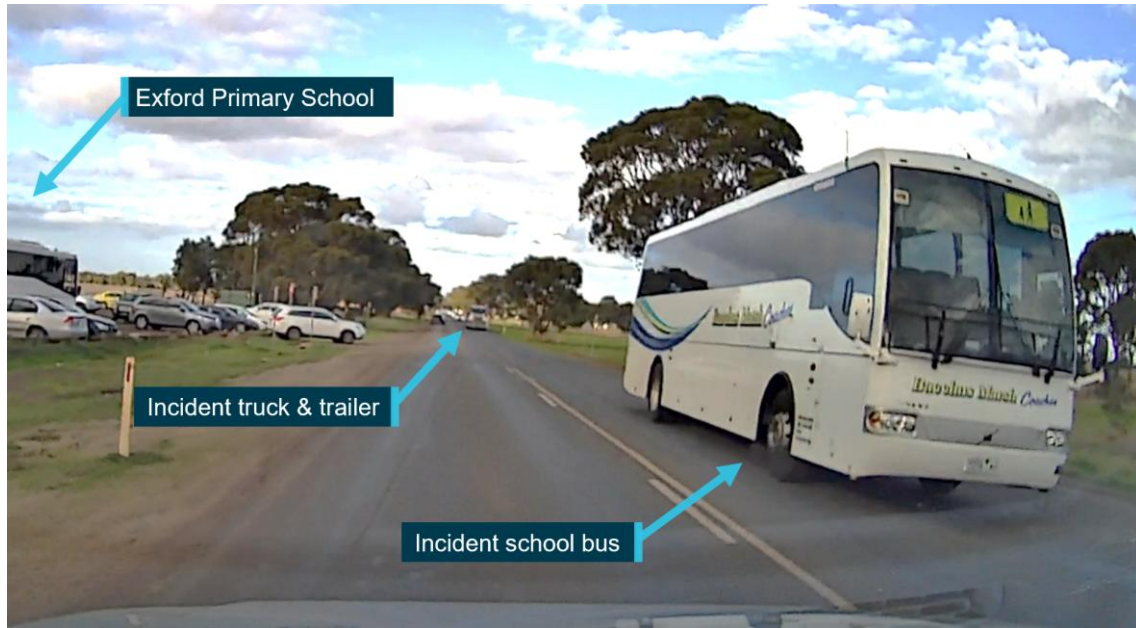
Figure 18: School bus departing primary school

A vehicle traveling in the opposite direction on Exford Road approaching the primary school was equipped with a forward and rearward facing camera that recorded high definition (HD) video. Footage from the camera shows the school bus travelling away from Exford Primary School on Exford Road with the incident truck and trailer approaching from behind. At that point, the speed limit in the school zone was 60 km/h and the truck was travelling about 110 m behind the school bus (Figure 18).

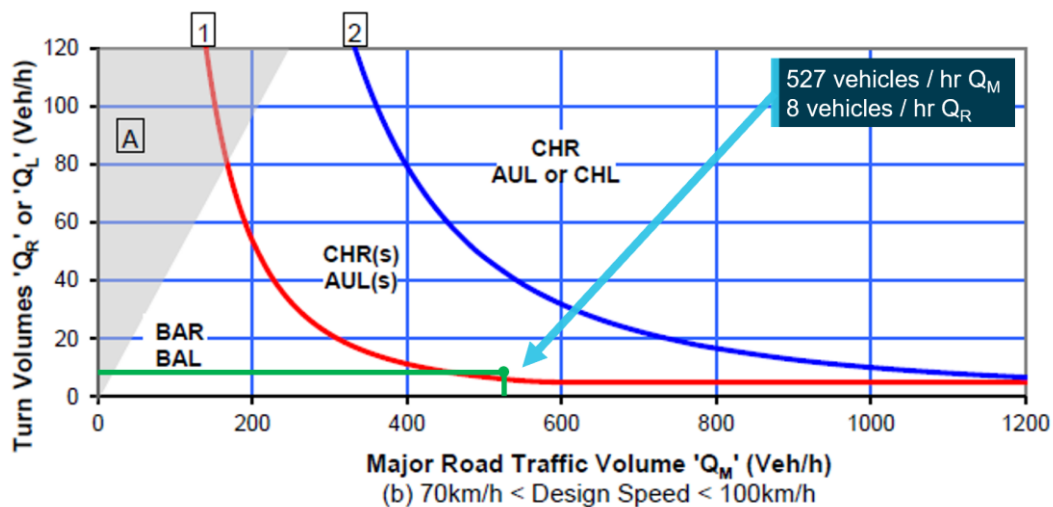
Figure 20: Turn treatment warrants – major road unsignalised intersections

A traffic survey was conducted by the Melton City Council in July 2023, after the collision. The survey measured traffic volumes passing through the Exford / Murphys road intersection in both the morning and afternoon peak periods. The afternoon hourly peak data for traffic turning right from Exford Road is plotted in green on the turn treatment warrant that would apply to the intersection (Figure 20).

The data measured at the 2023 survey indicates that traffic volumes were at the threshold in the Austroads guidelines to consider a short channelised right-turn treatment (CHR(s)) at the Murphys

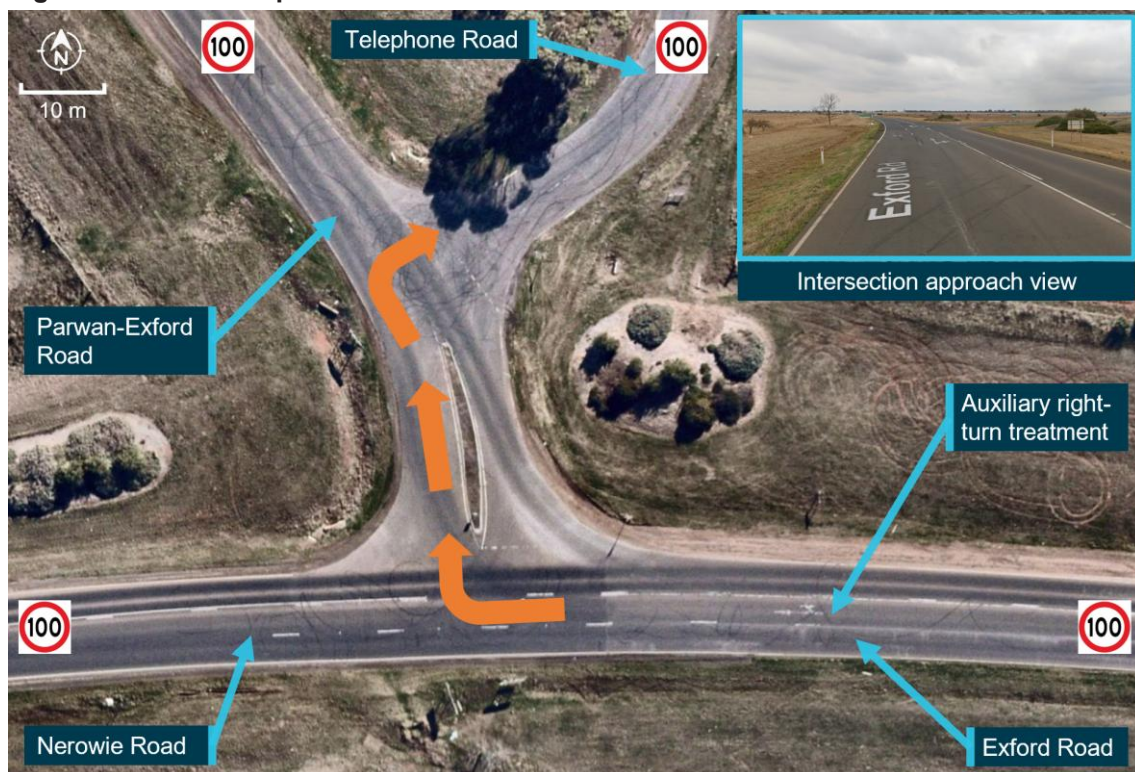
Figure 21: Bus route post incident

The school bus drop-off route was designed to include Murphys Road to service students residing on that road. On the approved school bus route, the bus would turn right into Murphys Road and travel in an anticlockwise loop before rejoining Exford Road to travel east. In the months after the collision, the Murphys Road loop was first excluded from the route (due to there being no student drop-offs) and then later reestablished in the opposite direction with the bus turning right at Parwan-Exford Road (Figure 21) and travelling in a clockwise loop to re-enter Exford Road from Murphys Road.

This modified clockwise loop replaced the right turn at Murphys Road. The right turn at Parwan-Exford Road turn was on a section of Exford Road with 2 westbound lanes and so afforded vehicles travelling behind a turning vehicle to pass to the left. The new right turn road was a higher (100 km/h) speed zone posing other risks. The original and subsequent route options highlight the different characteristics and risk profiles present with different route options.
