Reaction to fire test report

Test standard: Ad-hoc test based off ISO 13785-1:2002

System: A cassetted aluminium composite panel wall system

This report documents the findings of the first of three ad-hoc reaction to fire tests on a cassetted aluminium composite panel (ACP) external wall system - performed on 27 November 2023. The test was based on ISO 13785-1:2002.

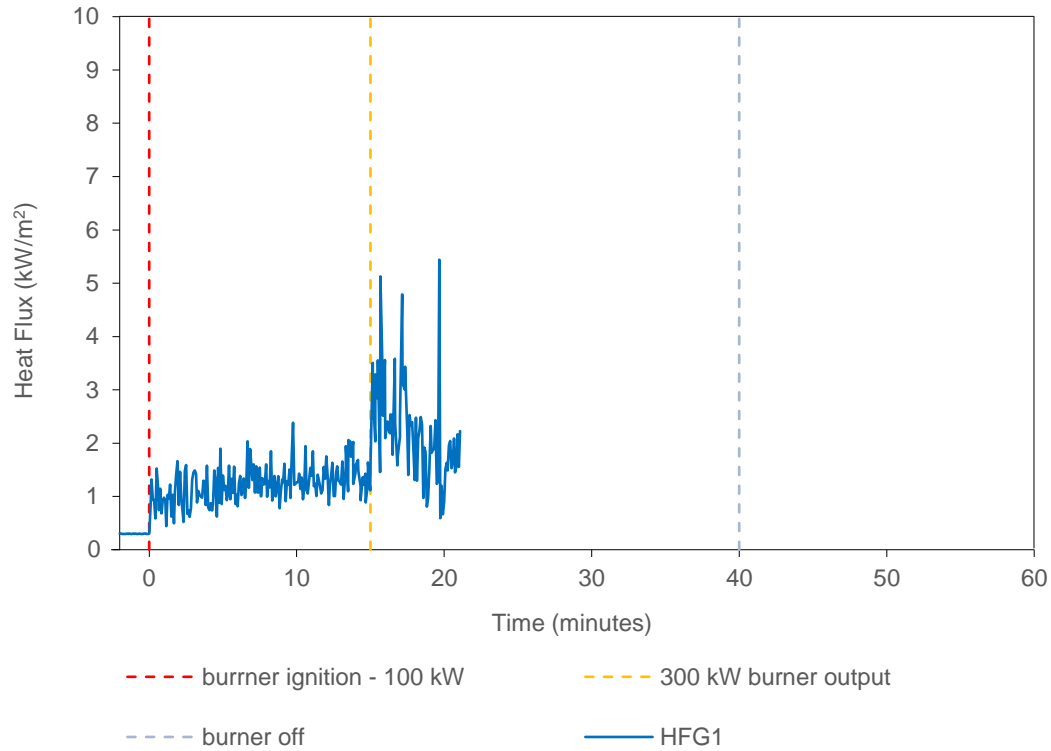
Figure 4 Heat flux data collected by heat flux gauge.

Note: At 21 minutes 7 seconds, the water cooling pipe became disconnected from the heat flux gauge.

20	35	All	A buildup of gas was released out from the sides of the specimen.
21	07	All	The water cooling pipe became disconnected from the heat flux gauge.
21	19	All	Significant flaming was present on the right side of the specimen, to a height of 2B.
22	09	2A	The corners of the panel were deforming outwards.
29	00	1C/2A	The join sustained flaming on the left side, which appeared to be independent of the burner.
40	00	All	The burner was switched off.
42	55	1A/2A	The panel was flaming at the edges.
44	10	1C/2A	Intermittent flaming was present in the join between the two panels.
45	55	All	External flaming had decreased, and smoke emissions had increased.
50	27	All	External flaming ceased.
60	00	All	The reaction to fire test ended.

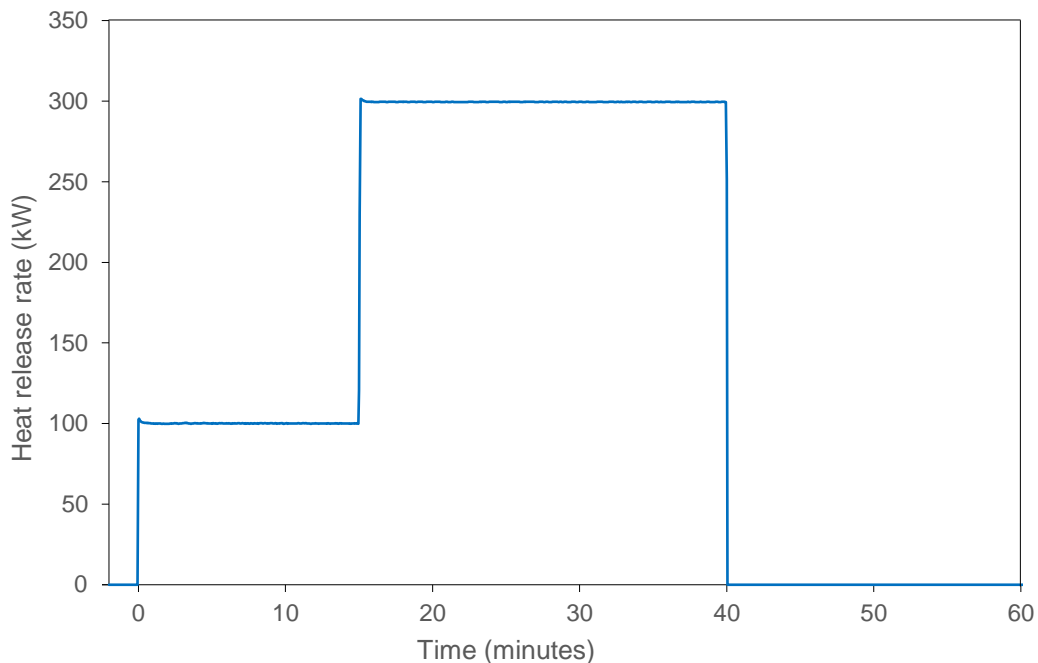
Figure 5 Heat release rate of burner.

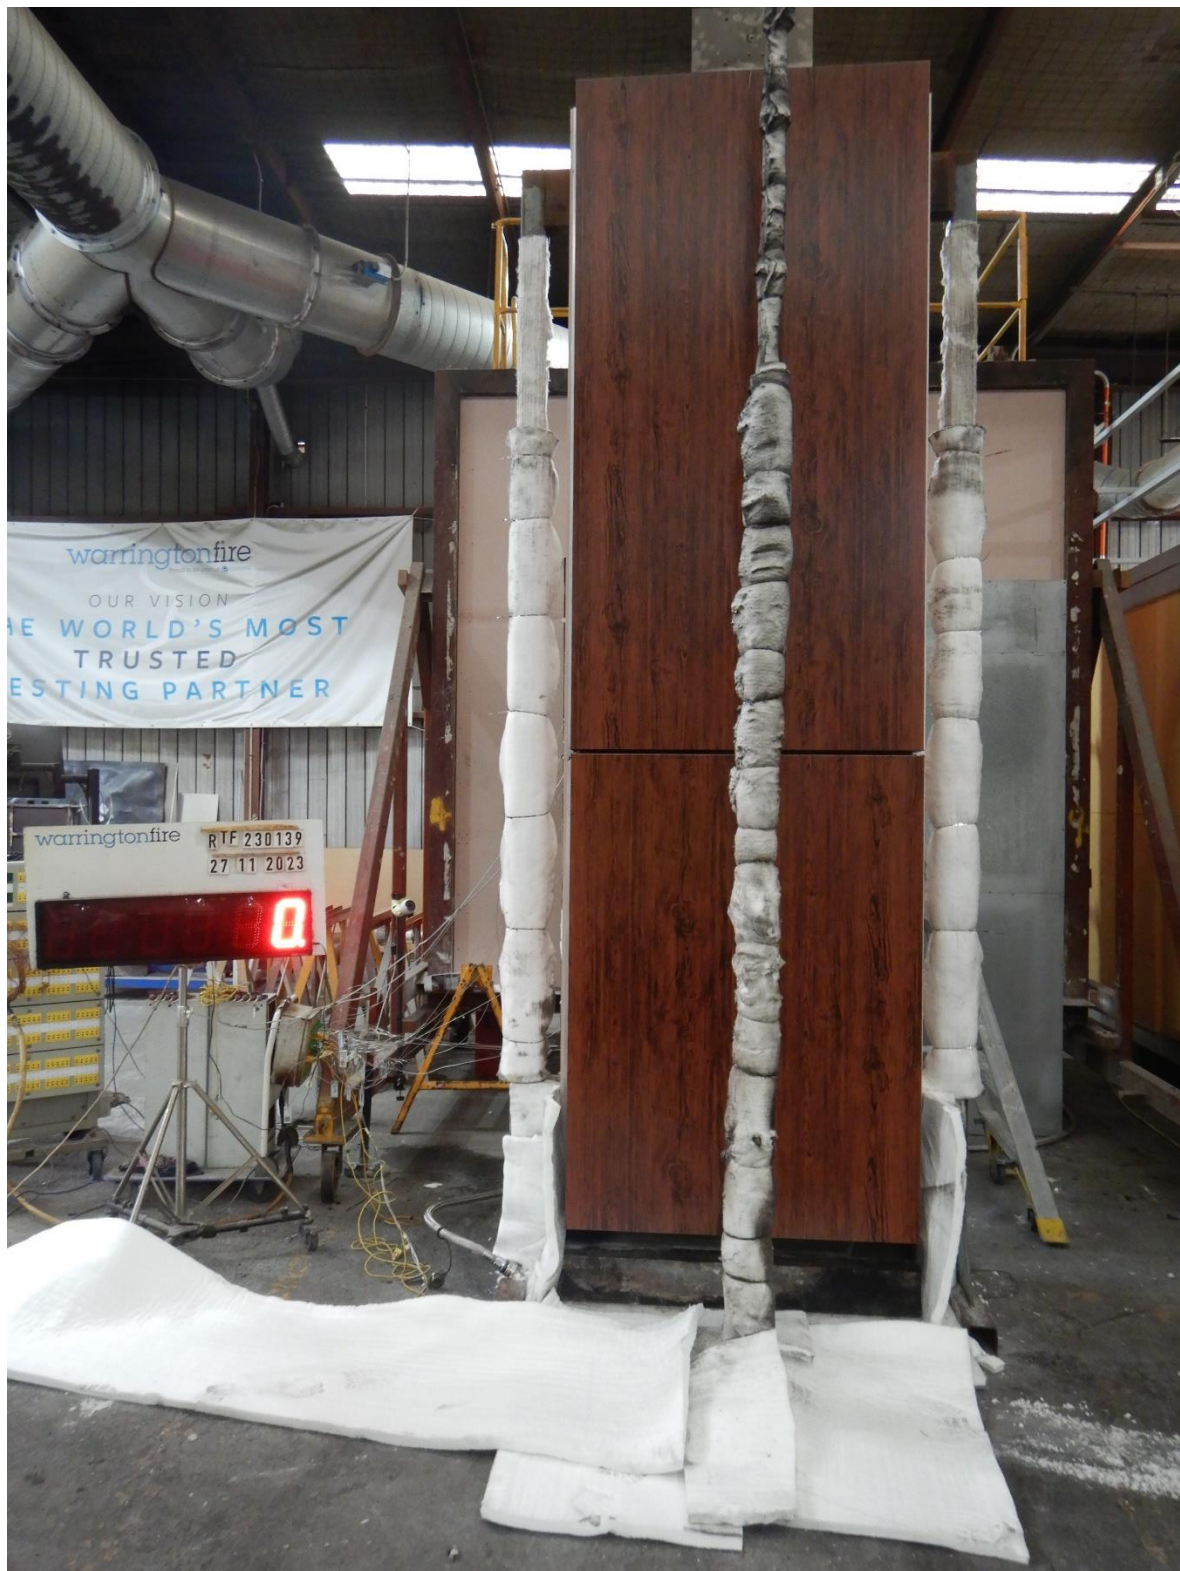
Figure 11 The specimen before the reaction to fire test

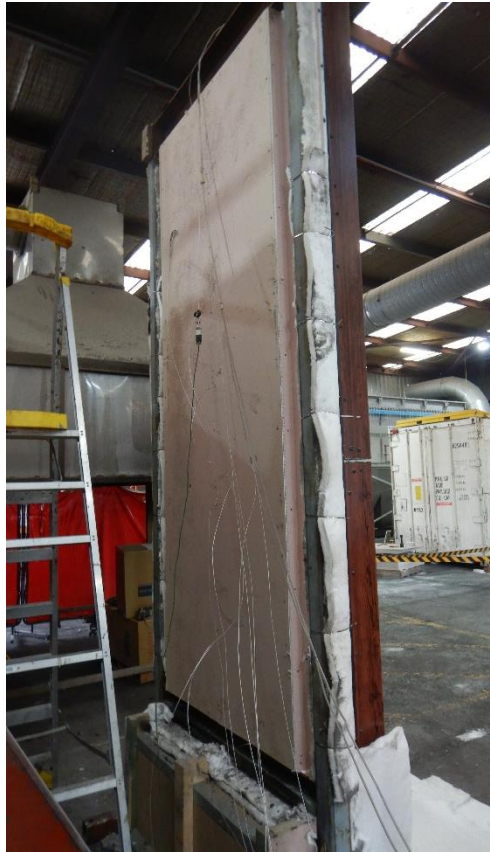
Figure 12 The specimen before the reaction to fire test – unexposed side

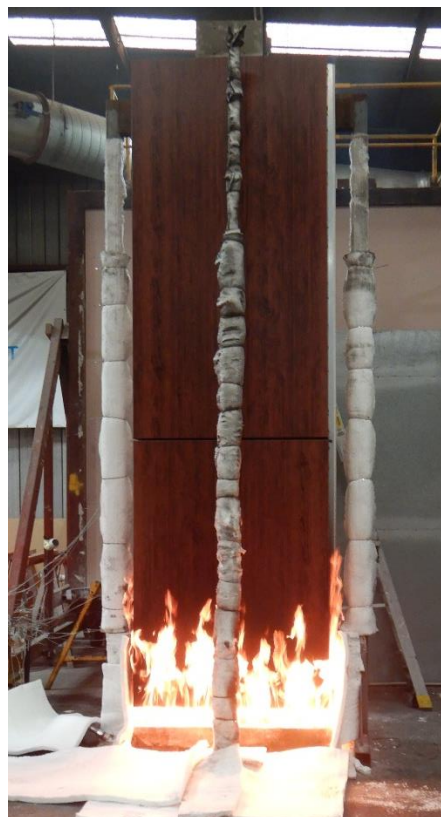
Figure 13 The specimen 2 minutes 44 seconds into the test (burner output at 100 kW)

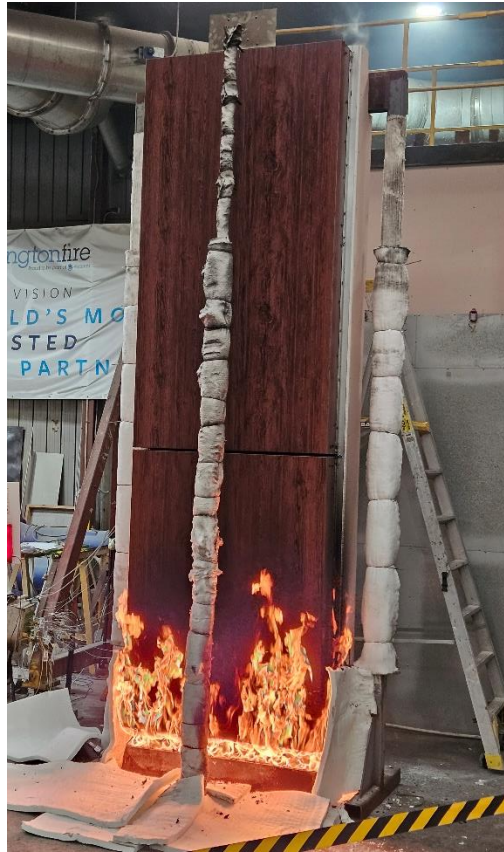
Figure 14 The specimen 8 minutes 35 seconds into the test (burner output at 100 kW)

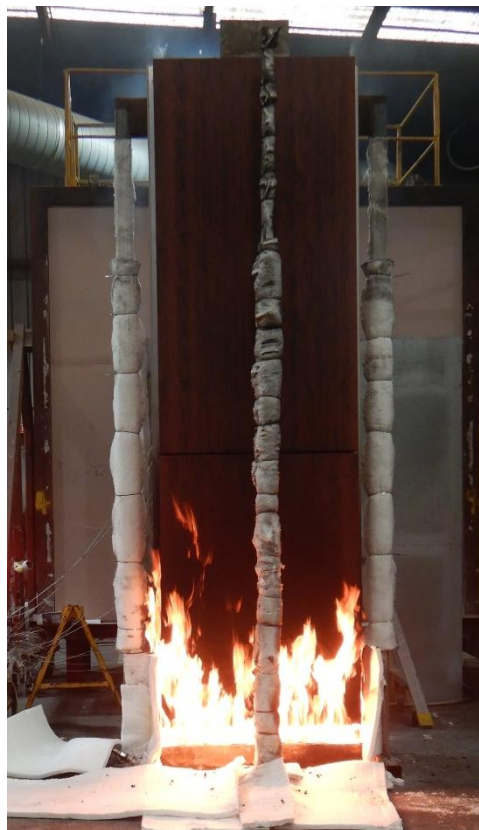
Figure 15 The specimen 14 minutes 55 seconds into the test (burner output at 100 kW)

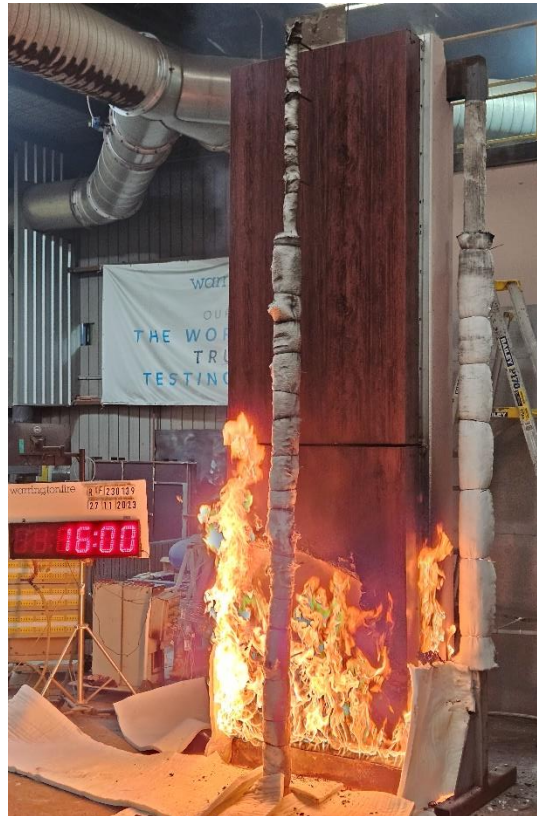
Figure 16 The specimen 16 minutes into the test (1 minute after burner output was changed to 300 kW)

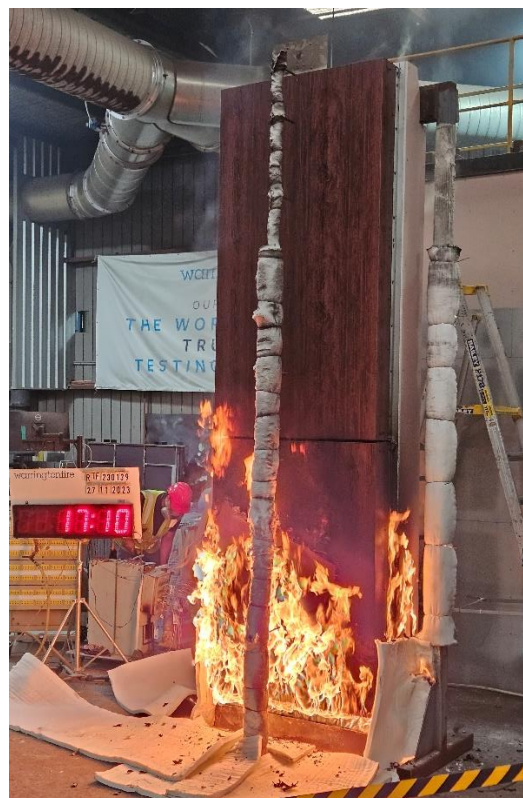
Figure 17 The specimen 17 minutes 10 seconds into the test (2 minutes 10 seconds after burner output was changed to 300 kW)

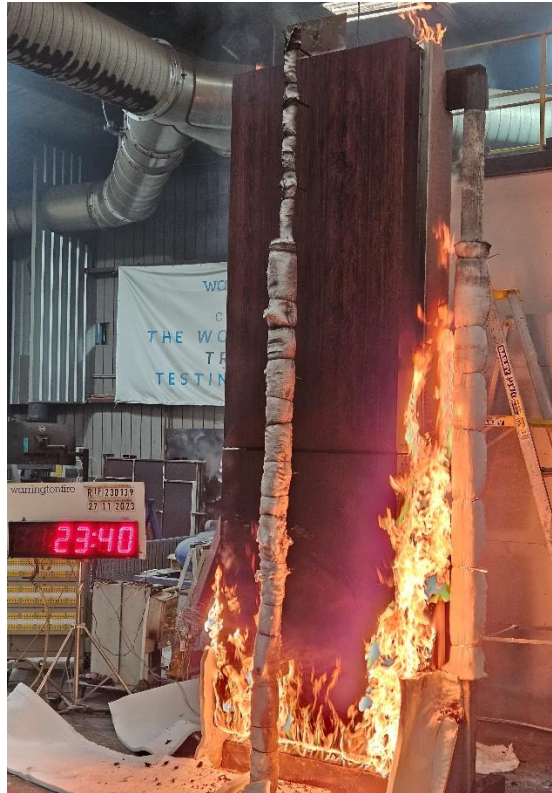
Figure 18 The specimen 23 minutes 40 seconds into the test (8 minutes 40 seconds after burner output was changed to 300 kW)

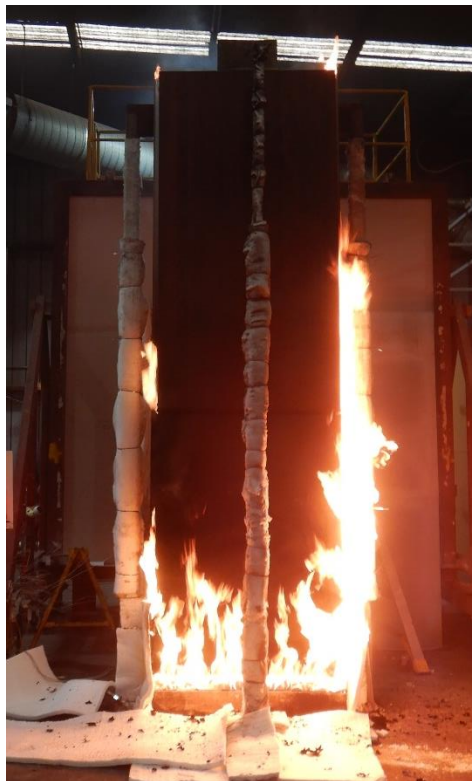
Figure 19 The specimen 29 minutes 50 seconds into the test (14 minutes 50 seconds after burner output was changed to 300 kW)

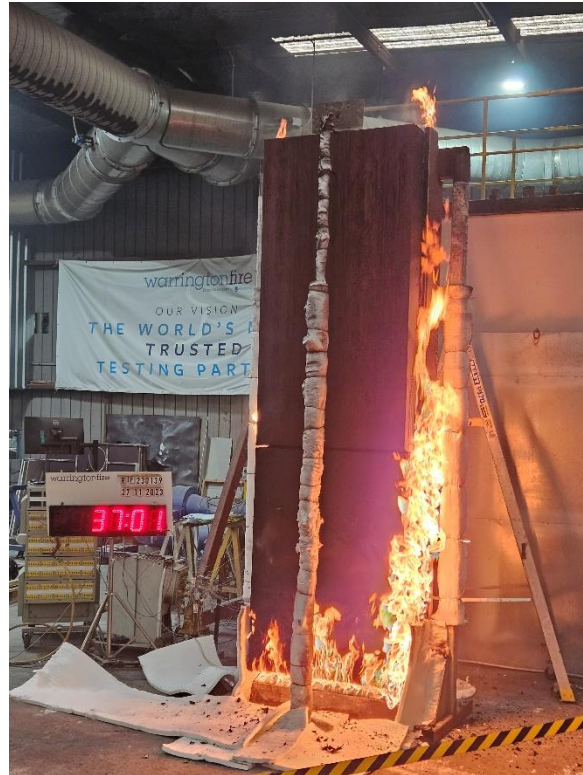
Figure 20 The specimen 37 minutes 1 second into the test (22 minutes 1 second after burner output was changed to 300 kW)

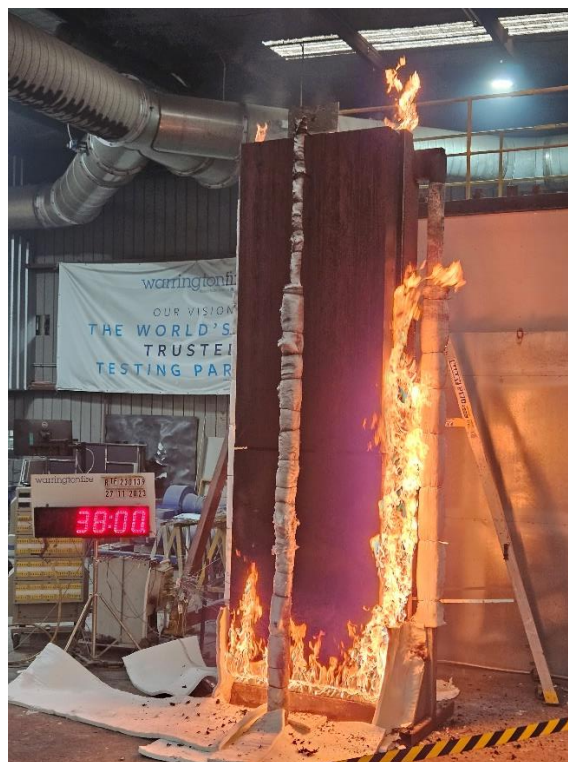
Figure 21 The specimen 38 minutes into the test (23 minutes after burner output was changed to 300 kW)

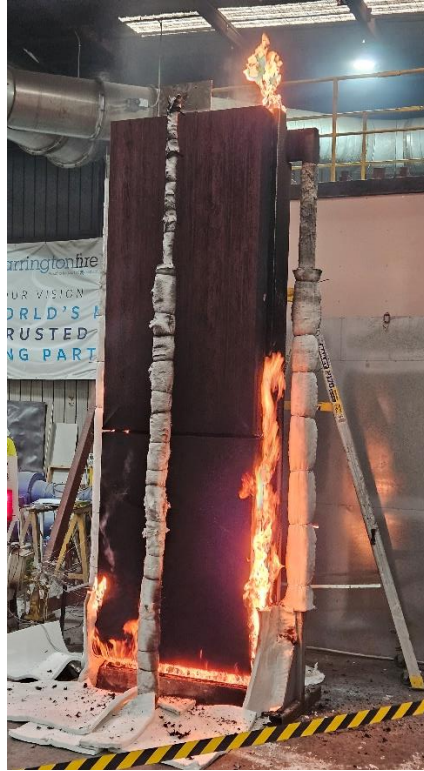
Figure 22 The specimen 40 minutes 30 seconds into the test (30 seconds after burner was switched off)

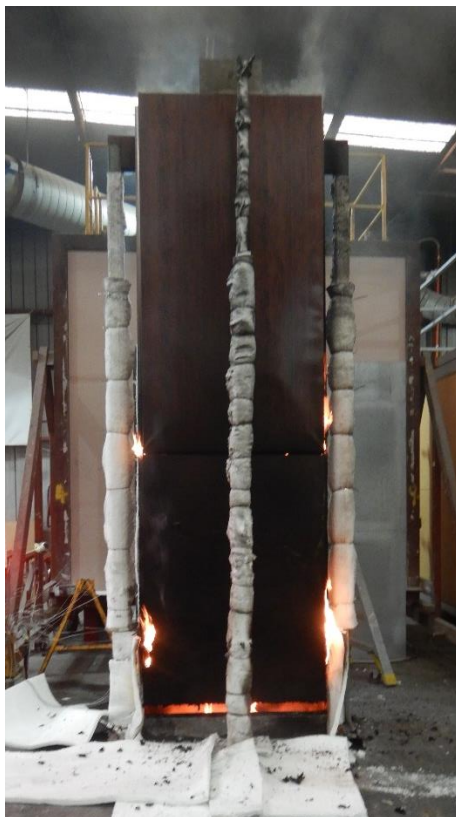
Figure 23 The specimen 42 minutes 25 seconds into the test (2 minutes 25 seconds after burner was switched off)

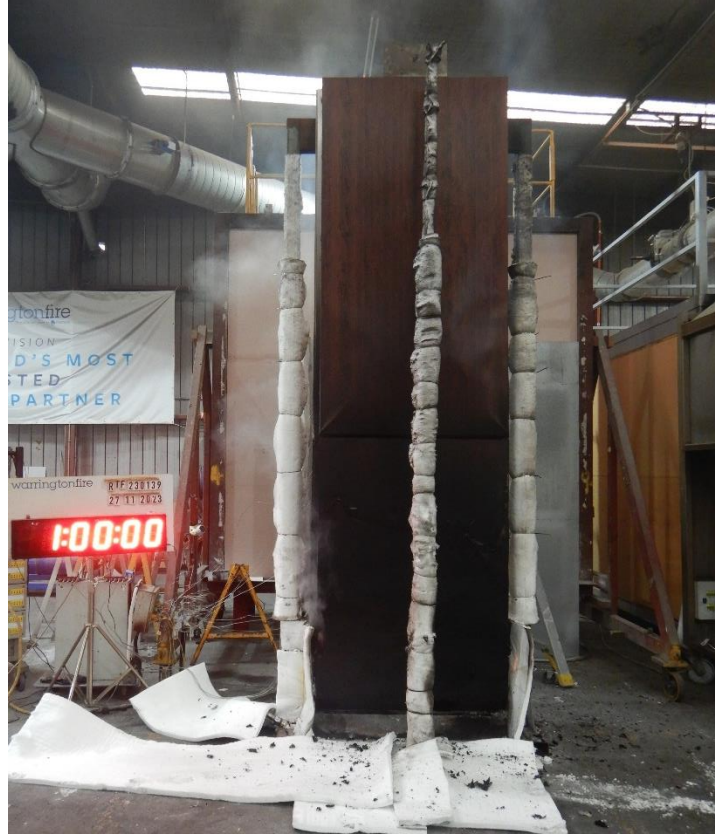
Figure 24 The specimen at the end of the test

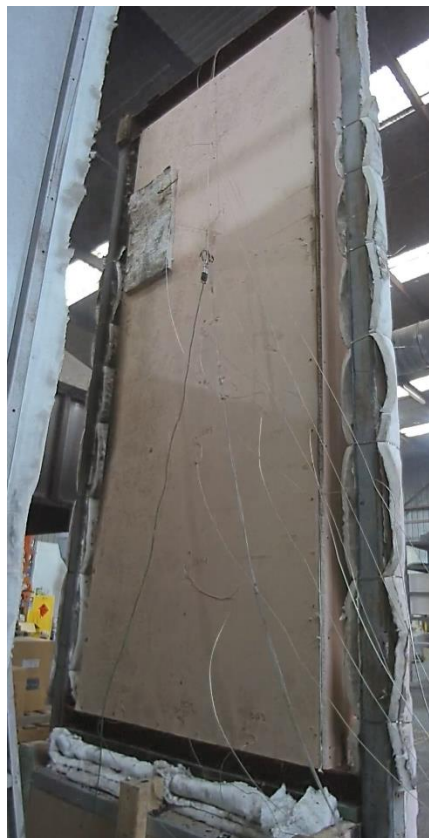
Figure 25 The specimen after the test – unexposed side
