# Reaction to fire test report

Test standard: Ad-hoc test based off ISO 13785-1:2002

Test sponsor: Cladding Safety Victoria (CSV)

System: A cassetted aluminium composite panel wall system

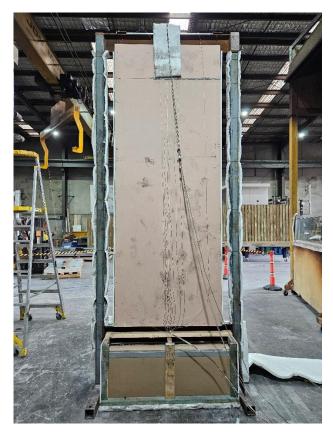
Figure 12 The specimen before the reaction to fire test – unexposed side

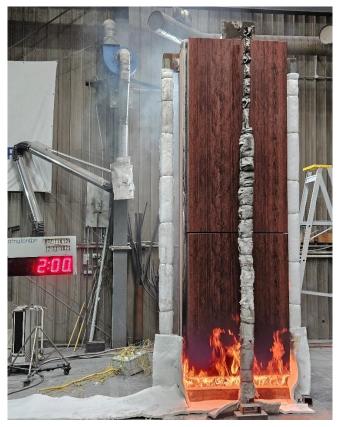
Figure 13 The specimen 2 minutes into the test (burner output at 100 kW)

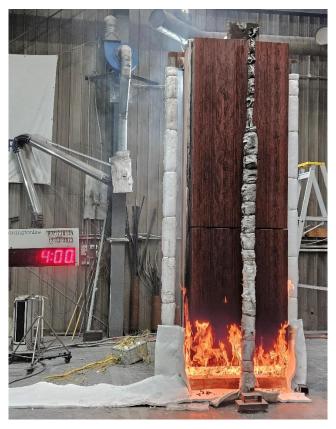
Figure 14 The specimen 4 minutes into the test (burner output at 100 kW)

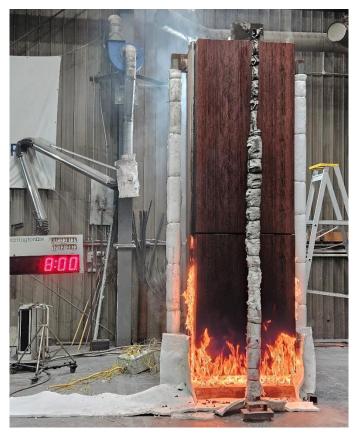
Figure 15 The specimen 8 minutes into the test (burner output at 100 kW)

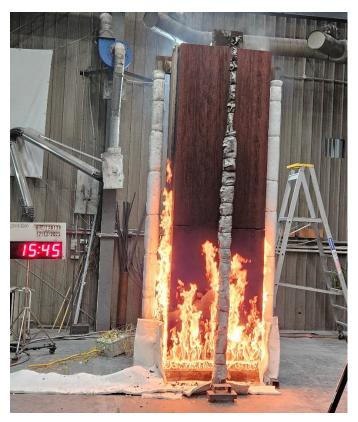
Figure 16 The specimen 15 minutes 45 seconds into the test (45 seconds after burner output was changed to 300 kW)

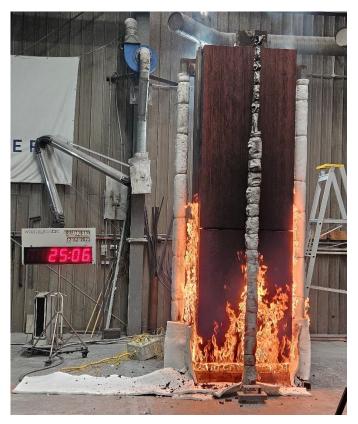
Figure 18 The specimen 25 minutes 6 seconds into the test (10 minutes 6 seconds after burner output was changed to 300 kW)

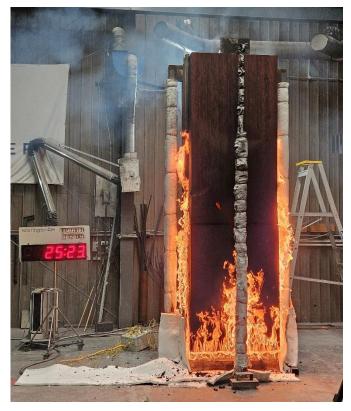
Figure 19 The specimen 25 minutes 23 seconds into the test (10 minutes 23 seconds after burner output was changed to 300 kW)

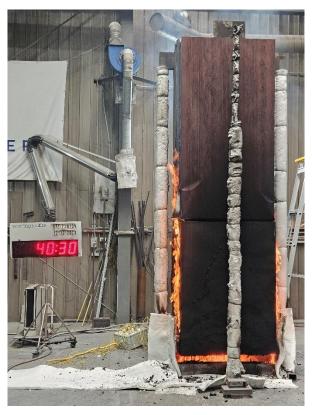
Figure 22 The specimen 40 minutes 30 seconds into the test (25 minutes 30 seconds after burner output was changed to 300 kW)

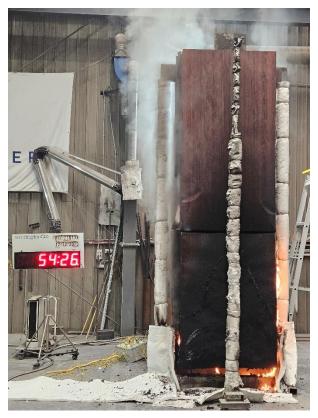
Figure 24 The specimen 54 minutes 26 seconds into the test (14 minutes 26 seconds after burner was switched off)

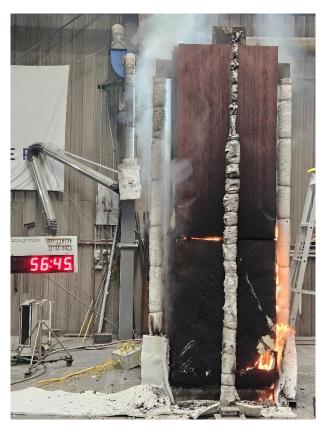
Figure 25 The specimen 56 minutes 45 seconds into the test (16 minutes 45 seconds after burner was switched off)

Tit	me	Section	Observation	
Min	Sec			
56	18	1A	The front face of the panel cracked open at the bottom right. The panel was flaming on the inside.	
57	18	1A/1B/1C	The left side of the panel had stopped flaming.	
69	19	All	Flaming decreased.	
77	38	1C/2A	Flaming at the join ceased.	
82	46	All	All visible flaming ceased.	
90	00	All	The reaction to fire test ended.

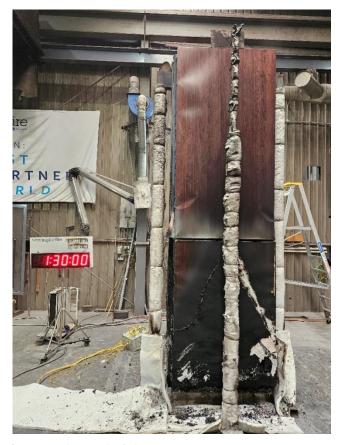
Figure 27 The specimen at the end of the test

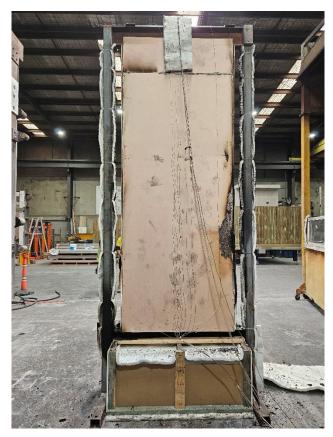
Figure 28 The specimen after the test – unexposed side.

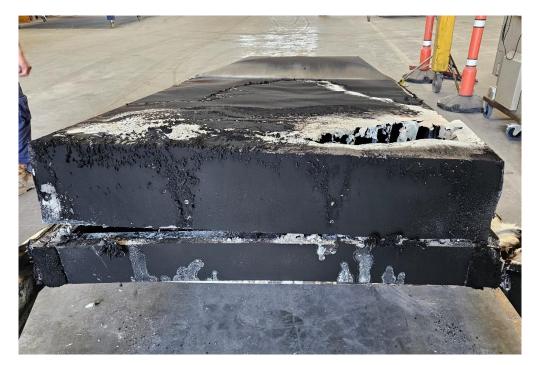
Figure 29 The specimen after the test – underside.
