Reaction to fire test report

Test standard: Ad-hoc test based off ISO 13785-1:2002

System: Aluminium composite panel wall system representative of the in-situ wall located at [REDACTED]
[REDACTED] – Scenario 2 - Test 2

Job number: RTF220104

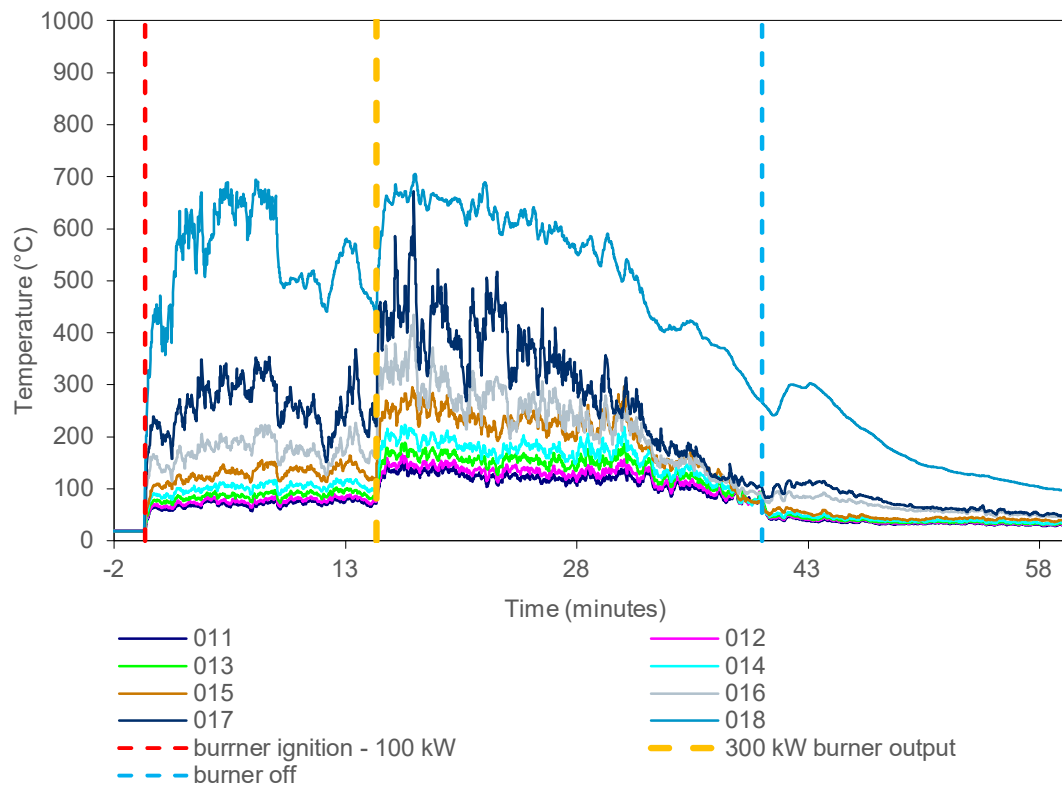
Figure 3 External temperature data collected by thermocouples placed 60 mm from the front face of the specimen.

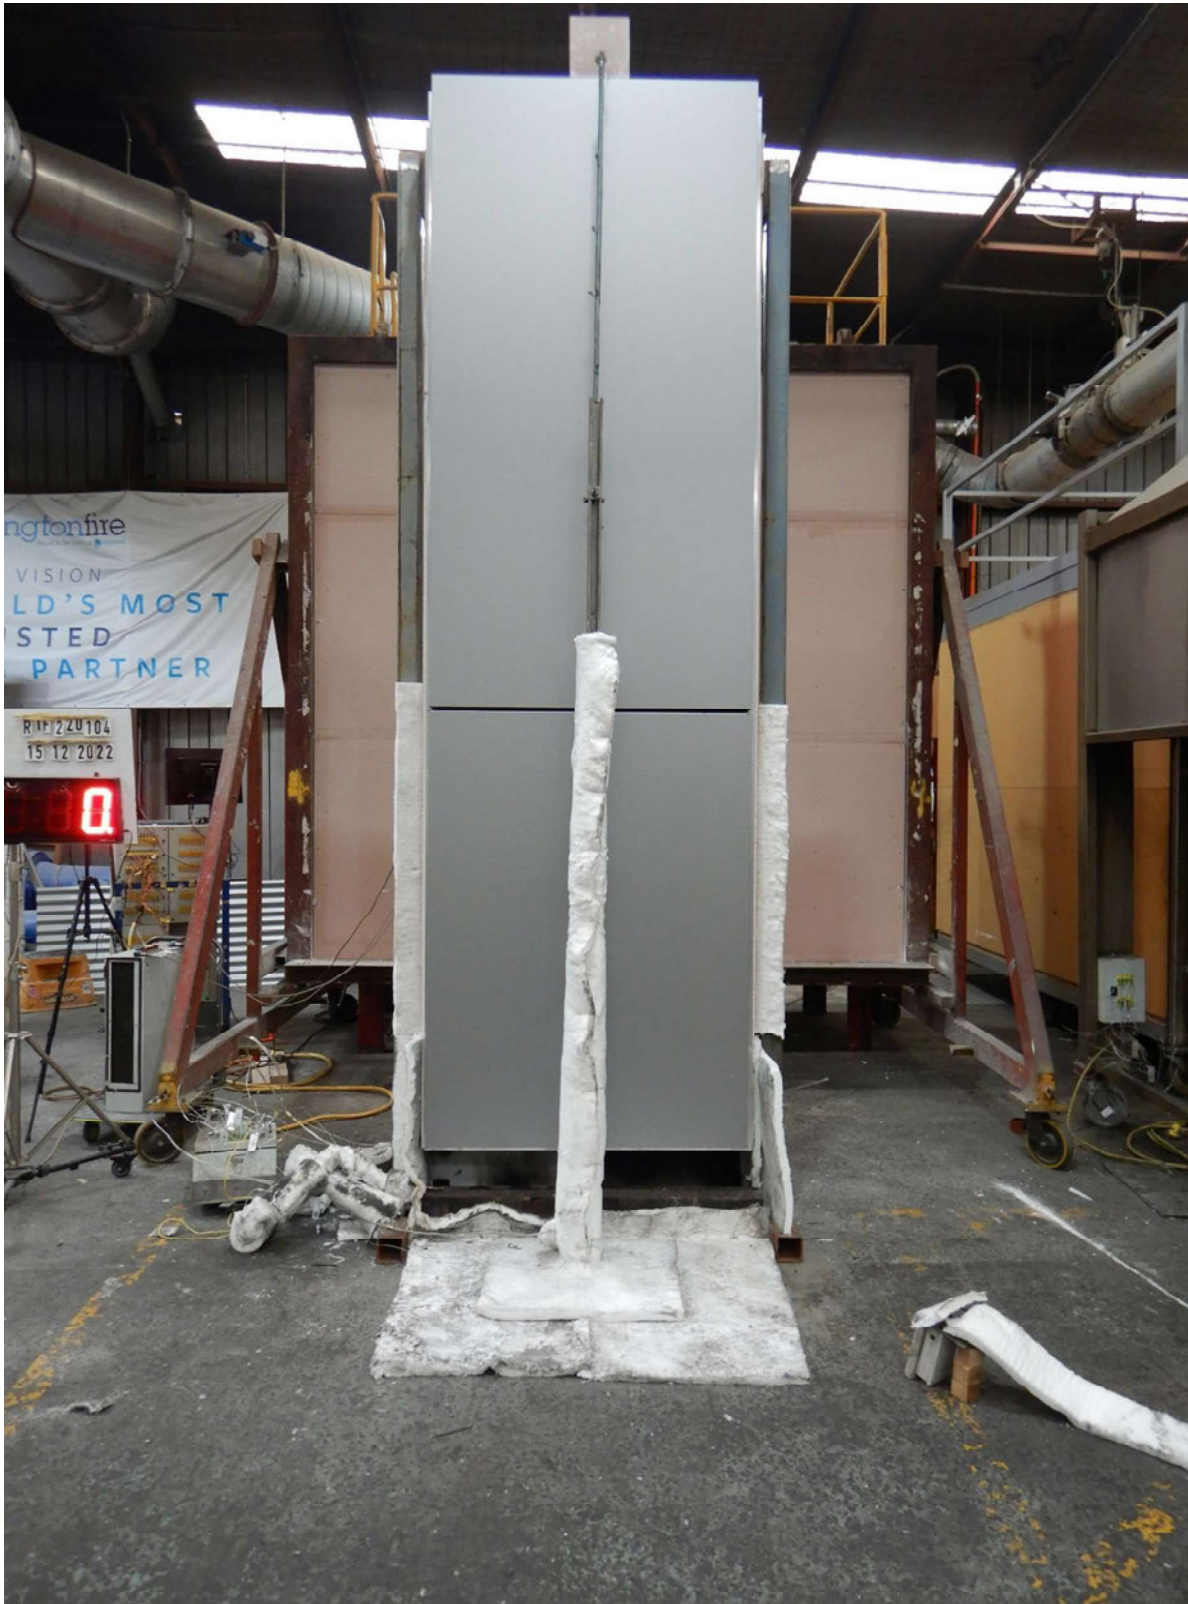
Figure 9 The specimen before the reaction to fire test

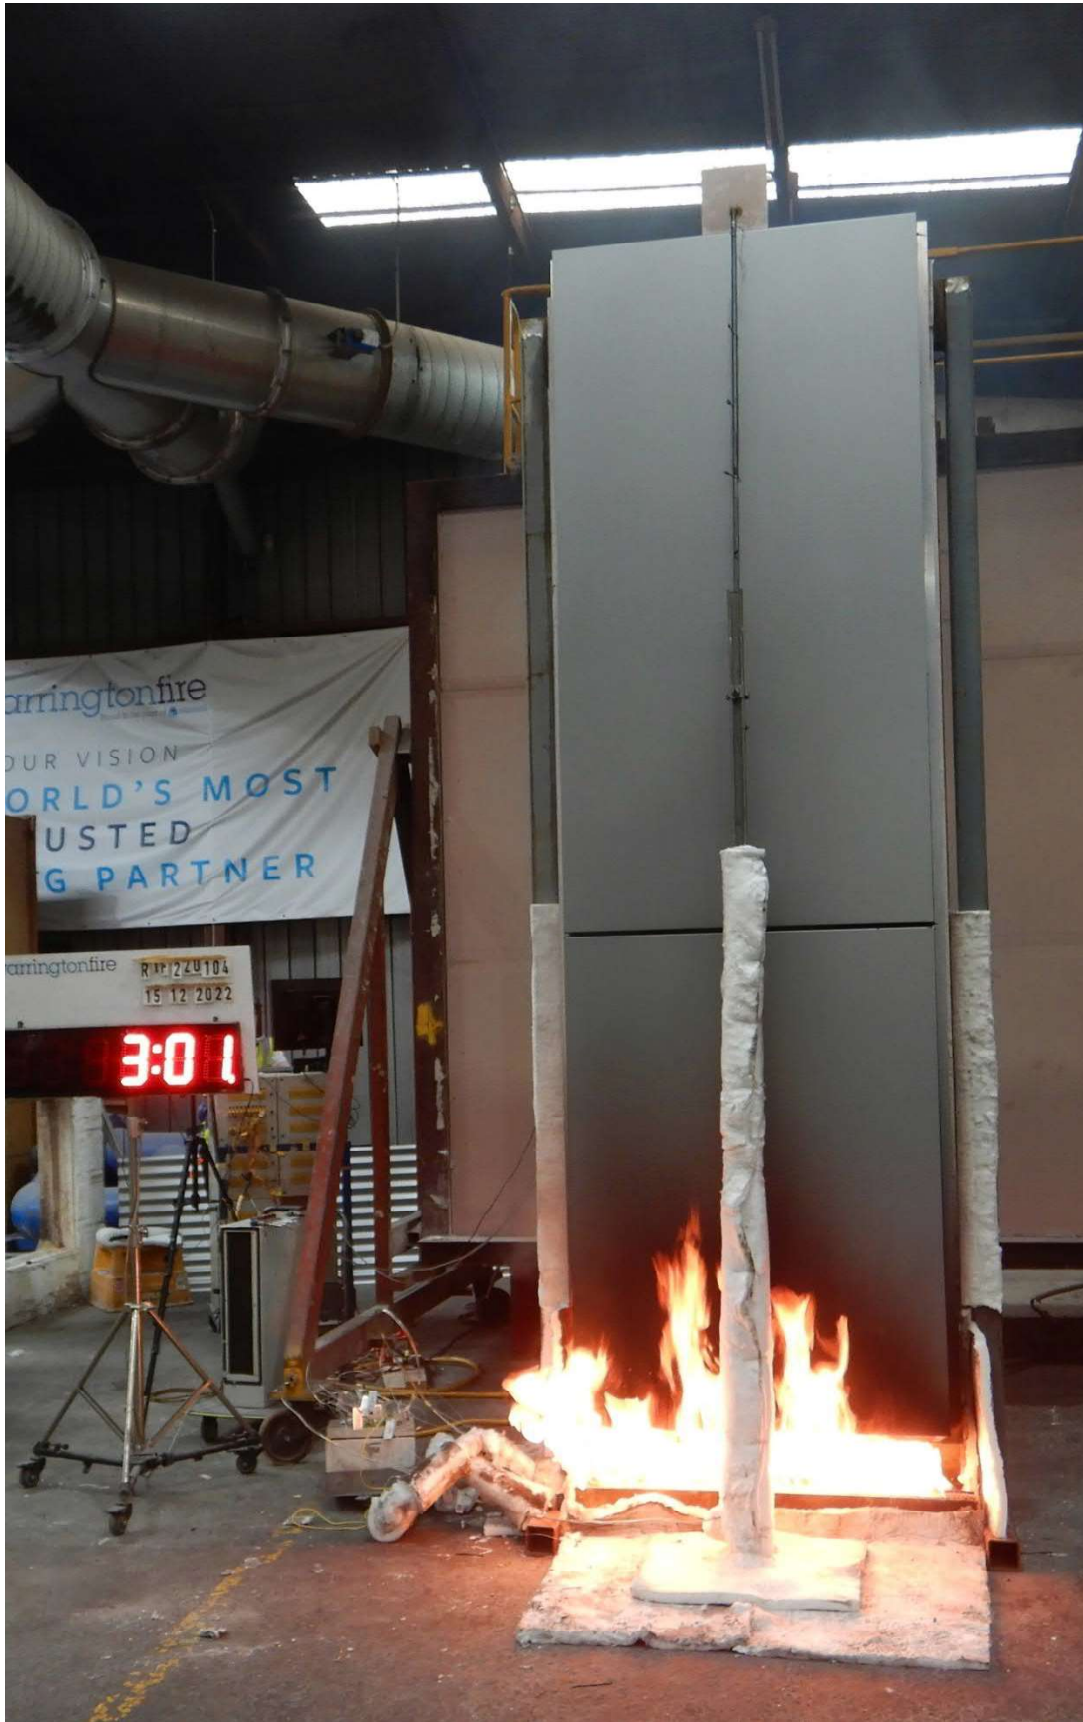
Figure 10 The specimen 3 minutes 1 second into the test (burner output at 100 kW)

Time		Observation
Min	Sec	
-2	00	Data collection started.
0	00	The reaction to fire test was started with the burner ignited with a heat output set at 100 kW.
0	40	The bottom ACP started to discolour.
1	45	Discolouration extended further up the ACP.
2	51	The bottom edge of the bottom panel had bowed/deformed slightly.
3	33	Molten flaming debris was dripping from the west corner.
4	30	The bottom ACP had discoloured all over.
7	15	There was a lot of emitting on the unexposed side along the bottom edge of the plasterboard.
9	00	There was a sudden pop (release of gas) from the bottom ACP.
13	42	Flames were intermittently spreading up the west edge of the ACPs reaching the horizontal join.
15	00	The burner output was increased to 300 kW.
15	30	There was discolouration of the bottom section of the upper ACP.
16	50	There was flaming along the bottom east vertical edge.
17	40	There was a lot of flaming along the bottom west vertical edge.

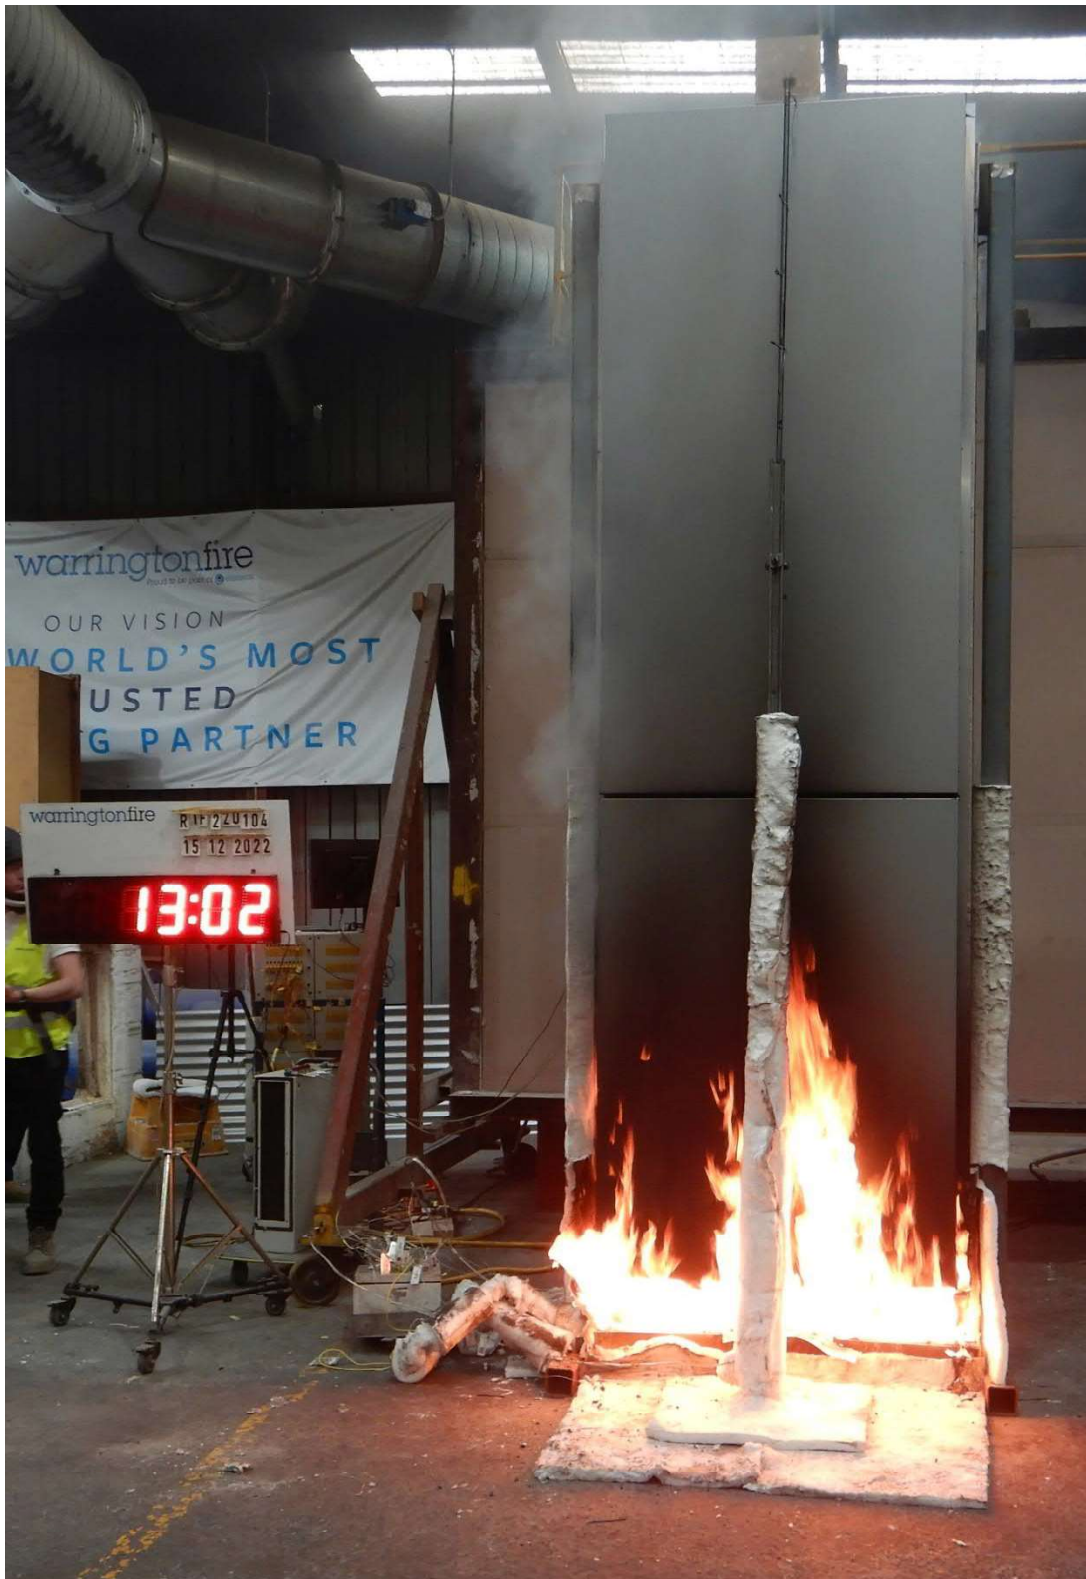
Figure 11 The specimen 13 minutes 2 seconds into the test (burner output at 100 kW)

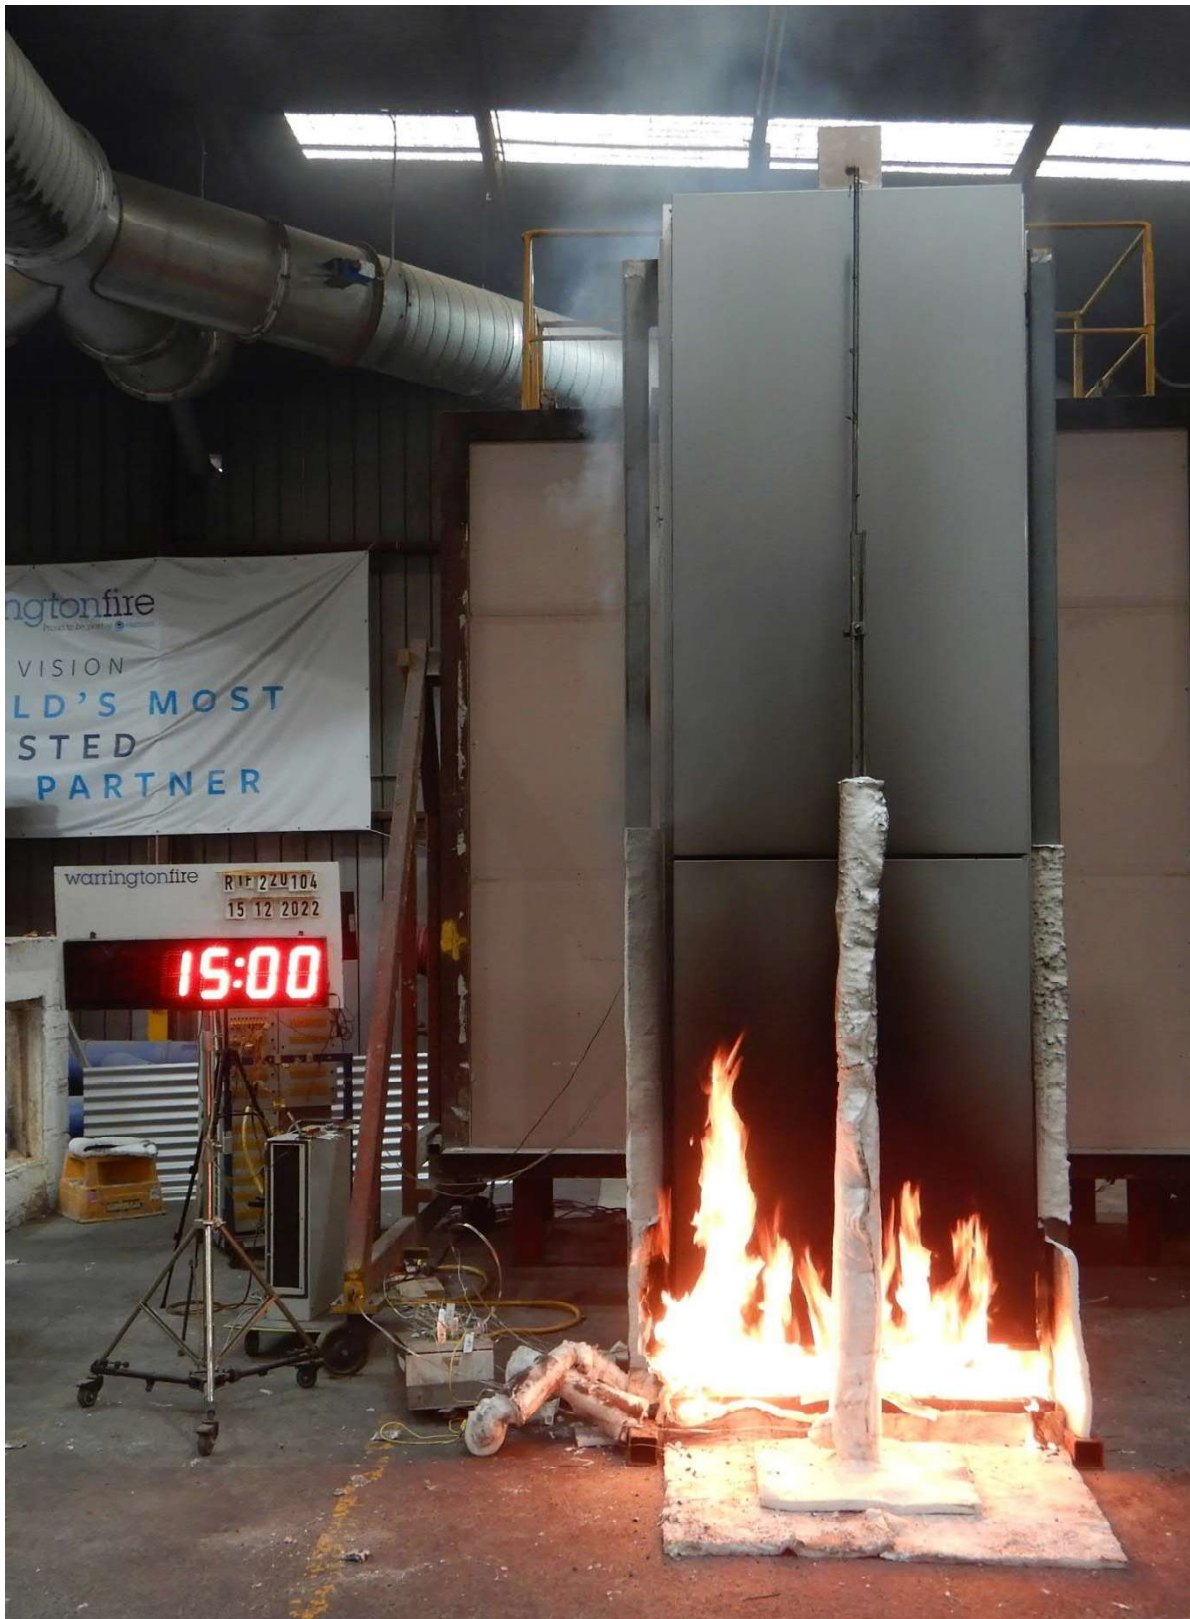
Figure 12 The specimen 15 minutes into the test (burner output at 100 kW changed to 300 kW)

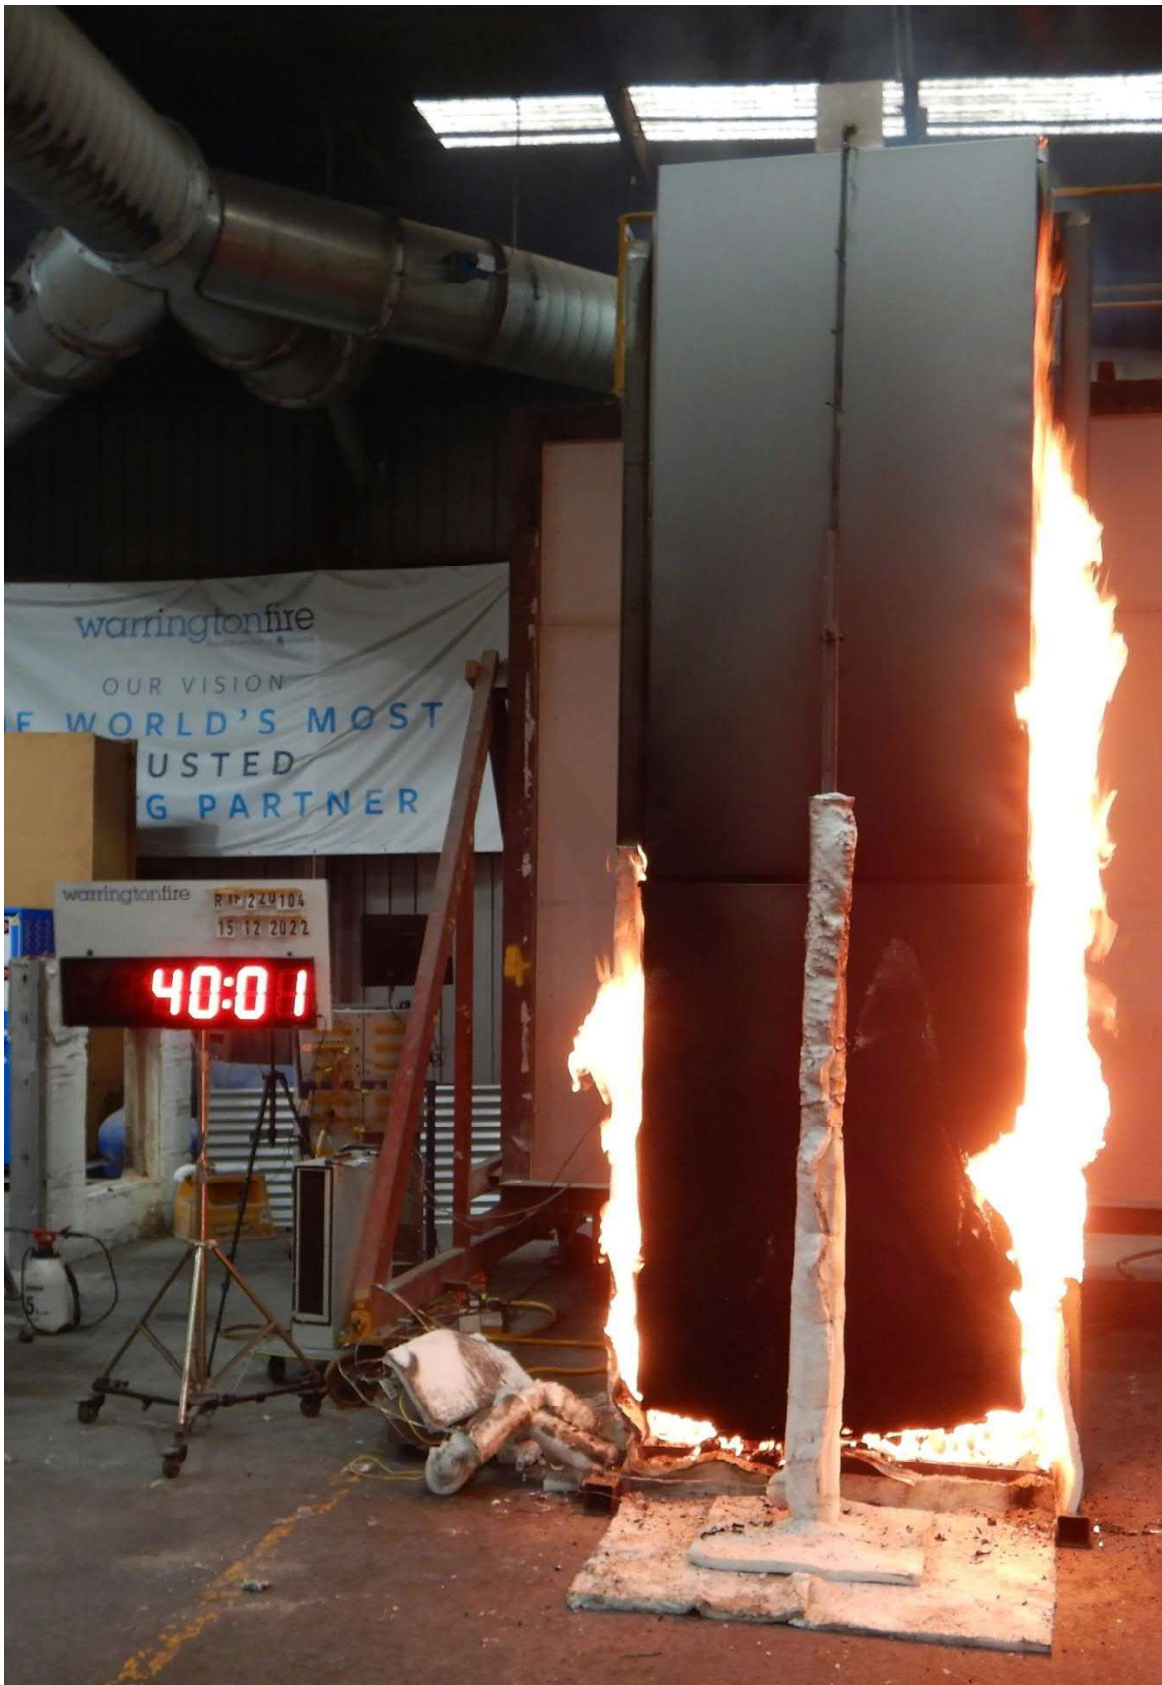
Figure 14 The specimen 40 minutes 1 second into the test (25 minutes 1 second after burner output was increased to 300 kW) – burner turned off.

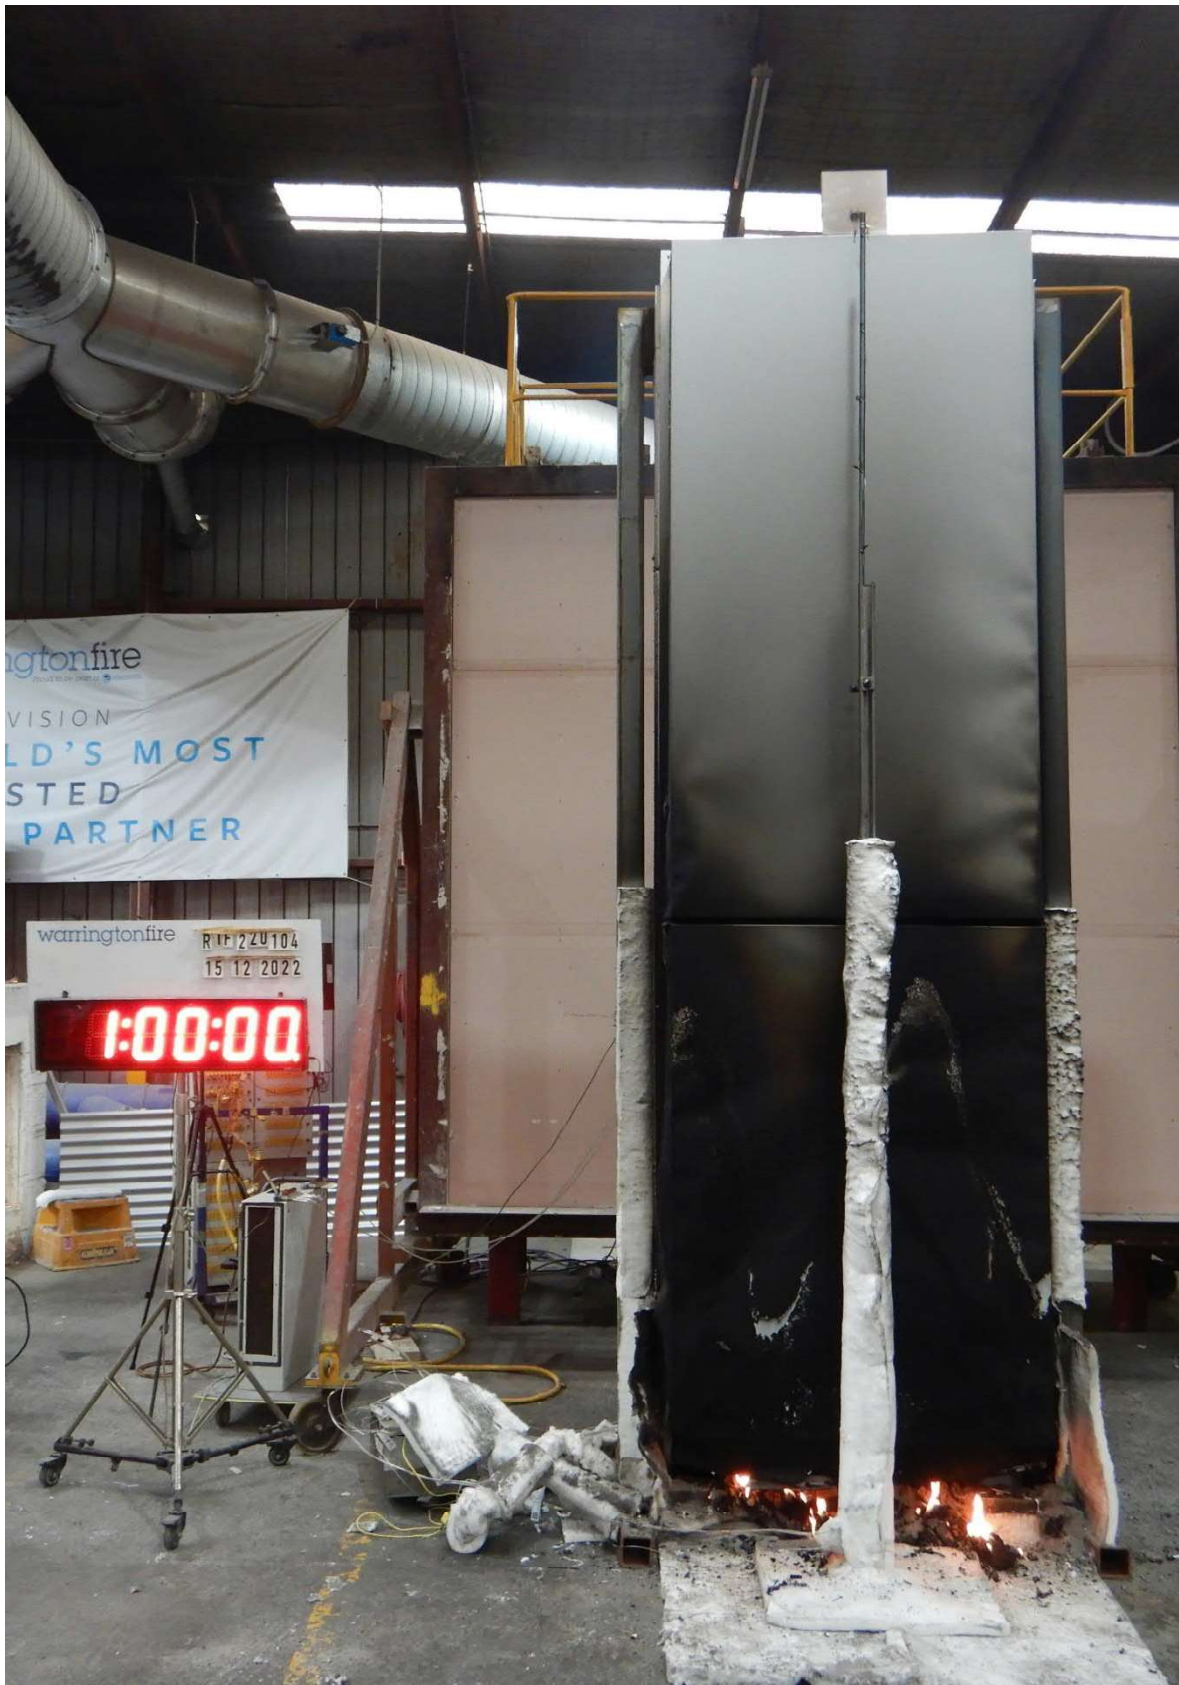
Figure 15 The specimen at the end of test.
