# Reaction to fire test report

Test standard: Ad-hoc test based off ISO 13785-1:2002 Test sponsor: Cladding Safety Victoria (CSV) System: A cassetted aluminium composite panel wall system Job number: RTF230111 Test date: 6 September 2023 Revision: R1.0

This report documents the findings of the first of three ad-hoc reaction to fire tests on a cassetted aluminium composite panel (ACP) external wall system - performed on 6 September 2023. The test was based on ISO 13785-1:2002.

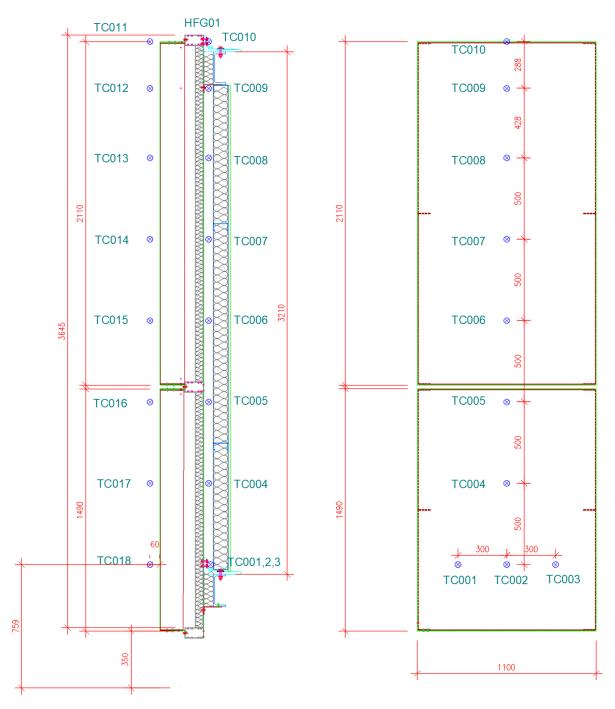
Figure 1 Instrumentation location

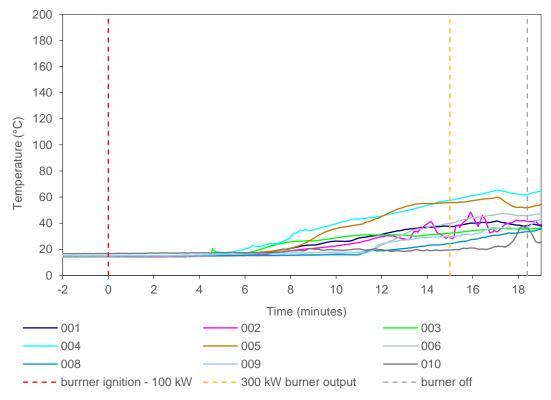
Figure 2 Internal temperature data collected by thermocouples placed within the cavity – between the internal and external segments of the specimen.

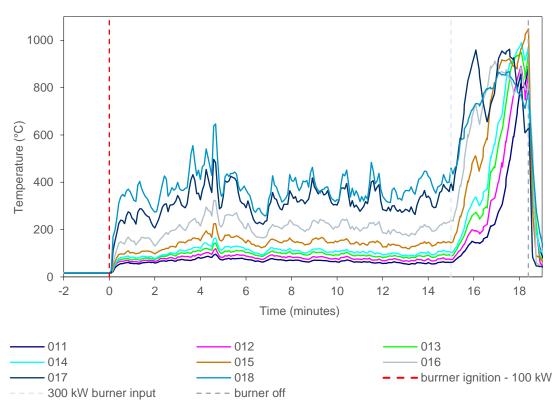
Figure 3 External temperature data collected by thermocouples placed 60 mm from the front face of the specimen.

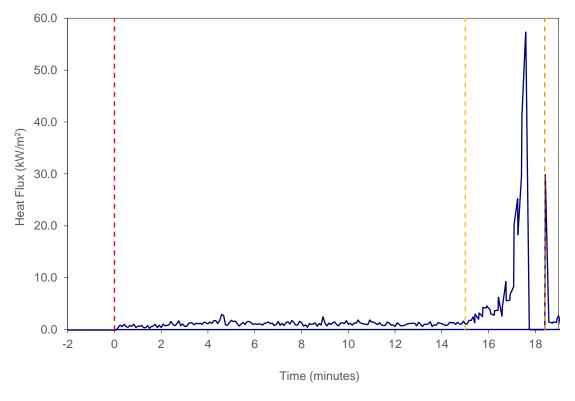
HFG1 ---- burrner ignition - 100 kW ---- 300 kW burner output ---- burner off

Figure 4 Heat flux data collected by heat flux gauges.

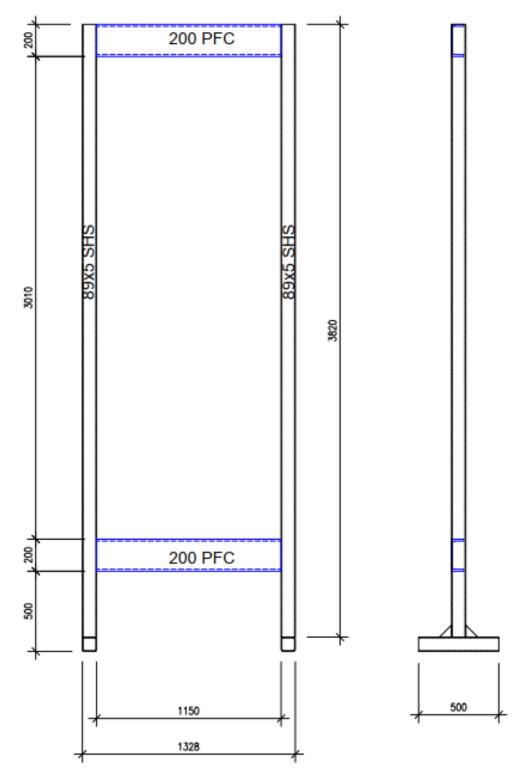
Figure 6 Elevation of rig support.

4.	Item name	Test rig frame - 90 × 90 SHS and 200 × 90 PFC frame	
	Size	90 mm × 90 mm × 5 mm thick and 200 mm × 90 mm × 10 mm thick – refer to Figure 6.

The drawings of the test assembly in Figure 6 to Figure 9 were provided representatives of Warringtonfire. Dimensions, unless specified, are in mm.

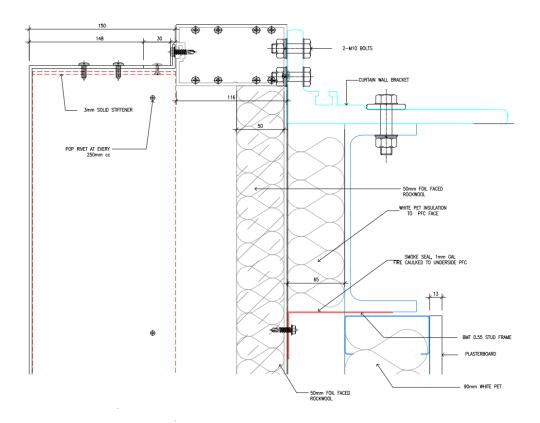
Figure 8 System assembly – top edge detail

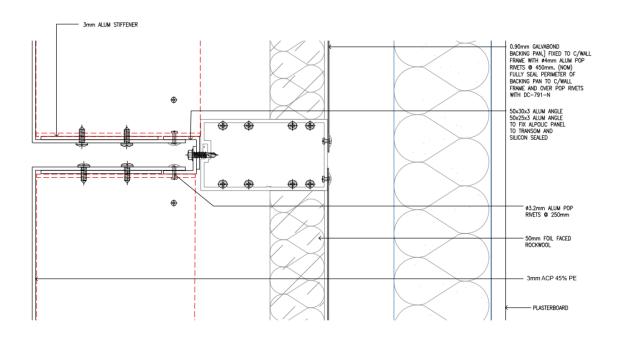
Figure 9 System assembly – middle join detail (D05)

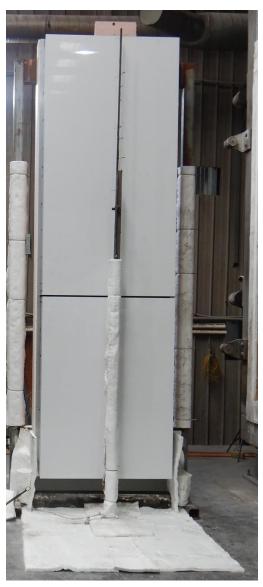
Figure 10 The specimen before the reaction to fire test

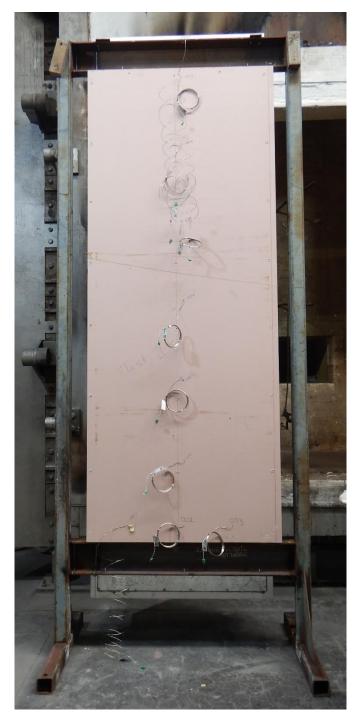
Figure 11 The specimen before the reaction to fire test – unexposed side

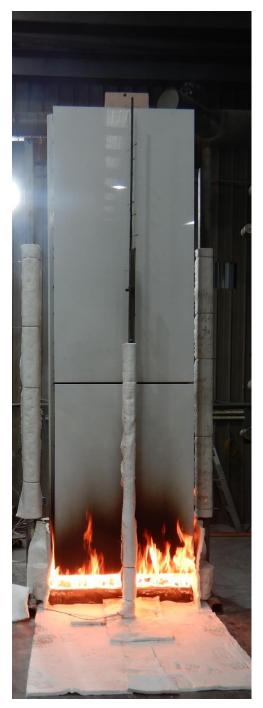
Figure 12 The specimen 1 minute 42 seconds into the test (burner output at 100 kW)

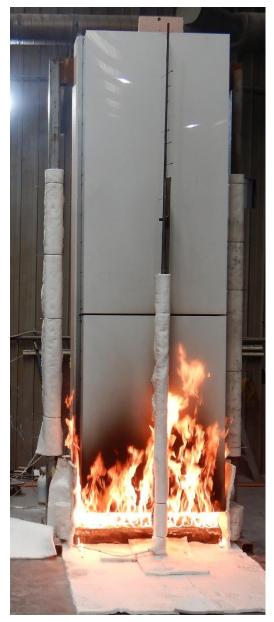
Figure 13 The specimen 3 minutes 11 seconds into the test (burner output at 100 kW)

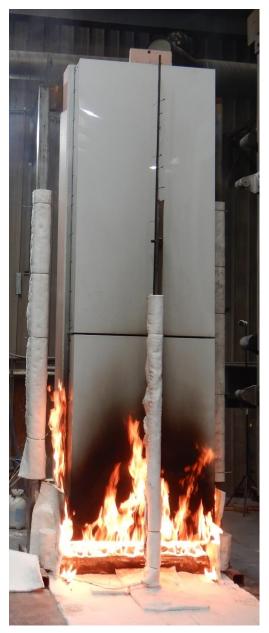
Figure 14 The specimen 4 minutes 53 seconds into the test (burner output at 100 kW)

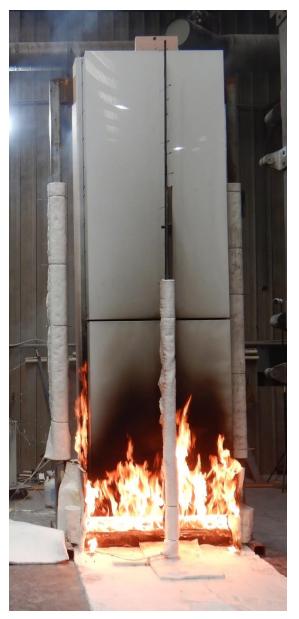
Figure 15 The specimen 9 minutes 53 seconds into the test (burner output at 100 kW)

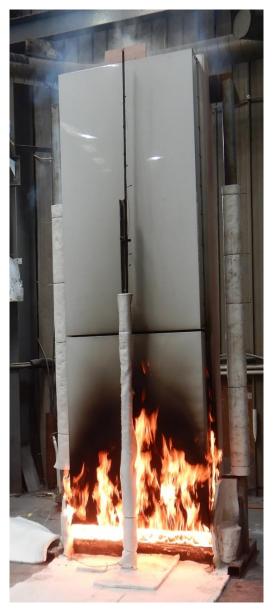
Figure 16 The specimen 13 minutes 14 seconds into the test (burner output at 100 kW)

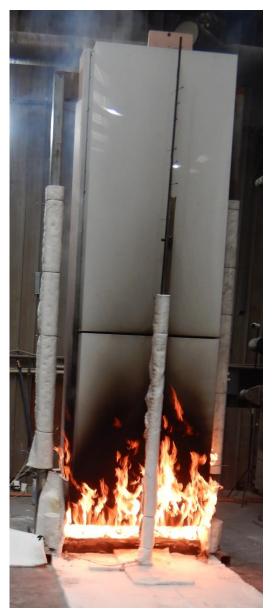
Figure 17 The specimen 14 minutes 45 seconds into the test (burner output at 100 kW)

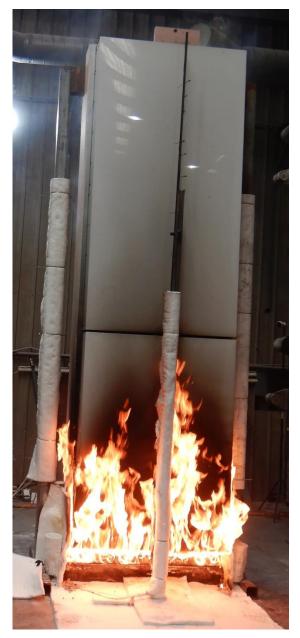
Figure 18 The specimen 15 minutes 2 seconds into the test (2 seconds after burner output was changed to 300 kW)

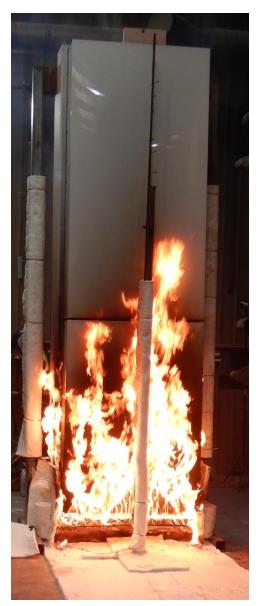
Figure 19 The specimen 15 minutes 41 seconds into the test (41 seconds after burner output was changed to 300 kW)

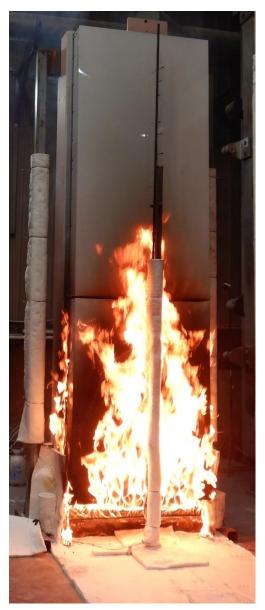
Figure 20 The specimen 15 minutes 56 seconds into the test (56 seconds after burner output was changed to 300 kW)

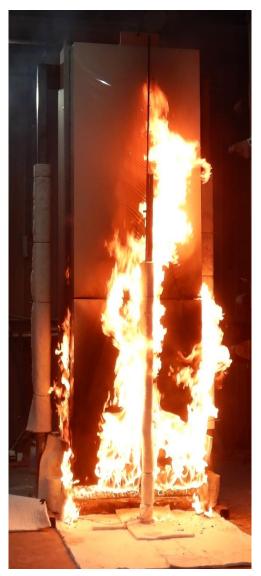
Figure 21 The specimen 16 minutes 55 seconds into the test (1 minute 55 seconds after burner output was changed to 300 kW)

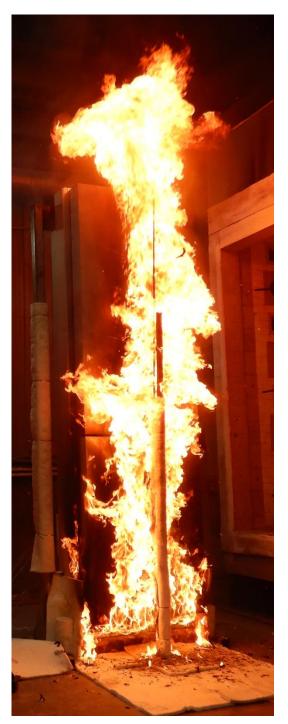
Figure 22 The specimen 17 minutes 45 seconds into the test (2 minutes 45 seconds after burner output was changed to 300 kW)

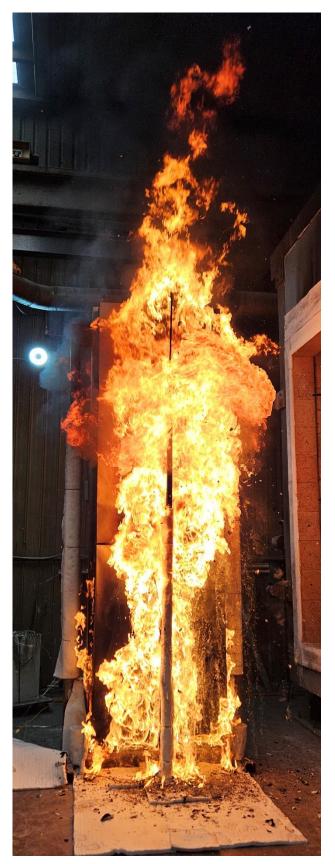
Figure 23 The specimen 17 minutes 52 seconds into the test (2 minutes 52 seconds after burner output was changed to 300 kW)

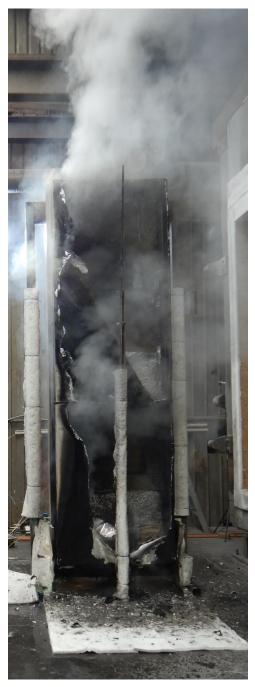
Figure 24 The specimen shortly after being sprayed with water

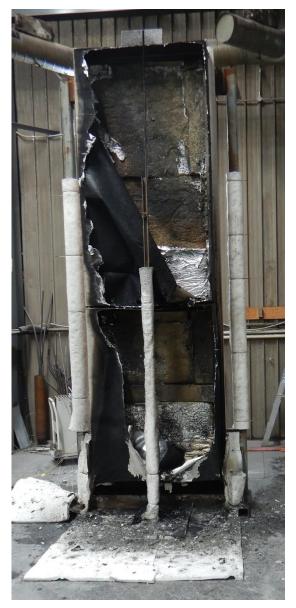
Figure 25 The specimen after the test.

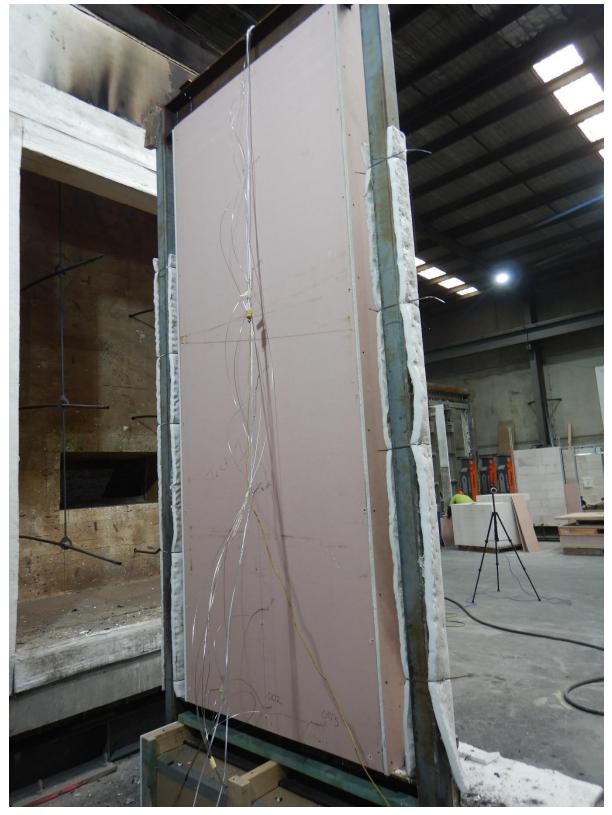
Figure 26 The specimen after the test – unexposed side.
