RESEARCH ANALYSIS

Clerk of Works: Promoting quality and safety in construction

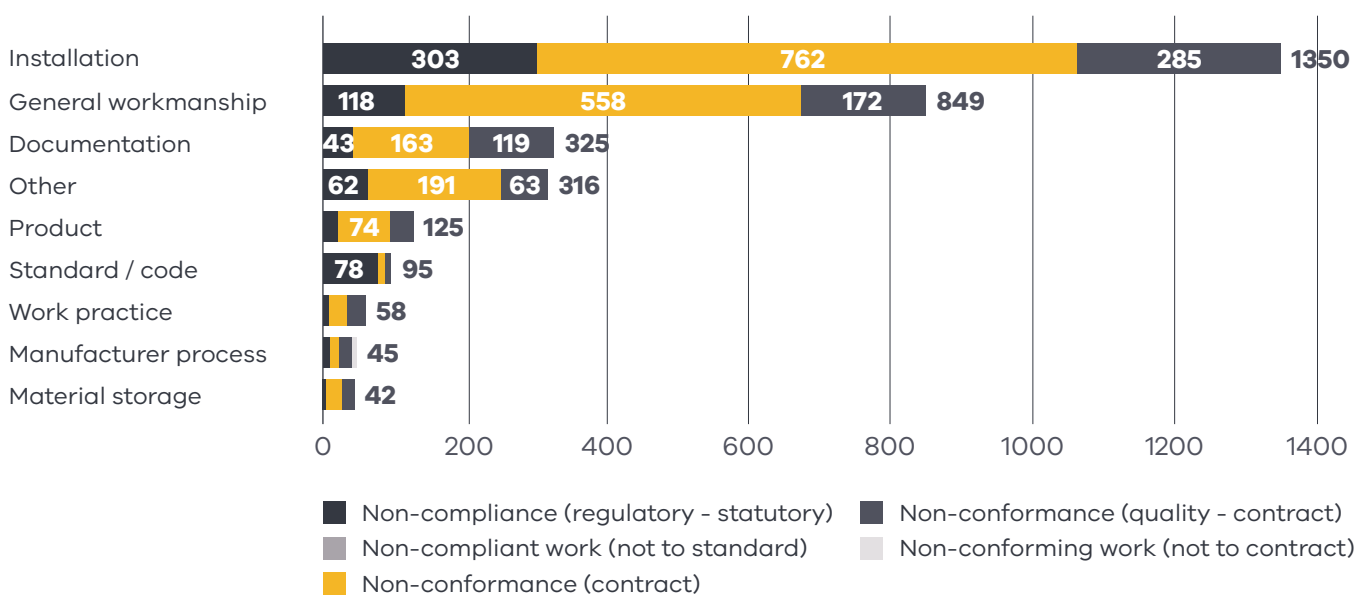
Figure 1. Quality observations by contributing condition and type

Figure 1 illustrates that over 60 percent of the quality observations (including both non-compliant and non-conforming types)³ are due to installation and general workmanship. These issues are associated with about 200 or more projects as determined by the Clerk of Works over the three-year period.

3 The types of non-compliance and non-conformance described in Figure 1 are defined as:

- Non-compliance – is a product, material or workmanship that doesn't conform to defined standards, codes or regulation.
- Non-conformance – is a contractual requirement, an item or process that does not meet the plans, specification or requirement of a process, system policies and procedures or CSV requirements.

Over 3,400 quality observations (both non-compliant and non-conforming types) were made on site from July 2021 to June 2024. Figure 1 provides a high-level summary of the quality observations recorded.

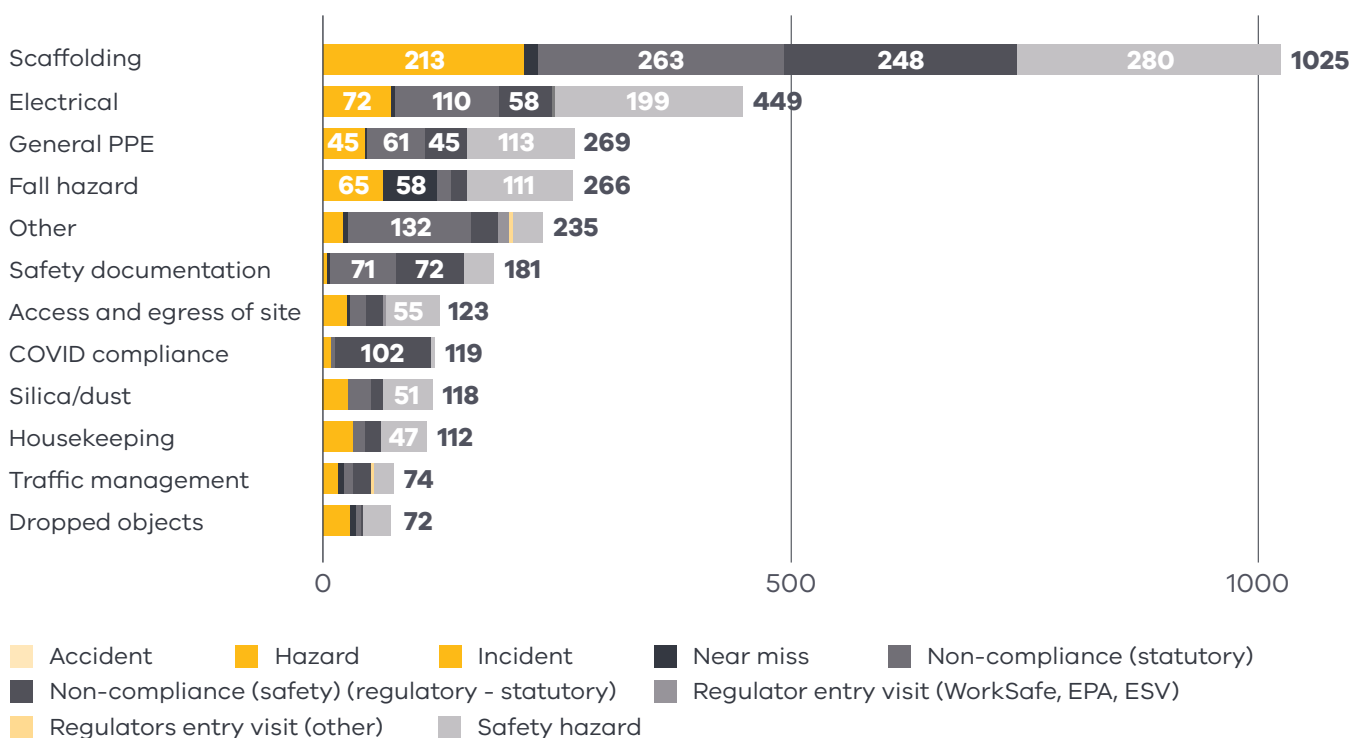
Figure 8. Safety observations made by Clerk of Works inspectors

Figure 8 shows that between 1 July 2021 and June 2024, the top five safety hazards observed by the Clerk of Works inspections were:

- **Safety documentation** – absence of planning for high-risk construction work (i.e. construction management plans, traffic management plans, COVID-19 plans and safe work method statements (SWMS)). Not planning the work can lead to injuries and illness. Victorian occupational health and safety legislation requires any activity defined as high-risk construction work must have a SWMS (consultation, sequential, hazards, risk and controls).
- **COVID-19 compliance** – to ensure all reasonable steps are taken to protect workers from the risk of contracting COVID-19 in the workplace.

Over 3,300 safety observations were made on site during the period to 30 June 2024. A high-level summary of the safety observations can be seen in Figure 8.

The hazards highlighted in Figure 8 made up the majority of the 1,664 safety hazards identified during this period. A possible cost saving, based on Safe Work Australia's data of a serious claim,⁴ could be up to \$26.2 million in compensation paid if these hazards were not identified and addressed, and on average, resulted in around 13,000 weeks in time lost from work and other associated costs.

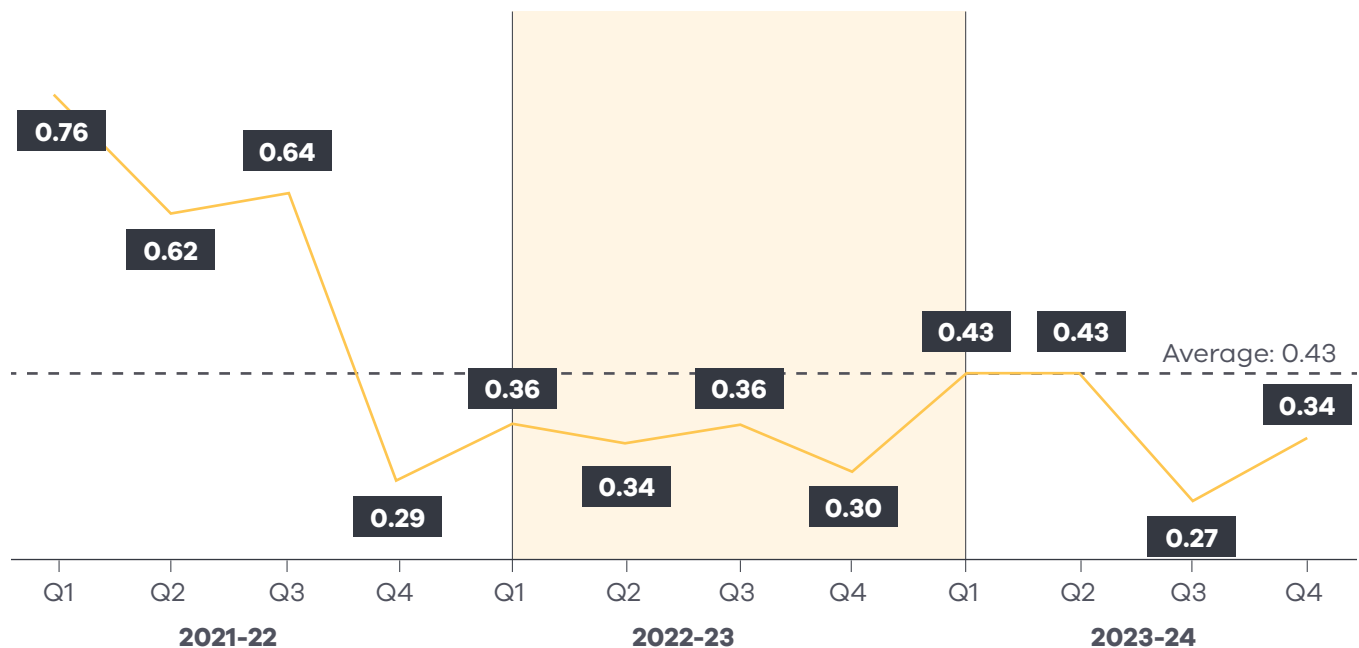
Figure 9. Rate of Clerk of Works observations per site over time

observation per site visit at the introduction of the inspection regime, it has reduced during the period to three observations across ten site visits at the end of the 2024 financial year. The results are illustrated in Figure 9.⁷

⁷ The significant improvement in the rate of observations per site during quarter 3 and quarter 4 of the 2021-22 financial year can be explained by a combination of factors including: the introduction of a new system at CSV to provide greater visibility of individual building schedules and better accuracy around the timing of site visits; better visibility of data on a daily basis to support monitoring of Clerk of Works activities; a change in the Clerk of Works contract manager accompanied by a review of practices and associated process improvements; a change in Clerk of Works providers; and, active knowledge-sharing by CSV leading to improvements in on-site practices with our program partners.
